Preview of PCI's New Zealand earthquake reconnaissance team report

Precast concrete structural design in New Zealand

Case study: PricewaterhouseCoopers office building

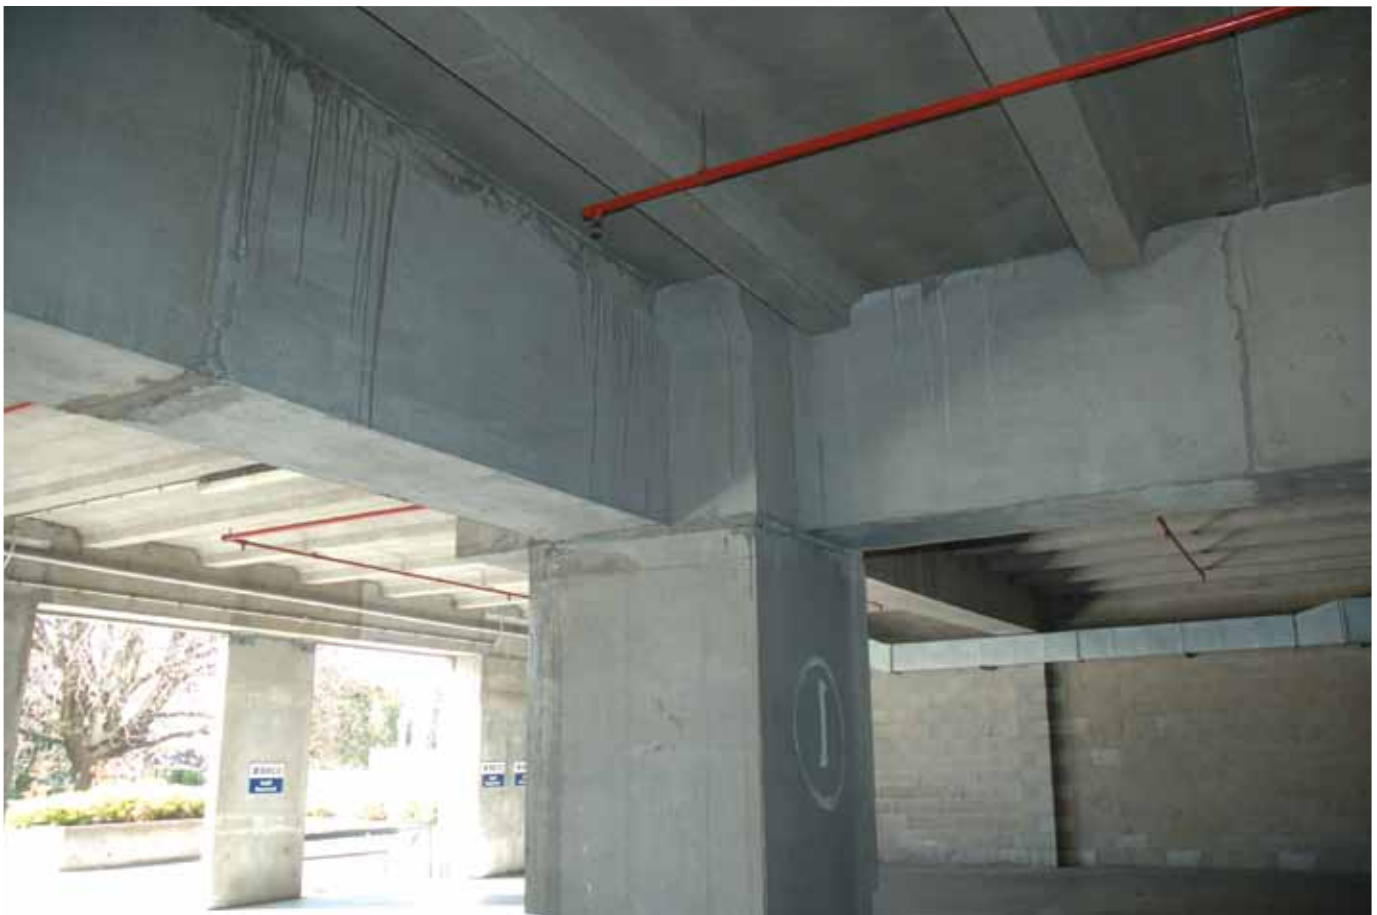
Figure 3 shows the perimeter moment-resisting frame (background) and the interior “gravity” frame (foreground) following the earthquake of February 22. As can be seen, the columns are more closely spaced in the perimeter frame.

Figure 3. Corner joint in first-level parking podium area after February 22, 2011, earthquake in New Zealand. Photo courtesy of Franz Kahn.

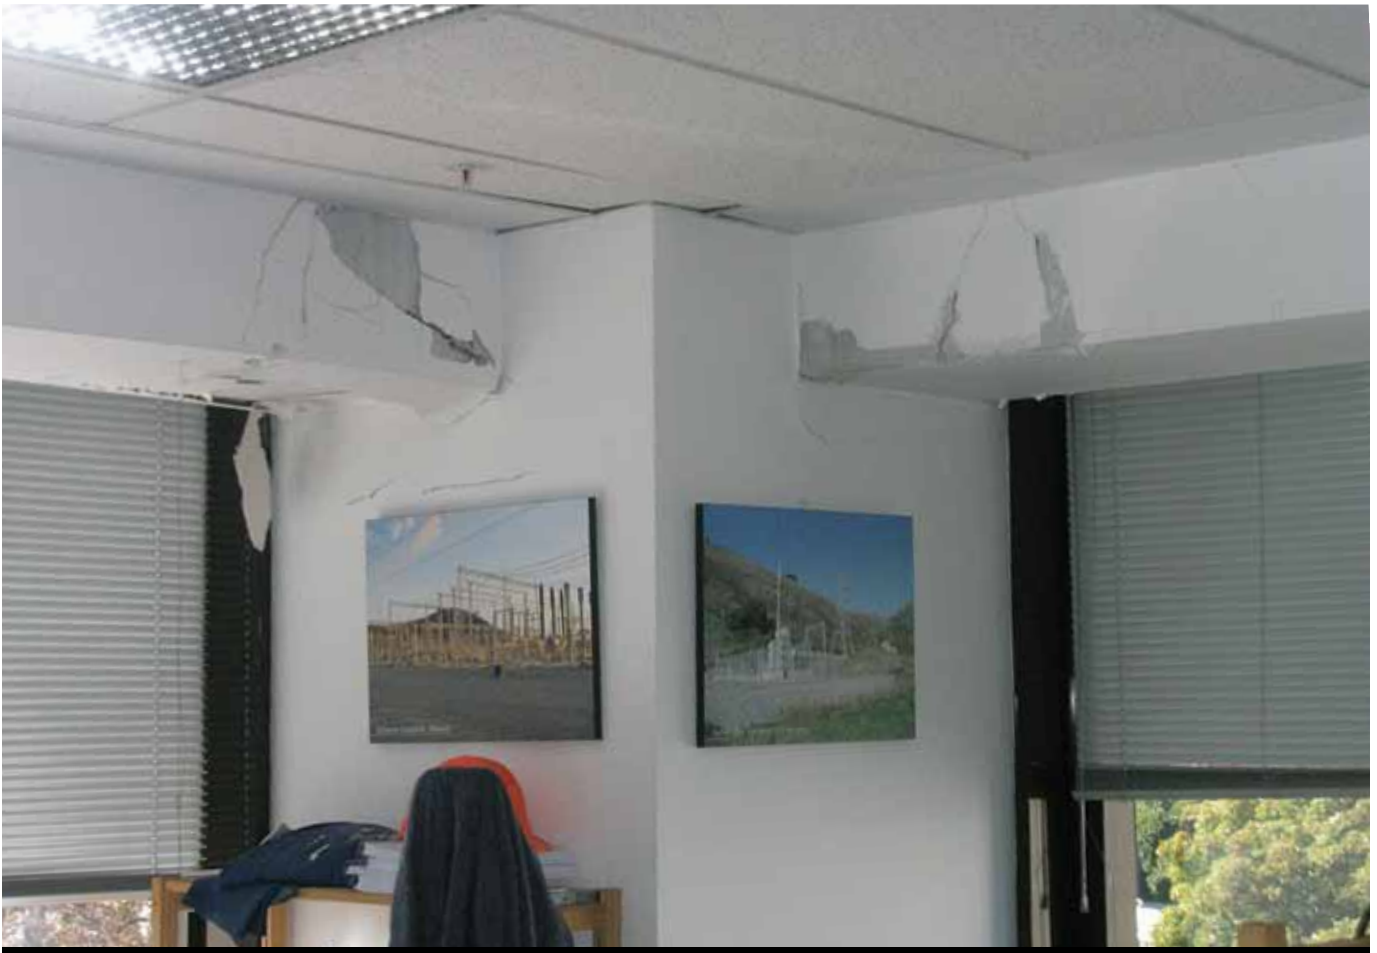
A visual survey of this building by the authors showed a pattern of damage consistent with capacity design (**Fig. 4**). The lowest two floors, situated above a parking garage and undergoing less deformation, showed no plastic hinging. The lower- to midlevel floors showed the greatest beam de-

formation and damage, and the upper floors less damage. Figure 4 shows the damage to the perimeter frame on the interior of the 10th floor. The north-south beam exhibits flexural-torsional cracks from earthquake displacement perpendicular to the frame, while the east-west beam exhibits flexure cracks. The authors judge that the flexural cracking observed does not reduce the strength of the beams and does not substantially diminish their continued deformation capacity or the ability of the structure to resist future earthquakes.

The exterior moment-resisting frame of the PricewaterhouseCoopers building performed as intended, forming the desired flexural plastic hinges at the ends of the beams. No structural damage was observed in the columns. Where the damage was greatest, cracking and flexural torsion were associated with these hinges. The extent of the damage is not surprising given the extreme intensity of the earthquake motions. The authors judge the office building to have met or exceeded its design requirements to avoid collapse in the maximum considered earthquake.

Figure 4. Corner joint in upper floor indicated damage suffered in February 22, 2011, earthquake in New Zealand. The north-south beam (upper left) exhibits flexural-torsional cracks, while the east-west beam (upper right) exhibits flexure cracks.
