FAILURE MODES AND INSPECTION METHODS FOR NON-COMPOSITE ADJACENT PRESTRESSED CONCRETE BOX BEAM BRIDGES

Clay Naito¹, Ph.D., PE, Lehigh University Department of Civil Engineering, Bethlehem, PA

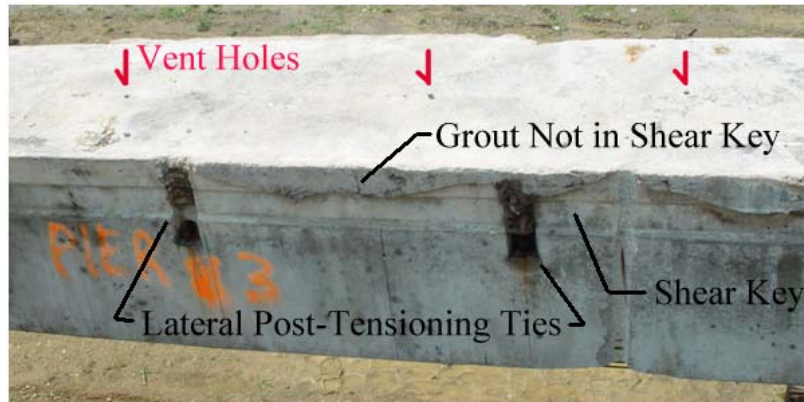
lateral ties. Furthermore, the construction details in some of the early systems provided only a narrow opening through which to grout the shear key. As illustrated in Figure 2, demolition of decommissioned bridges indicates that in many cases incomplete grouting of the shear keys occurred. The staggered lateral post-tensioning combined with improperly fabricated shear keys laid the ground work for long term serviceability issues.

Figure 2: Improper grouting of a shear key

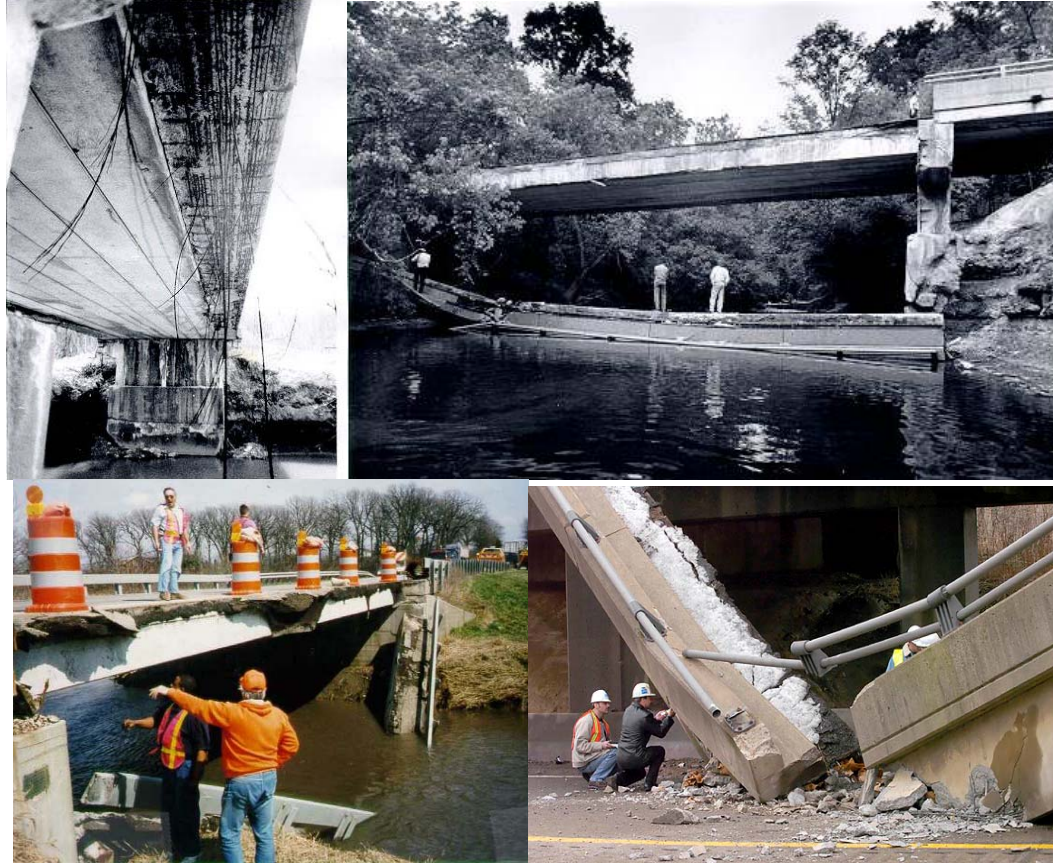
Three beam failures followed the problems in Indiana. In 1986 inspection of a Cuyahoga County bridge in Ohio revealed complete spall of the fascia beam soffit and severed strands (Figure 3). A sag of 6 in. was noted in February 1989 and by August 1989 a complete failure of the beam had occurred. In 1997 an inspection of Illinois IDOT structure 046-0055 noted longitudinal cracking of the bottom flange, spalling and corrosion of the strands on a fascia beam. Within 6 months of the inspection the beam had failed. In Pennsylvania a 2004

inspection of the Lake View Drive Bridge over Interstate 70 revealed spall of the bottom flange and over 20 broken strands on the fascia beam. By December of 2005 strand deterioration progressed to the point where the beam failed near midspan and ended up in the Interstate below. These failures are illustrated in Figure 3.

Figure 3: Adjacent non-composite box beam failures (from top left clockwise: Ohio bridge pre-failure, Ohio bridge post-failure, Pennsylvania failure, Illinois failure)

The commonality of these failures was clearly observable deterioration of the prestressing steel strands. The steel reinforcement was heavily corroded and significant spalling of the concrete cover on the beam bottom flange had occurred. Based on the post failure inspection of the beams the question was not why the beams had failed but how they had remained in service with such high levels of corrosion and steel section loss.

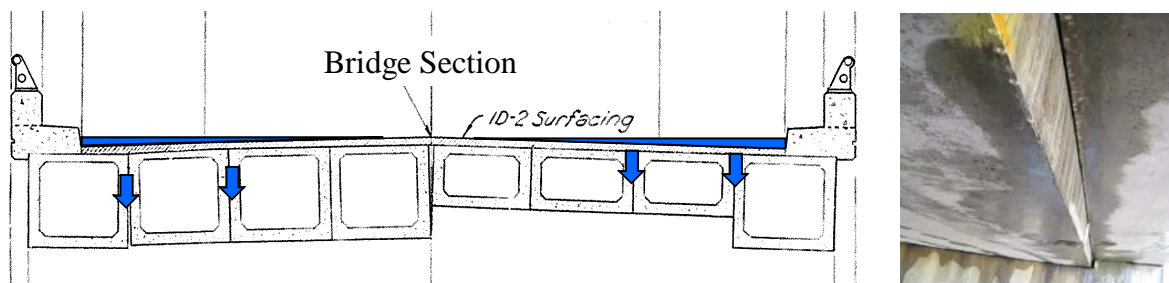
In many Northeastern states deicing chemicals are used in the winter to ensure safe driving conditions. These deicing chemicals typically come in the form of sodium chloride (NaCl), calcium chloride (CaCl_2), or magnesium chloride (MgCl_2). The chloride present in the deicing chemicals wash from the road surface through the longitudinal bridge joints and onto the supporting beams. In most adjacent box beam bridges a curb and parapet is fabricated on the fascia beam. This curb section combined with cross-slope of the bridge deck, the permeable asphalt wearing surface, and either damaged or non-existing waterproof barriers result in water seepage onto the beams. The concept and a photo of the water transmission are illustrated in Figure 4.

Figure 4: Water transmission from deck to beams

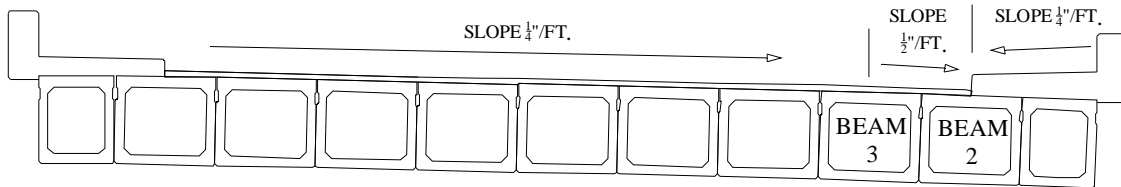
The cross-slope of the bridge and the placement of the sidewalk can directly influence the long-term damage to the individual bridge members. A section of the Main Street Bridge in South Strabane Township is illustrated in Figure 5. Bridge inspection revealed heavy corrosion damage only on beams 2 and 3. Due to the placement of the sidewalk, the fascia beam was protected from continual water flow. These observations can be used to identify failure of water barriers and shear keys on existing systems. Also, this concept can be used to identify likely areas of corrosion initiation.

Figure 5: Main Street Bridge section

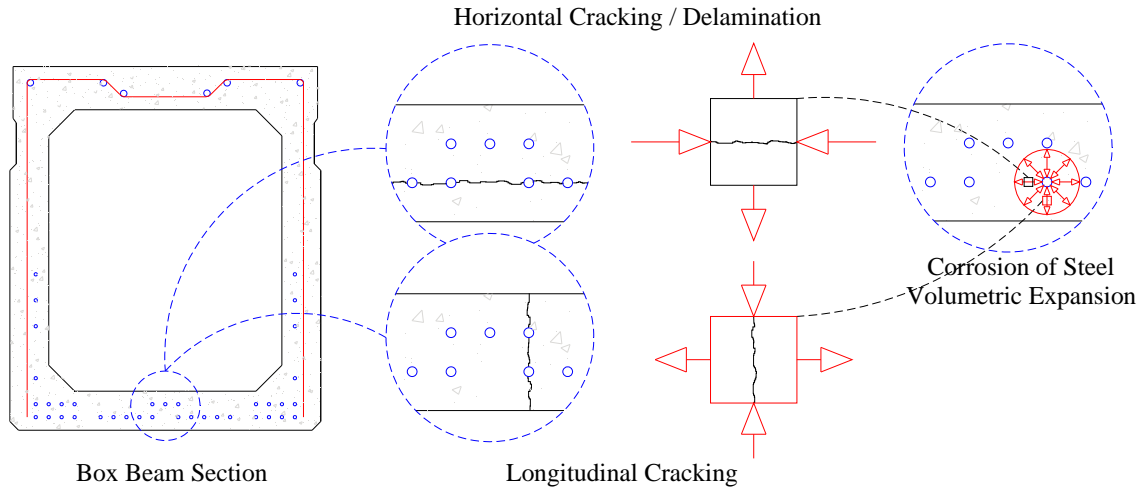
Once elevated levels of chloride are absorbed into the concrete the corrosion mechanism initiates. The chlorides create an ionic defect in the passive layer of protection around the steel resulting in corrosion product formation. The corrosion process results in an increase in volume of up to 6.5 that of the original strand size. As the strands corrode and increase in size a compression force is placed on the surrounding concrete. In accordance with mechanics concepts a tensile stress also forms perpendicular to the compression force. When the tensile stress exceeds the tensile capacity of the concrete a crack is formed. These cracks can occur horizontally in the form of delaminations or vertically as longitudinal cracks. Typically, delamination cracks form when corrosion occurs over multiple strands and the volumetric expansion of the individual strands work together to split a horizontal section. For regions where isolated corrosion is occurring, a longitudinal splitting crack is more common.

Figure 6: Corrosion induced cracking
