DINGMAN DRIVE BRIDGE – REINSTATEMENT OF SEVERED STRANDS ON PRESTRESSED GIRDERS DAMAGED BY VEHICLE IMPACT

Andrew F. Turnbull, P.Eng., Ministry of Transportation Ontario, London, Ontario, Canada
Wade F. Young, P.Eng., Ministry of Transportation Ontario, London, Ontario, Canada
Clifford Lam, P.Eng., Ministry of Transportation Ontario, St. Catharines, Ontario, Canada

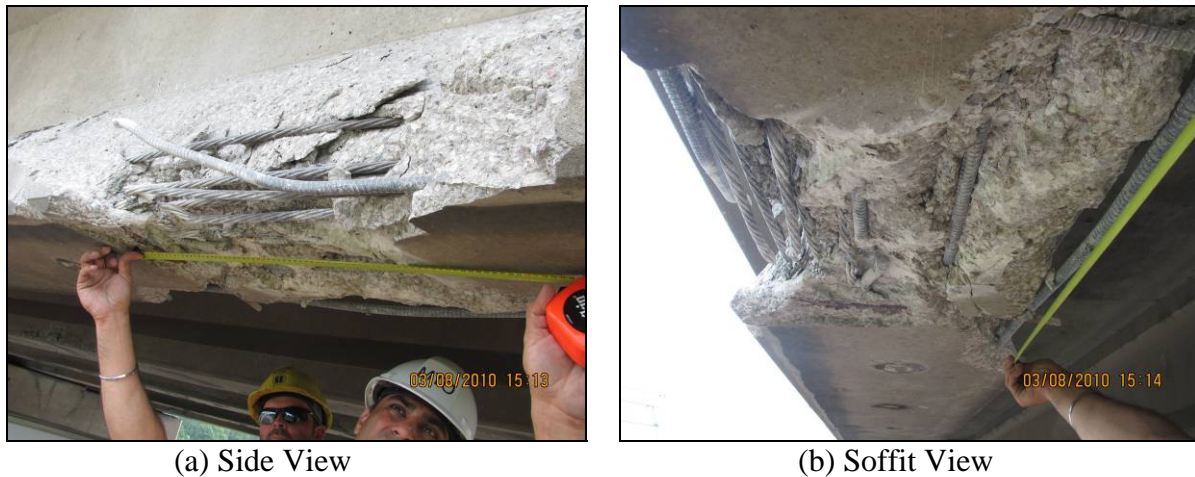
Fig. 5: Girder #1 Impact Damage

Girder #1 – Severe spalling of the bottom flange of the girder occurred over a length of approximately 4.2 metres. Three ½-inch diameter prestressing strands in the bottom row and two #5 longitudinal reinforcing bars in the bottom flange were severed. Two rows of prestressing strands in the bottom flange debonded over a length of approximately 1.7

metres. A hairline (less than 0.1 mm wide) to narrow (0.1 to 0.3 mm wide) crack, approximately 11 metres long developed at the interface of the girder web and top flange.

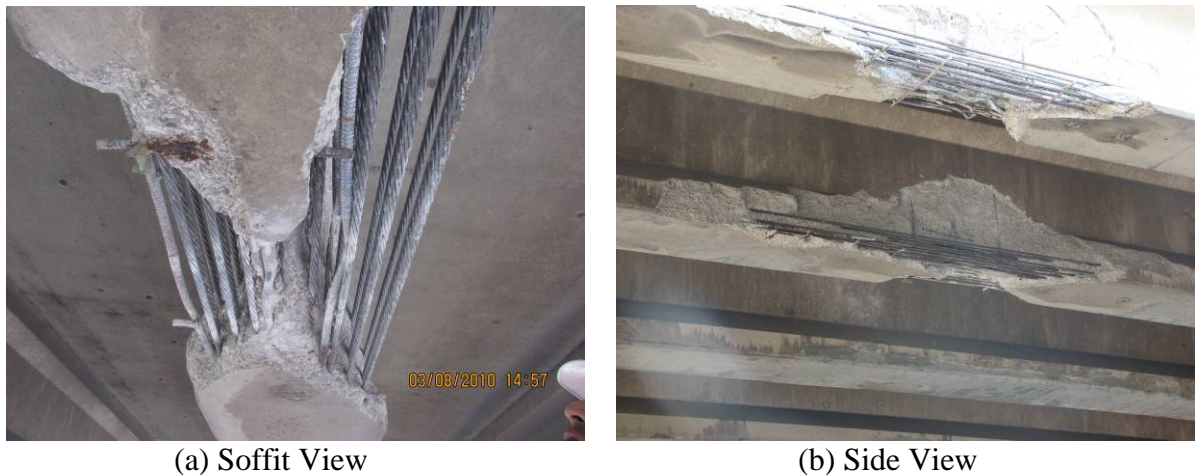
Fig. 6: Girder #4 Impact Damage

Girder #4 – Severe spalling of the bottom flange of the girder took place over a length of approximately 3.6 metres. One longitudinal #5 reinforcing bar was severed. Three rows of prestressing strands in the bottom flange were debonded over a length of approximately 3.6 metres. Although there were small nicks in two prestressing strands, no wires were severed. A hairline to narrow crack, approximately 4 metres long developed at the interface of the girder web and top flange.

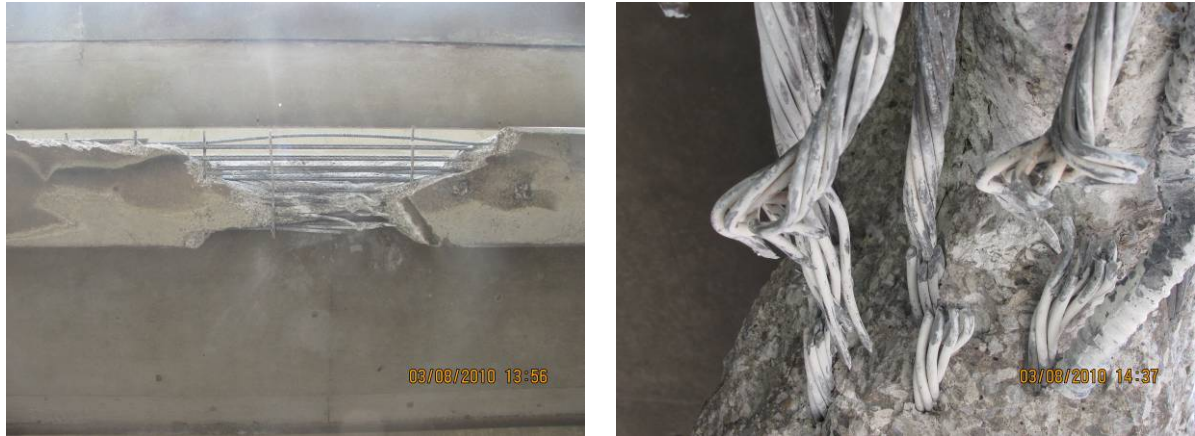
Fig. 7: Girder #5 Impact Damage

Girder #5 – Severe spalling of the bottom flange of the girder occurred over a length of approximately 5.2 metres. Three ½-inch diameter prestressing strands in the bottom row and

one prestressing strand in the second row (4 wires) were severed, as was one #5 longitudinal reinforcing bar in the bottom flange. Three rows of prestressing strands in the bottom flange debonded over a length of approximately 3.4 metres. A hairline crack, approximately 8 metres long developed at the interface of the girder web and top flange.

(a) Soffit View

(b) Severed Strands

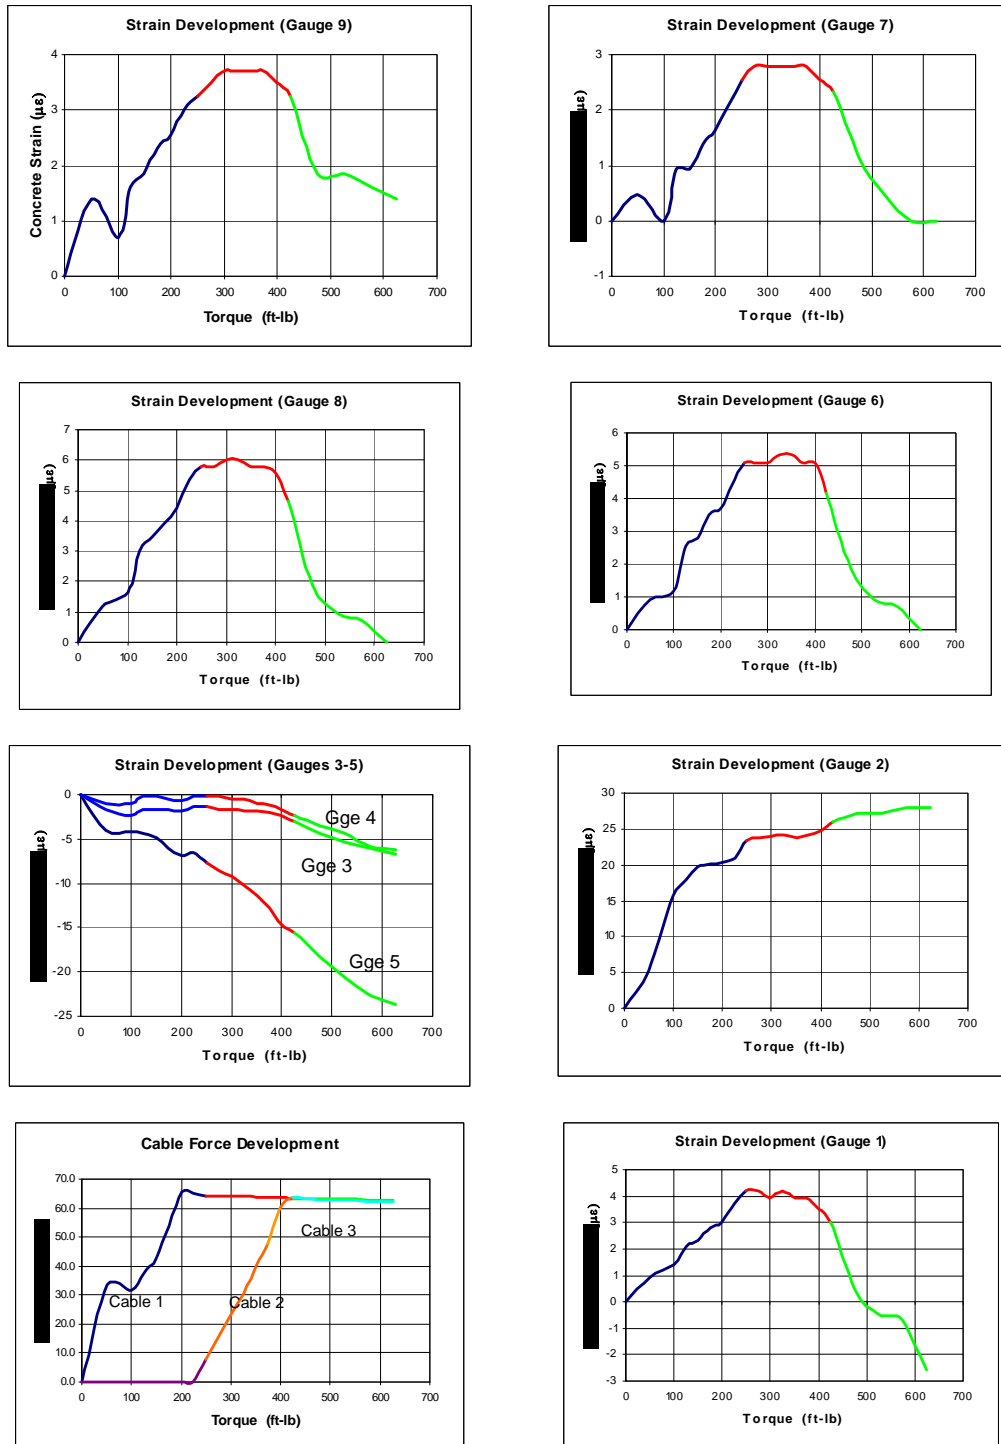
Fig. 20: Concrete Strains and Strand Forces

The experimental strain data obtained during the splicing of the three severed strands are shown in Figure 20. Note that for display purposes, the torque values shown in the plots are cumulative values to show the effect of tensioning each individual cable on the concrete strains and cable forces. The following observations can be made:

- (1) The maximum force measured in the mechanical coupler was about 65 kN.
- (2) The stressing of the strands did not have a significant effect on the concrete around the damaged area with maximum strains of about $-25 \mu\epsilon$ measured by gauge 5 and $28 \mu\epsilon$ by gauge 2. This corresponds to a concrete stress of less than 1 MPa, which indicates that the prestressing force caused by the tensioning of the mechanical couplers was effectively neutralised by the large stiffness of the deck system around the damaged area.

The design force for each prestressing strand after all losses was 105 kN. The prestress in the strands was checked by measuring the elongations, which were close to calculated values. Due to the variability of the two measured results, the final force in the strands is estimated to

be between 60% and 90% of the design force. Since the three broken strands in each girder represented less than 10% of the total number of strands, this was considered acceptable.
