EMERGENCY REPLACEMENT OF BRIDGES

Geetha Chandar, PE, Texas Department of Transportation, Austin, TX
John M Holt, PE, Texas Department of Transportation, Austin, TX
Jamie Farris, PE, Texas Department of Transportation, Austin, TX
Mark A Steves, PE, Texas Department of Transportation, Austin, TX

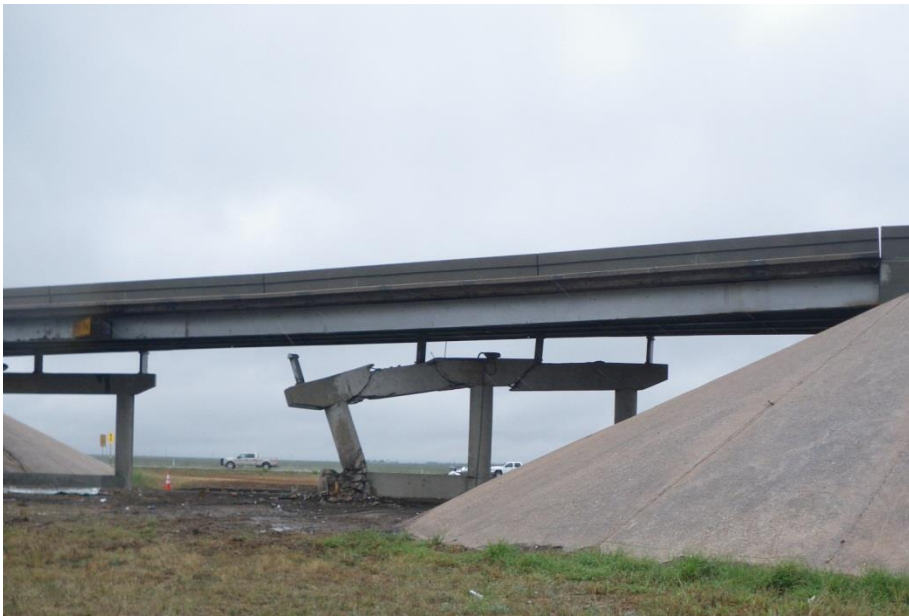
The EB US 84 bridge over WB IH 20 in Nolan County was struck by a tractor-trailer on Thursday, September 27th 2012. The truck lost control, swerved off the roadway and hit the bridge bent causing severe damage to two of the three columns. The remaining column was also damaged at the bent cap to column connection. The continuous steel I beam superstructure and deck also suffered damage due to the loss of support from the bent that was impacted. The damage to the bridge forced the immediate closure of both IH 20 WB and US 84 EB.

Figure 1 Overview of Damaged Bridge at US 84 over IH 20 in Nolan county

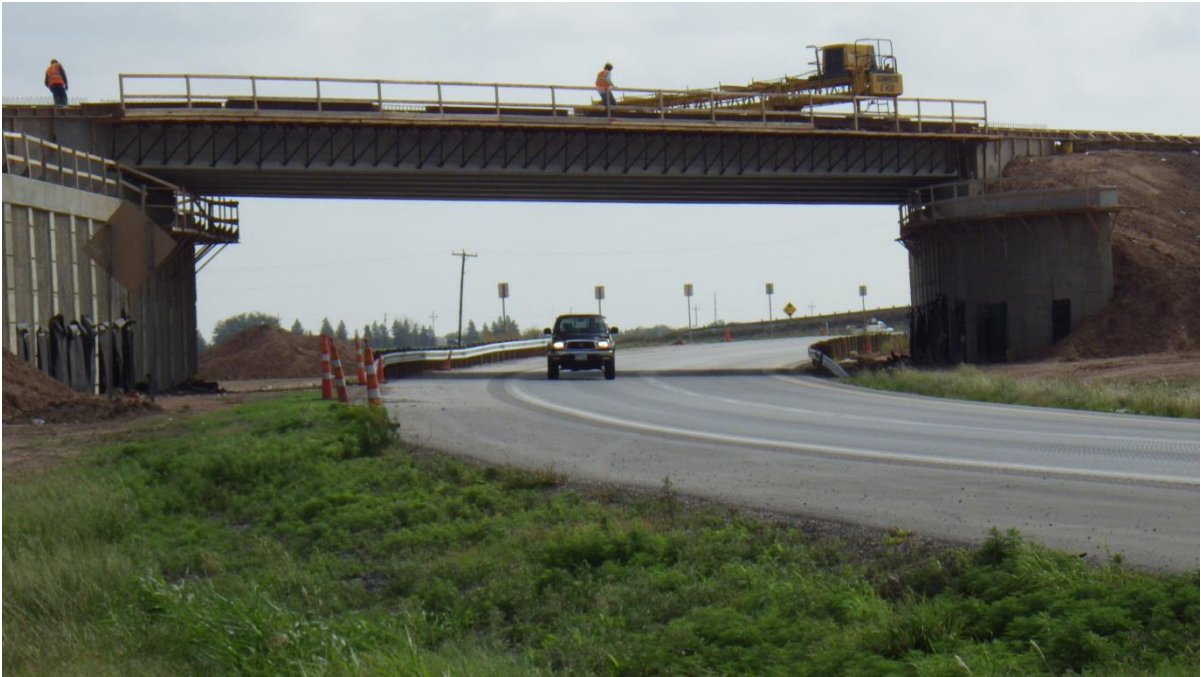
Both replacement bridge abutments are oriented with the same bearing, but have varying skews of 52.83 degrees and 56.73 degrees since the bridge geometry relies on a horizontal curve. The abutments have tightly spaced drilled shaft foundations because they also support a retaining wall that wraps around both ends of the bridge. Figure 2 shows the two abutments with different skew angle and support retaining wall.

Figure 2 New single span bridge structure under construction

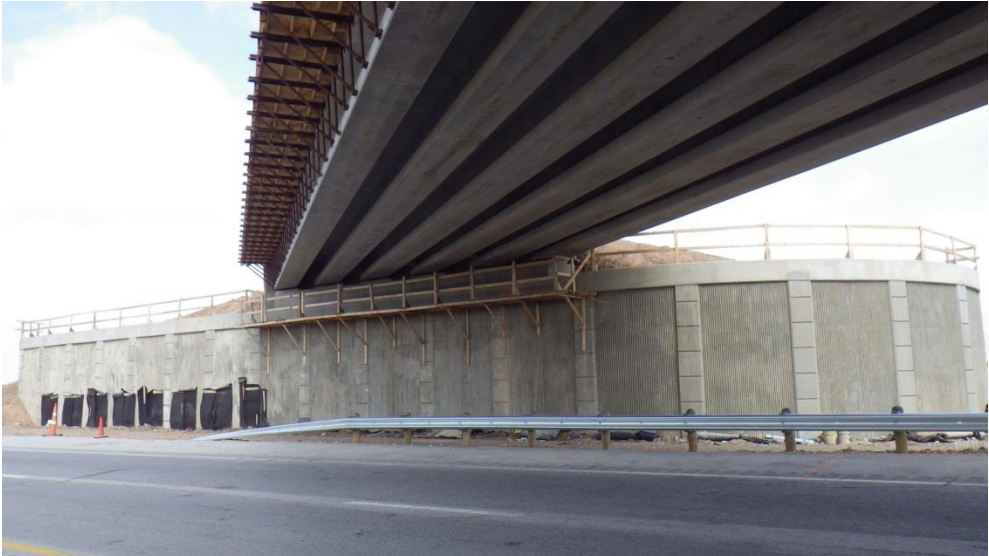
Figure 3 New Retaining wall wraps around the abutment

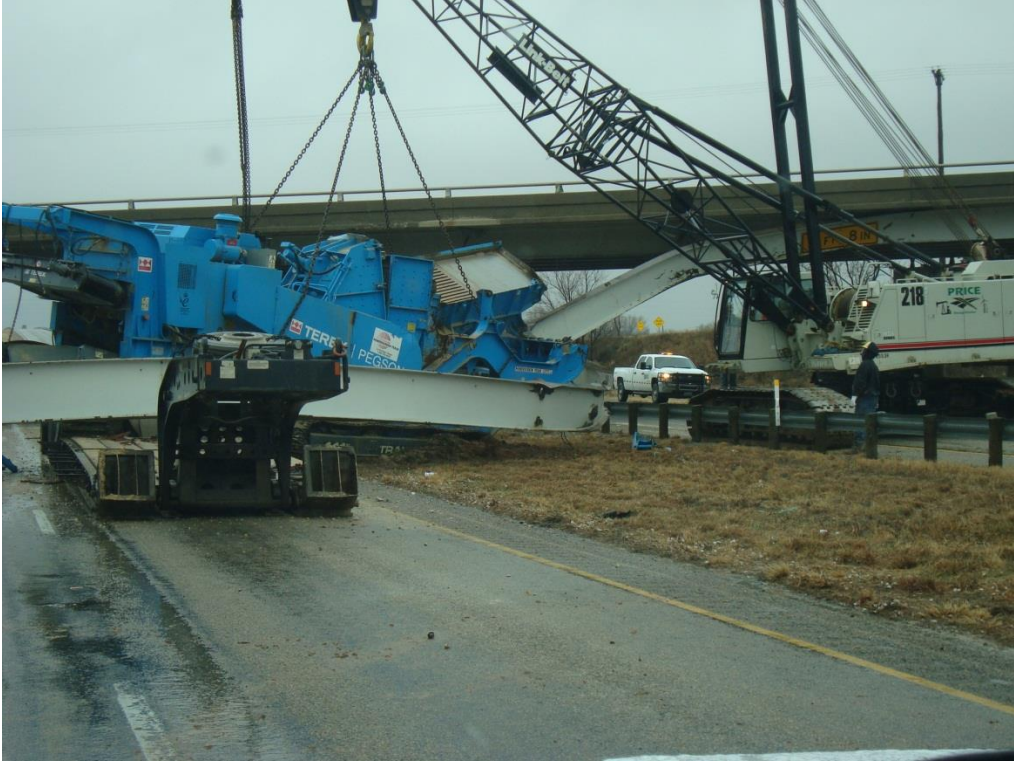
The U.S. Highway 180 overpass at U.S. Highway 84 in Snyder was damaged Tuesday February 6th, 2013 by an 18-wheel truck carrying an oversize load, according to the Texas Department of Public Safety. No one was injured in the wreck, which occurred when an 18-wheeler carrying a rock crusher attempted to pass underneath the bridge. The truck, which is permitted to travel at 14 feet in height, attempted to pass beneath a bridge marked at a height of 14 feet 5 inches. The over-weight equipment pulled and damaged the exterior steel girder. This caused damage to the bridge deck partially. This incident happened three months after the accident of the Nolan county bridge, which was under construction.

Figure 6 Damaged Bridge – US 180 Overpass at US 84 in Snyder County

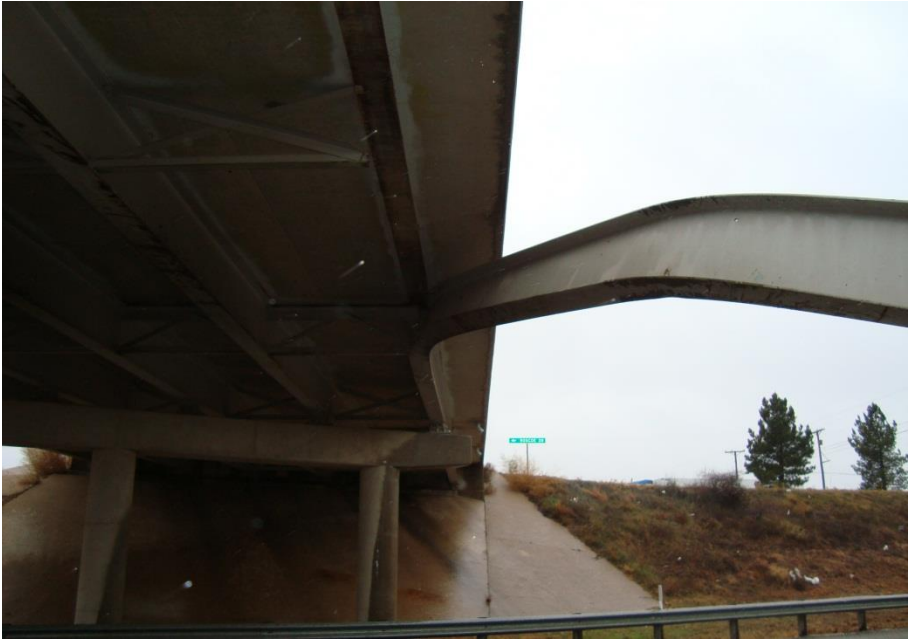
Figure 7 Steel Girder Damaged by the 18 Wheeler Truck

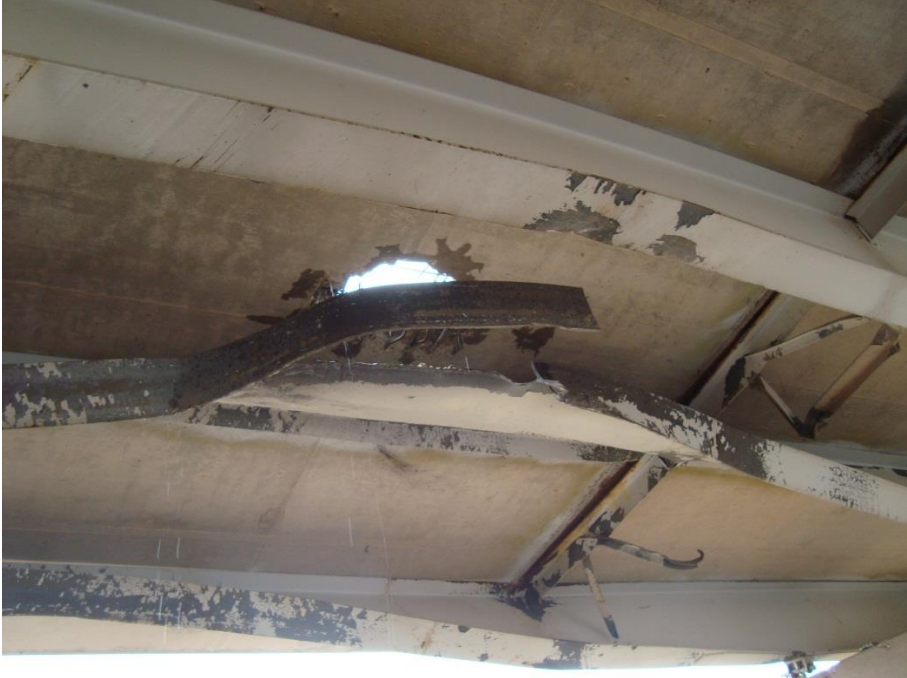
Figure 8 Damaged Bridge Concrete Deck

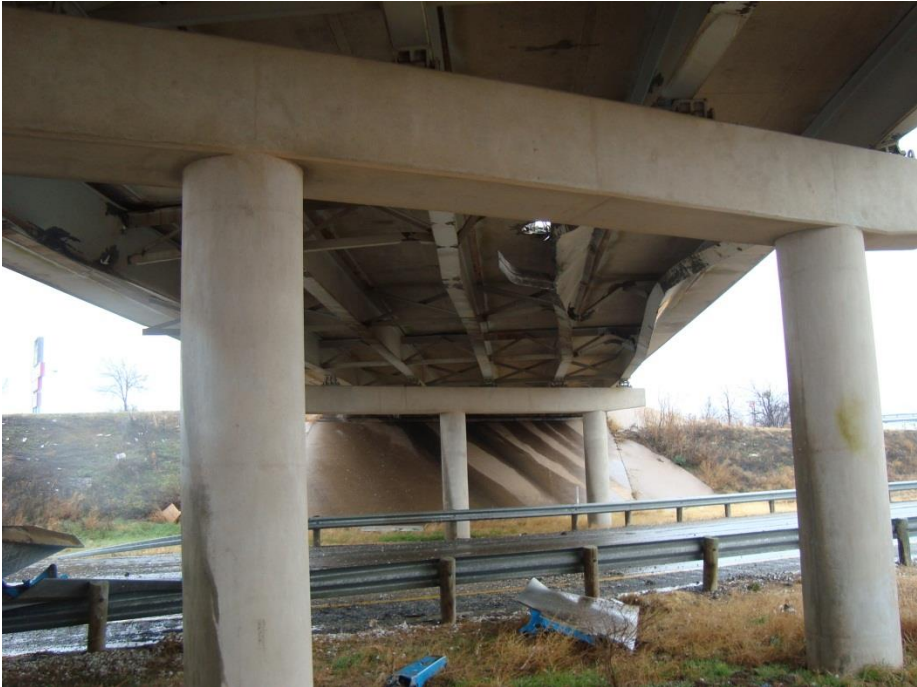
Figure 9 Damaged Bridge (Under view)

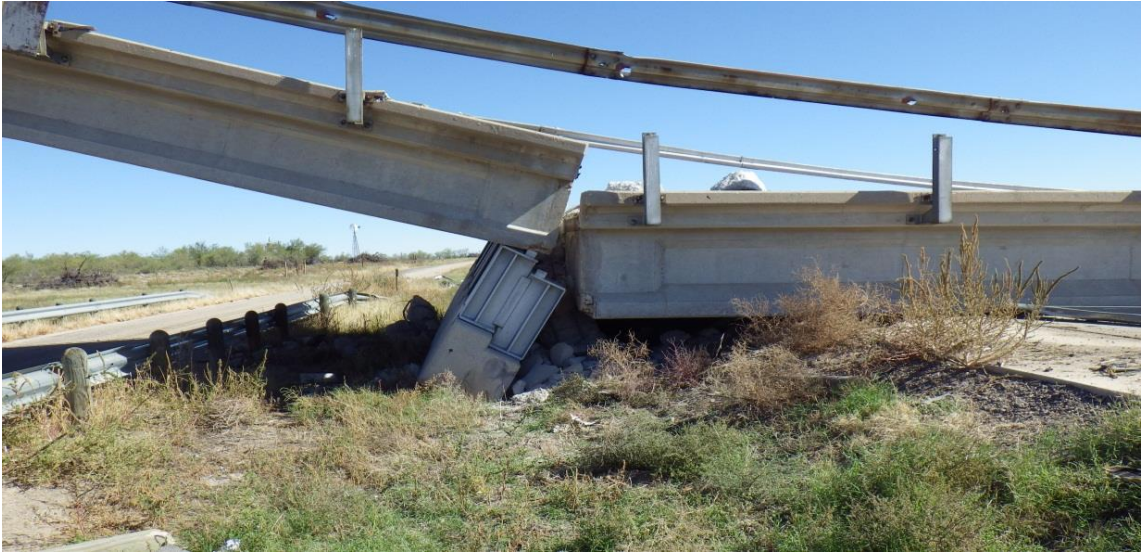
On November 6th 2013, an 18-wheeler lost control and struck the columns of an interior bent of the IH 20 Underpass at FM 2599, causing a partial collapse of the bridge. Since the bridge crosses an interstate highway, rapid replacement was necessary. While the original and new designs were both fairly conventional, there were some design considerations that helped facilitate a speedy and effective replacement of the damaged structure.

Figure 12 Westbound IH-20 Bridge Hit by 18-wheeler truck in Howard County

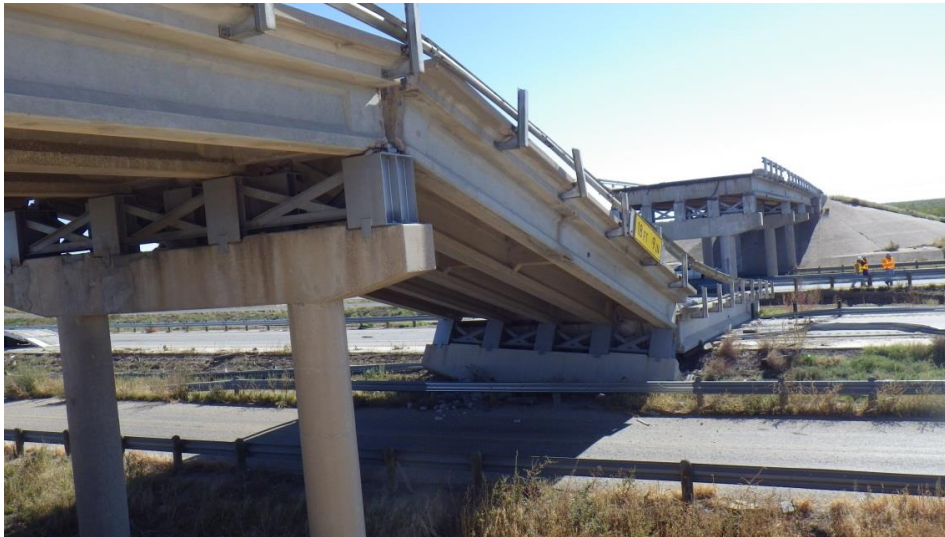
Figure 13 Overview of Damaged Bridge – IH 20 Underpass at FM 2599

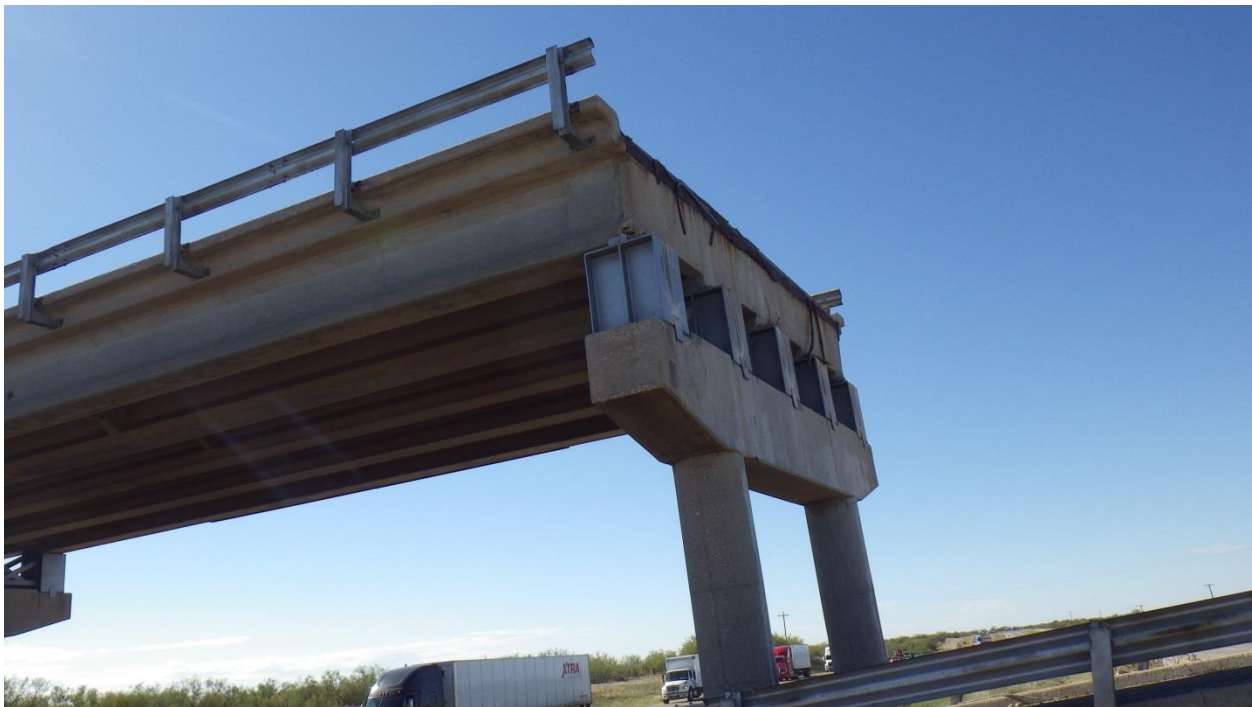
Figure 14 Partial Collapse of Columns of Interior Bent

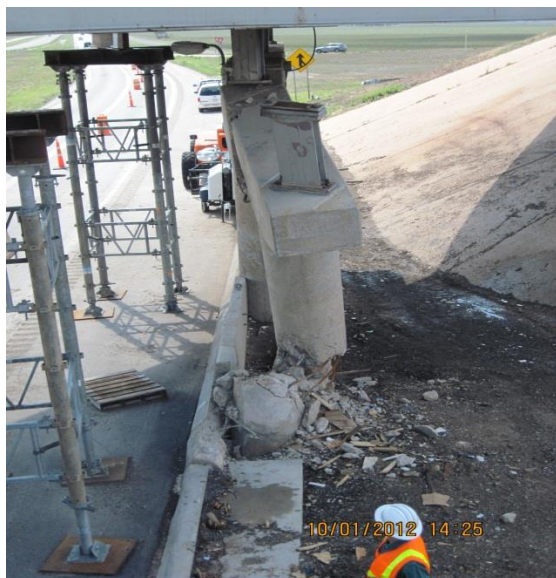
Figure 15 Damaged Columns Struck by 18-wheeler truck

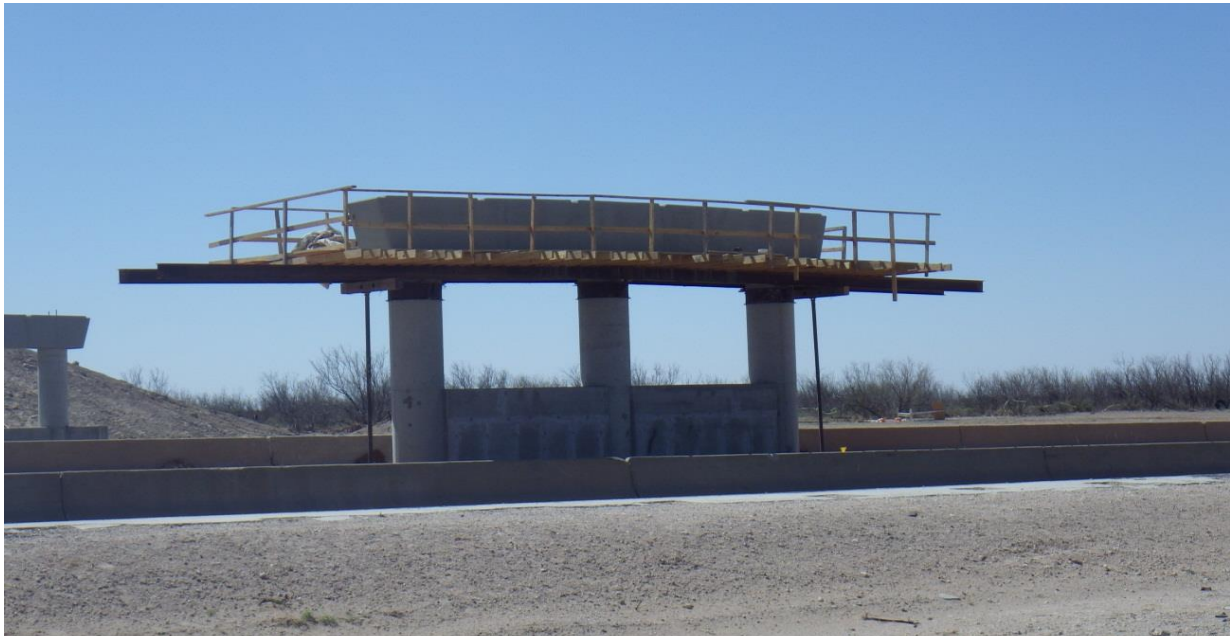
The original bridge had six spans, with additional interior bents between the frontage roads and the mainlanes. By using XB40 Prestressed Concrete X-Beams in the new bridge, the designer was able to span a mainlane and a frontage road in each direction (115 ft.), thus eliminating two interior bents. This is cost effective, and also shortens construction time. Figure 15 shows the construction of new bridge with four spans.

Figure 16 New Bridge Under Construction- IH 20 Underpass at FM 2599 in Howard County
