ASSESSMENT OF A PARKING GARAGE WITH A BROKEN PRESTRESSED SPANDREL BEAM

Bishal Parajuli, EIT, Dept. of Civil Engineering, University of Toledo, USA
Seyedowjan Hashtroodi, EIT, Robert Darvas Associates, Ann Arbor, MI
Douglas K. Nims, PhD, PE, Dept. of Civil Engineering, University of Toledo, USA

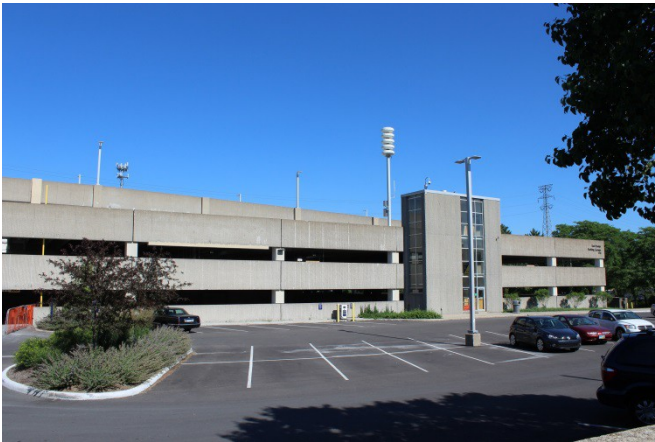
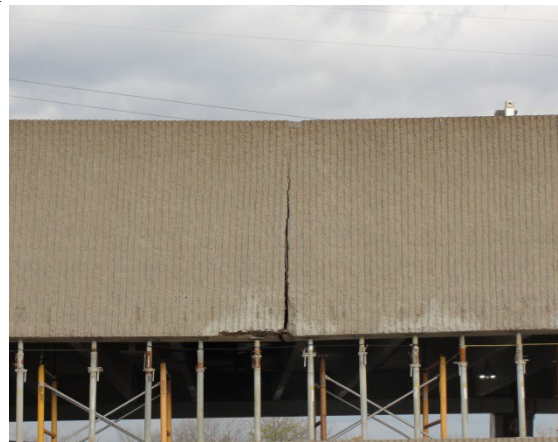
In September 2013, an exterior prestressed spandrel beam in a parking garage in Northwest Ohio failed. The 40 year old L shaped prestressed spandrel beam failed brittlely and unexpectedly due to severe corrosion of the prestressing strands. A large crack occurred at the mid-span of the beam extending nearly to the top of the beam and the concrete above the crack spalled. The beam failed completely and was prevented from falling when the broken pieces wedged against the adjacent beams. Figure 1 shows the parking garage and figure 2 shows the crack. Post failure visual inspection revealed little external indication of the extent of the corrosion. After the failure, the garage was immediately closed and inspected. The garage was reopened after extensive repairs including strengthening of some spandrel beams and the addition of columns to shorten some beam spans.

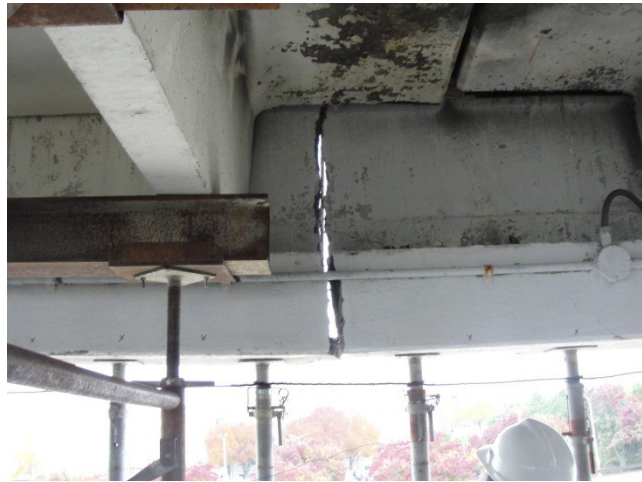
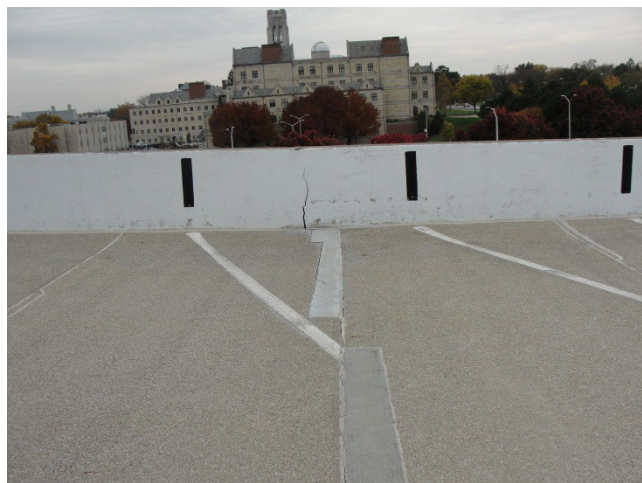
Figures 5 and 6 show the interior and exterior details of the crack. Note in Figure 5, the concrete is spalled at the top of the crack. In Figure 6, evidence of water leaking through the deck joint near the crack location can be observed. Figure 7 shows the crack extending upward from the deck to within a few inches of the top of the beam. Note the repairs in the deck joint near the crack indicating a history of leakage. The failure surface was inspected thoroughly. Even though small cracks could be easily observed on the painted interior surface, there was no sign of any distributed small cracks near the main crack, which would normally form in a ductile failure. There was only one dominant crack which had propagated through the depth of the beam at the mid-span. This is evidence of a brittle flexural failure.

The crack was approximately two inches wide at the bottom of the beam. Viewed from inside the garage and from the top deck there was an easily visible kink in the beam. Inspecting the joint between the failed beam and the adjacent beams, it was clear the failed beam had broken into two pieces which had rotated as rigid

bodies. The downward motion had been arrested due to arch action with the top midspan of the beam in compression between the failed pieces and the lower corners of the broken beam pressed against the adjacent beams. The portion of the beam that the column was attached to had a smooth surface. The beam had rotated until the protruding rope roughened surface had come to rest against the column. The rough texture of the column may have inhibited further rotation and caused tension in the bolts designed to resist torsion in the spandrel. Thus, it is possible the rough texture of the exterior face prevented the collapse.

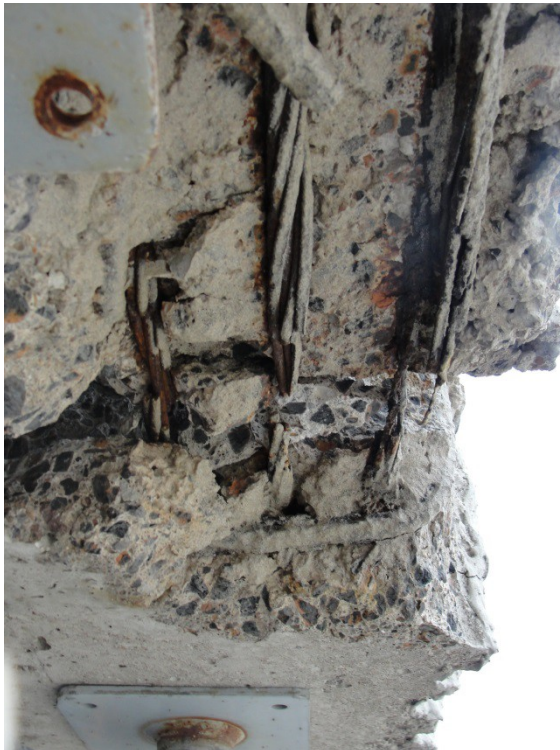
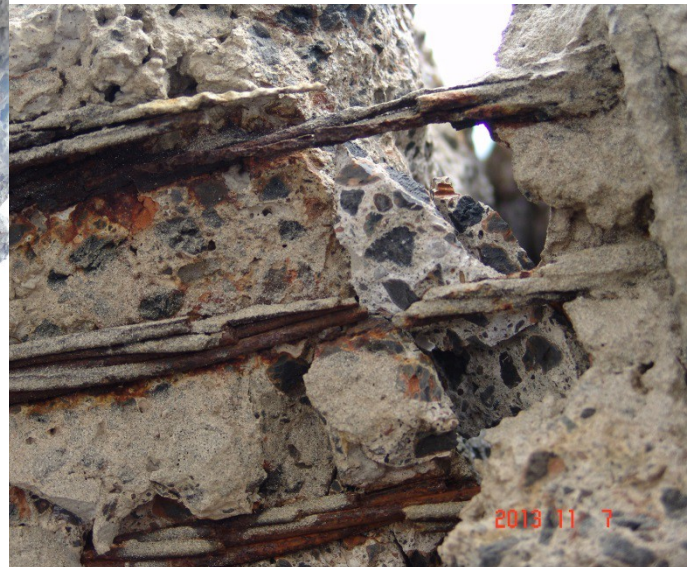
Figures 8 and 9 show details of the ½ inch strand breaks at the crack. In figure 3, this is the lowest level of strand below the stem. The outer two ½ inch strands are severely corroded with the outermost one essentially having completely dissolved. The inner most ½ inch strand also has extensive rusting. The ¼ inch strand in the bottom of the ledge could be felt, but not clearly inspected visually. The vertical face of the flange on the interior of the garage is painted white and cracks are easy to observe. However, in the region of the dominant crack, no cracks adjacent to the main crack were observed on the vertical face and there was no visible signs such as spalling, efflorescence or discoloration of the concrete on the bottom of the beam.

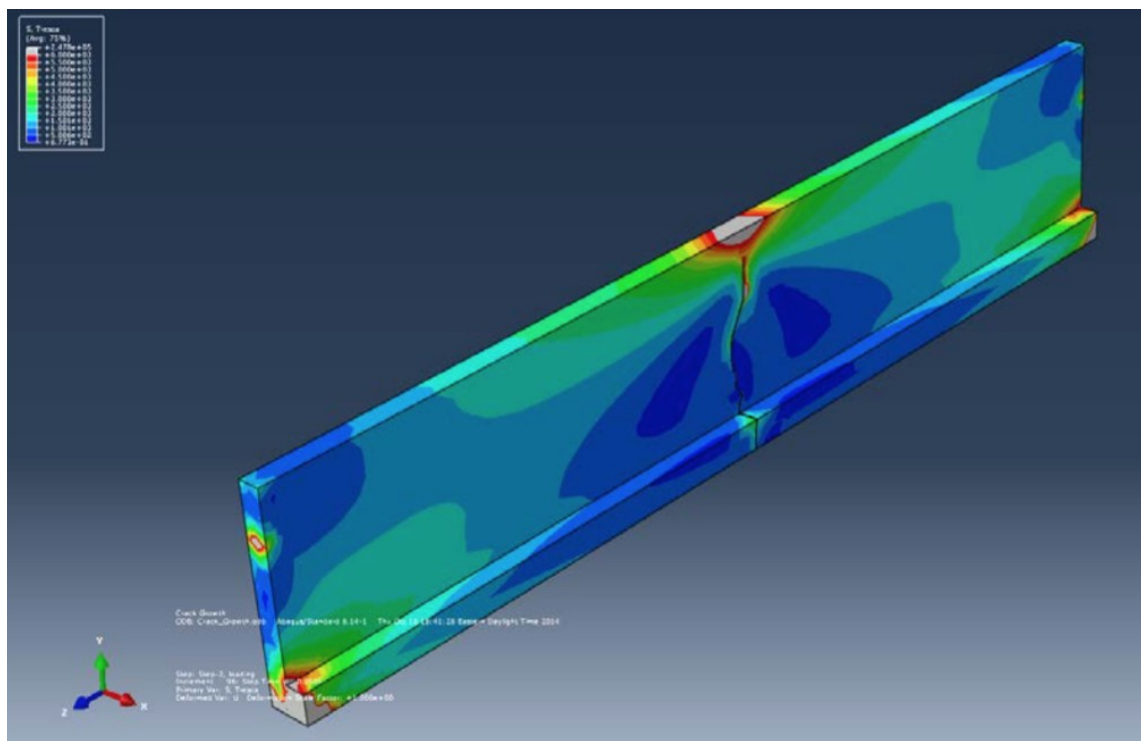
The crack propagation of the beam at a few stages before complete failure is presented in the figure 15. It can be observed that at this stage, the crack has propagated through the depth of the beam and the crack tip is at the compression zone of the beam. Comparing figures 2 and 15 – the analysis and actual crack patterns are similar.

The analyses confirmed that the observed strand loss and condition of the beam is consistent with the observed failure. All of the three analytical approaches gave results that were consistent with each other and the observed damage to the beam. The analyses indicate that the beam was initially designed with adequate ductility and capacity and the deterioration of approximately two strands would be sufficient to enable brittle failure. The cracking moment capacity of the intact section is significantly greater than the likely load at failure. A crack approximately 7 inches long would reduce the cracking moment capacity to the estimated demand at the time of failure.

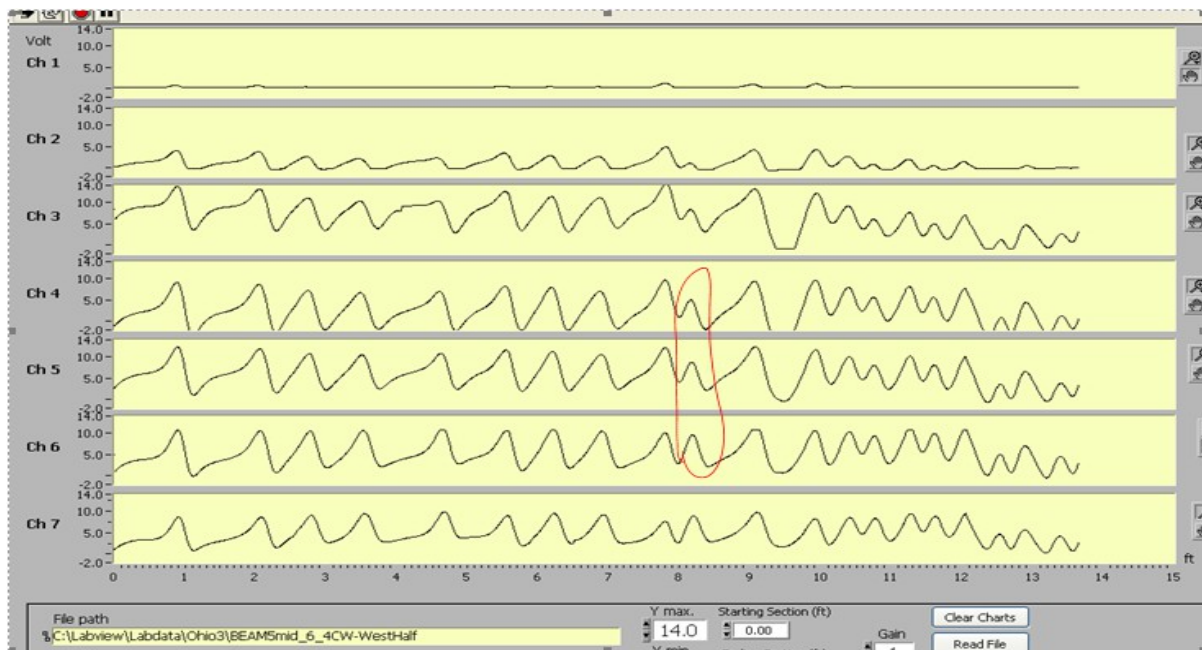
Overall, the MFL results showed some small anomalies, but no evidence of major corrosion. Significant corrosion leaves a clear signature (Fernandes, 2012 and Ghorbanpoor 2010), but no such indications were found. Three beams were excavated to confirm the results of the magnetic inspection. The amplitude (peak) of the graph marked the presence of transverse stirrup and the distance between two regular peaks indicated the distance between the stirrups in the beam (Fernandes, 2012). Any irregularity in the signal implied the presence of corroded bar or a wrongly placed stirrup. The results for two of the excavations will be discussed here. Figure 17 shows the results from beam 5mid-6-4CW. The red circle designates an anomaly.

Upon evacuation, the strand was found to be sound and it was determined that the anomaly was caused by an extra piece of steel in the beam.

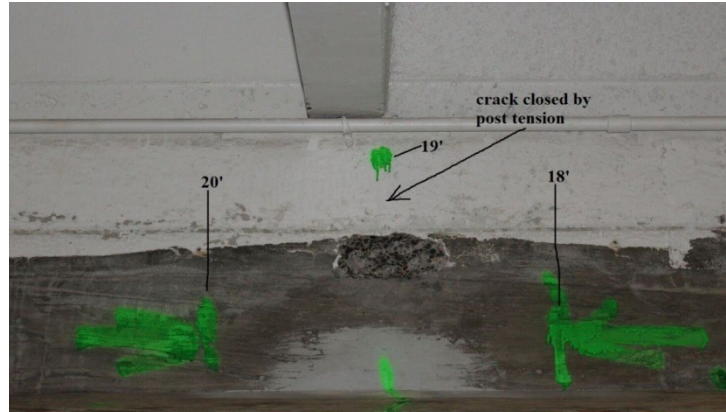
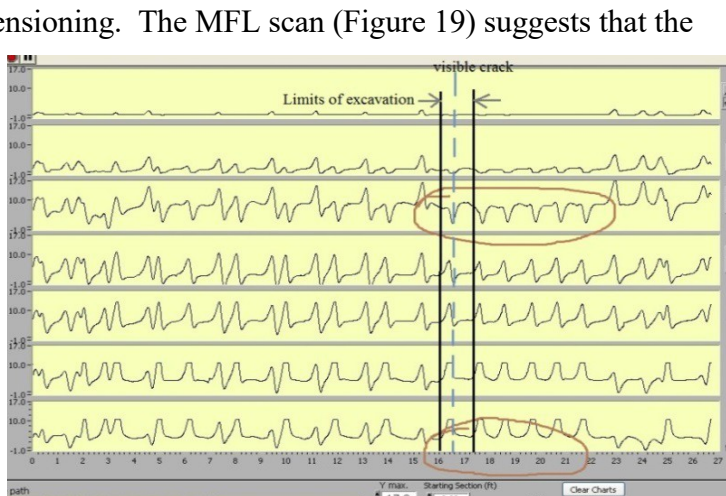
Beam 8-9-4CW had a potentially significant crack. This crack, which wrapped around the flange of the spandrel, was observed by the PDG project manager to be opening and closing with temperature. Because the crack was active, the beam was externally post-tensioned before the strand was evacuated. The crack was visible in the region between 18' and 19.5' as marked in figure 18, which shows the region that was excavated. In this figure, the white region is the existing spandrel and the unpainted region is the concrete covered for the external post tensioning. The MFL scan (Figure 19) suggests that the strands in the region of the crack may have some minor general corrosion. The anomalous region is circled. Note that since the scan results are offset by 2', the crack region falls between 16' and 17.5' on the scan plot.

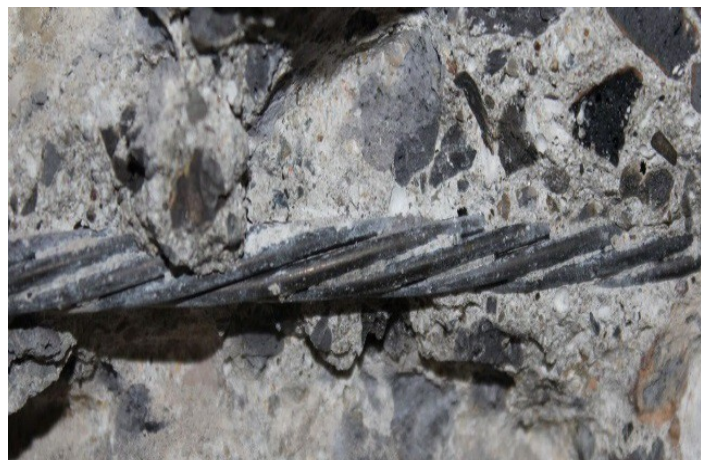
Upon excavation, the condition of the strands was found to be healthy with no visible corrosion (figure 20). The concrete in the excavation was tested with phenolphthalein. This pH test confirmed that the concrete still had a pH above 12 so the passivating layer was intact. This is consistent with the condition of the strand showing no trace of corrosion.
