## DISTRESS AND REPAIR OF PRECAST PARKING STRUCTURE DECKS

Peter Tarara, Michael Lee, Carl Peterson and Donald Meinheit

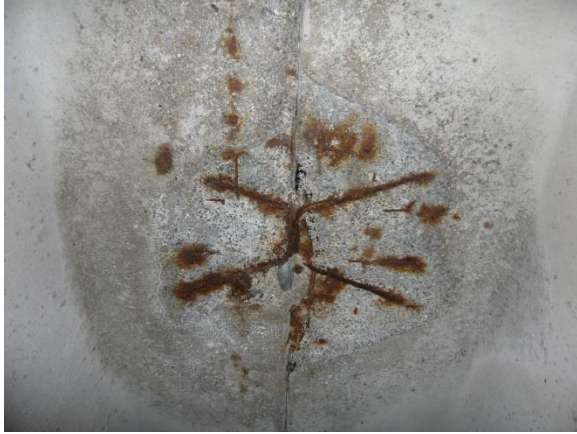
The type of deterioration can be different for pre-topped and field-topped decks. Deteriorated concrete is often observed on double tee flanges in the form of cracked, raveled, delaminated, or spalled concrete (Figures 3 and 4). Deteriorated concrete is most often concentrated along double tee joints, at flange-to-flange connections, and near the ends of double tees along the drainage edge of the deck. For pre-topped decks, spalling of concrete in the flanges usually occurs near the joint where the welded wire reinforcing (WWR) is located near the top surface because of its placement over the flange-to-flange connections. Debonding, freeze-thaw deterioration and scaling of concrete are typically observed on field-topped decks. Breaches in the joint sealant and unsealed cracks in double tee flanges allow water and deicing salts to either run down the flange edge onto the exposed connections or to penetrate the flanges. Corrosion of embedded flange-to-flange connections and the embedded WWR in the flanges can result from repeated exposure to moisture. The deterioration is often most pronounced at the roof decks in colder climates that are subject to moisture from the elements, deicing salts used in the garage after snow storms, and snow removal equipment. When the embedded steel corrodes, it expands and the resulting stresses cause cracking of the surrounding concrete in a plane parallel to the concrete surface (a delamination). Delaminations that break away from the substrate concrete produce spalling. Spalling has also been observed below or adjacent to steel flange-to-flange connections that do not exhibit any signs of corrosion (Figure 5). Spalling observed near non-corroded connections is typically caused by localized stresses in the concrete associated with

*Figure 3. Concrete spall below flange-to-flange connection that is corroding in field-topped deck*

Due to the relatively shallow thickness of the double tee deck, usually 4 inches for pre-topped systems and occasionally slightly thicker for field-topped systems, full-depth repairs are typically preferred to partial-depth repairs so as to provide a more durable cast-in-place repair with mechanical anchorage. Sometimes, full-depth repairs are required due to the aggressiveness of most concrete removal processes and partial-depth repairs are often not feasible because the thinner remaining concrete is susceptible to cracking from the concrete removal process. At deteriorated areas in the pour strip concrete, demolition is required around chord reinforcing to clean the steel and adequately anchor the patch which often results in a full-depth repair-

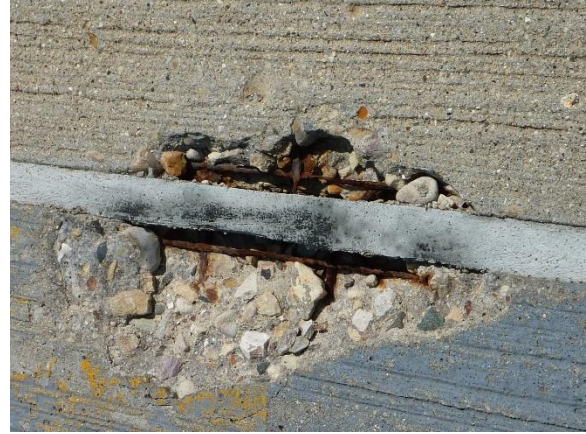
*Figure 4. Cracked and spalled concrete above flange-to-flange connection in pre-topped deck*

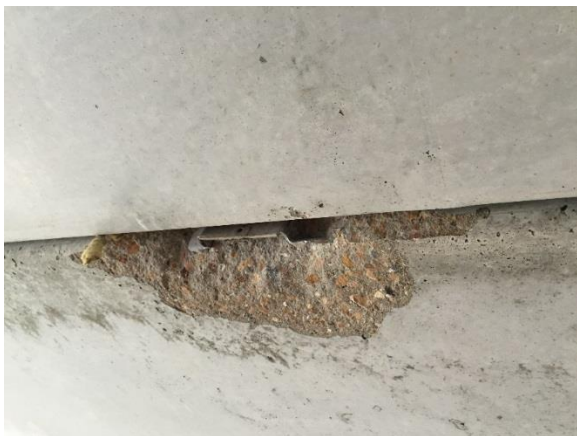
*Figure 5. Concrete spall below stainless steel flange-to-flange connection in pre-topped deck*

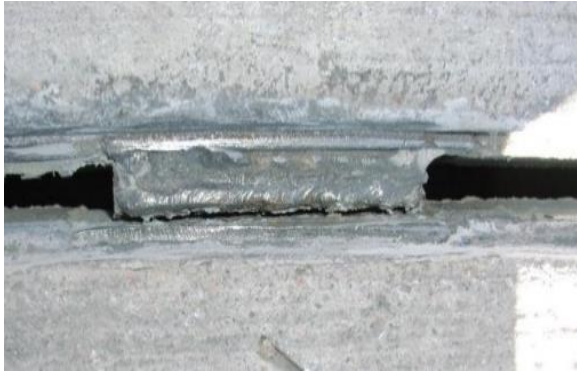
Several undesirable conditions are often observed at the flange-to-flange connections including poor welding, improper installation of connectors or slugs, and failed connection welds. Failed connections have been observed at both connections with corrosion related deterioration and connections with no corrosion related deterioration. Failed connections may involve a fractured weld or a fractured connector faceplate (Figure 8 and 9). Fractured welds are often the result of one or more of the following conditions: poor quality and/or undersized welds, corrosion related deterioration leading to a reduced section, or overloading. In addition, overload, impact loading from vehicles or snowplow blades, and repeated loading may contribute to fractured welds and failed connections. As discussed, stresses are also induced in the concrete and connectors from in-plane movement transverse to the joint between members of the deck due to drying shrinkage, temperature changes, and diaphragm action. If the width of ramp double tee joints at sloping ramps is not increased slightly to account for sloping geometry, the joints in the ramps will be slightly wider than the joints in flat areas of the garage, which can result in an increase of bending forces and stress on the connections. As individual connections fail, greater stresses are exerted on adjacent connections which can lead to progressive flange-to-flange connection failures.

*Figure 8. Fractured weld at flange-to-flange connection*

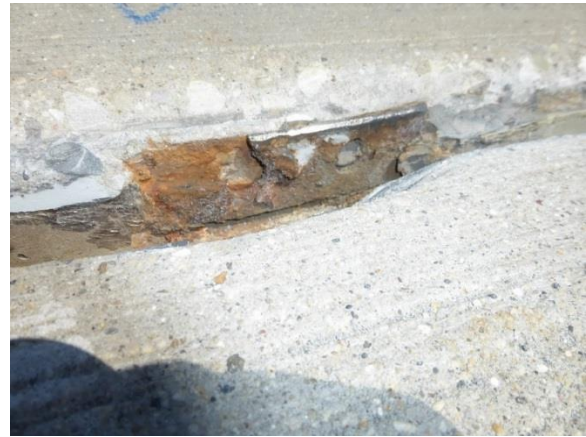
*Figure 9. Fractured faceplate at flange-to-flange connection*

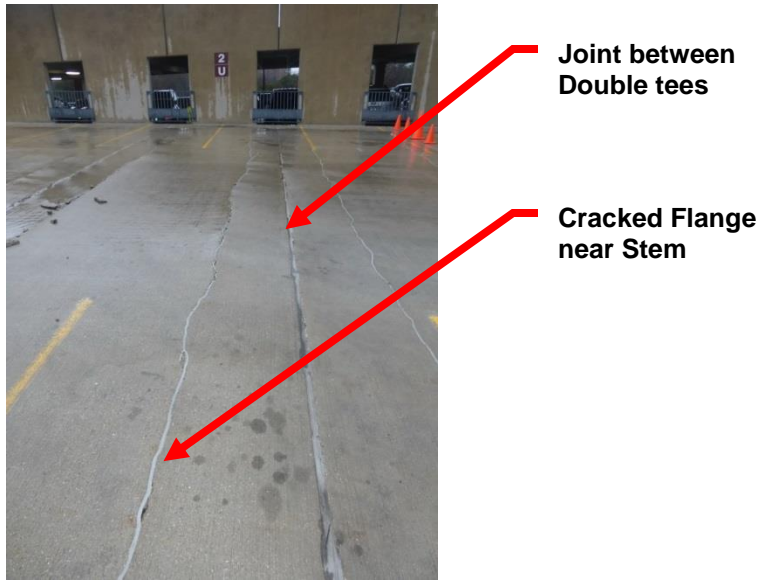
Longitudinal cracks in the top surface of the flanges, parallel to the direction of the double tee span, can occur near the supporting double tee stem (Figure 22). Double tee flanges are typically designed as propped cantilever beams with the joint as the location for the prop support and as continuous beams between stems. It has been our experience that these flange cracks typically occur at locations where flange-to-flange connections have already failed and the applied moment on the flange exceeds the cracking moment of the flange. Once the connections have failed, the stresses in the double tee flange increase when the load is placed near the tip of the flange. After the crack develops, the WWR engages, but may not be adequate for the cantilever bending moment. The cracking in the flange starts on the top surface of the flange where the tensile stresses are greatest but can progress, with time, to full-depth cracks from repeated loading of the flanges and loss of reinforcing steel cross section from corrosion. Therefore, longitudinal flange cracking

*Figure 22. Longitudinal cracks at adjacent double tee flanges*

should be a sign that it is necessary to repair the cracks and the connections. If the reinforcing steel has not lost a significant amount of cross section, the cracks can be repaired by routing the cracks and filling the cracks with sealant or a gravity fed epoxy after the flange connector is repaired.

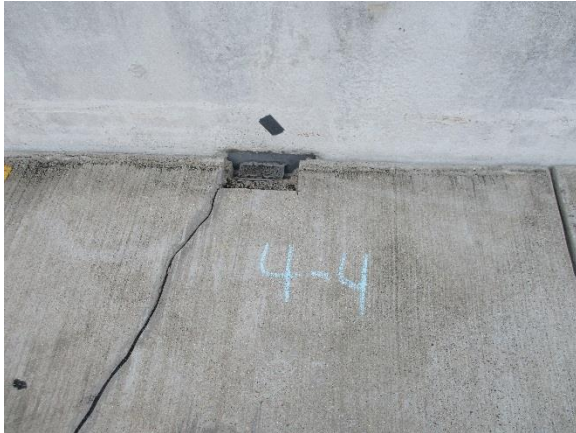
Other cracks are often observed at the ends of double tee flanges. Some flange cracks at the ends of the double tees are through-thickness and observed to start near the welded connections between the double tee and supporting member where the tee flange can develop restraint against transverse movement (Figures 27 and 28). Movement occurs in the double tee flanges from drying shrinkage of the concrete and temperature changes which leads to the cracking. Welded plate connections between the double tee and the supporting member (inverted tee beam or spandrel) can create a fixed point in the support member that does not accommodate the flange movement. These cracks are more likely to develop in the flange on the inside face of the stem as opposed to the outside face because the flange-to-flange connections can accommodate some lateral movement. These cracks typically do not continue the full length of the double tee likely because the restraint of movement diminishes toward the center of the tee.

*Figure 27. Crack at end of double tee that starts at stem connection to wall*

Open through-thickness cracks in the tee decks, if not protected from moisture, can lead to corrosion of the embedded reinforcing steel or prestressing steel in the stems, long-term deterioration of the concrete, and leakage into the lower levels of the garage. Although these cracks are typically not a structural concern, the cracks should be repaired to minimize water infiltration.

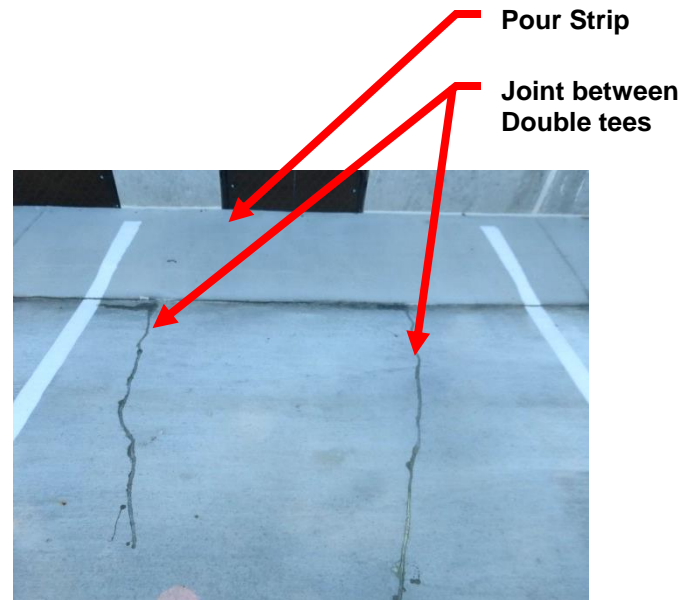
*Figure 28. Cracks at end of double tee in line with at stem connections to wall (cracks in pour strips are not visible)*
