PERFORMANCE OF COMPOSITE CONCRETE BRIDGE DECK UNDER HYDROCARBON POOL FIRE EXPOSURE

Eyosias Beneberu, Ph.D., P.E., Dept. of Civil Engineering, University of Texas at Arlington,
Arlington, TX

Nur Yazdani, Ph.D., P.E., Dept. of Civil Engineering, University of Texas at Arlington,
Arlington, TX

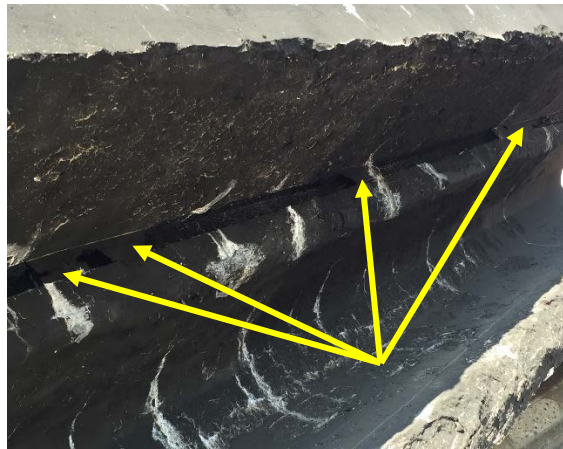
low thermal conductivity and high thermal capacity of concrete, which played a key role in slowing down the heat penetration to the interface. Among the girders, Girder 2 was provided with a cement-based dry mix fireproofing mortar for wet sprayed application. The detail information on the design and application scheme may be accessed in the literature²¹. As a result, its peak temperature was lower than that in Girder 1. As shown in Fig. 9, there is no loss in the yield strength for mild reinforcement up to a temperature of 400°C. Thus, the measured temperatures at the deck-girder interface did not adversely affect the shear resistance derived from the dowel action of rebars. Visual observation after the fire test revealed melted and charred bedding strips (Fig. 11). However, no cracking or interfacial slippage between the deck and the girder was observed that could affect the composite action. Differential thermal expansion during a fire event may cause distortion in the overall geometry of the deck. However, none was observed in the current investigation.

Fig. 11. Charred bedding strip

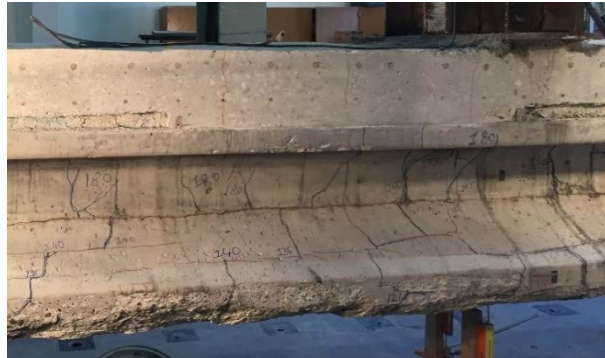
Following the fire test, the deck was saw cut and each girder was tested in the laboratory under a three-point bending set-up to determine their residual strengths [Fig. 12(a)]. During loading, it was observed that cracks originate from the girder and propagate towards the deck [Fig. 12(b)]. However, no slippage or cracking was observed at the interface between the two until

the conclusion of the test. All three girders failed by yielding of the prestressing strands. From the results of the fire and the residual strength test, it can be concluded that the fire did not affect the composite action between the girder and the deck.

(b) crack patterns

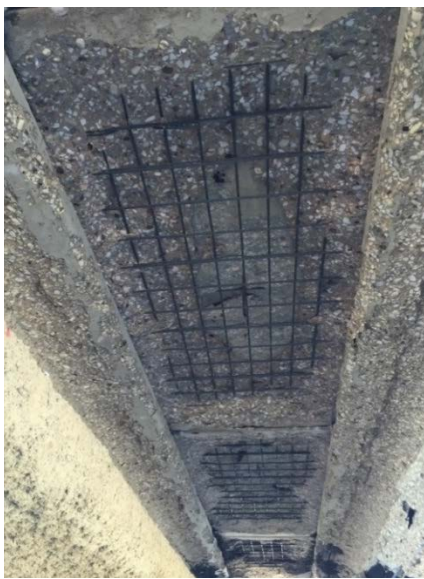
(a) Deck 2

Figure 13 (a) and (b) shows the bottom of the precast deck panels after the fire exposure. Deck 2 between girders 1 and 2 sustained maximum of 67 and 102 mm deep spalling on approximately 29% and 20% of the fire exposed surfaces, respectively. The spalling was more severe near the central part of the deck span where the positive moment is maximum. The rest of the exposed areas experienced none or smaller than the above-mentioned spalling. The longitudinal mild reinforcements and the transverse prestressing strands in the precast deck panels lost concrete cover for a length of up to 1.98 and 0.7 m, respectively. On the other hand, the fire exposed surface of Deck 3 between girders 2 and 3 experienced 67 and 102 mm deep spalling over 20% and 12% of the exposed surfaces, respectively. In Deck 3, the transverse and longitudinal reinforcements were exposed up to a length of 0.6 m and 1.83 m, respectively. It is apparent that the degree of spalling was more severe in Deck 1. This was due to the more intense fire in this deck resulting from the prevalent wind that pushed the flames towards that deck span. None of the prestressing strands or mild reinforcements was broken.

It may be noted that the most severely spalled section of the deck lost 102 mm deep concrete, equivalent to the entire thickness of the precast deck panels. In essence, the remaining undamaged part of the composite deck consisted of mostly the 102 mm thick CIP and the embedded mild steel rebars in it. The nominal flexural strength for the remaining thickness of the deck, without considering any material strength degradation due to temperature, was calculated herein, using AASHTO strip method²⁰. It was found to be 9.2 kN-m, which is a staggering 78% reduction as compared to the 41.6 kN-m flexural capacity of the deck before fire exposure. There was a high probability for the concrete and the reinforcement in the CIP part of this deck to have experienced some strength degradations due to the elevated temperature. So, the actual residual capacity of the remaining deck portion could be even lower than what was calculated above. However, the deck did not experience any collapse because applied bending moments were redistributed due to the continuity of the adjacent spans. Considering the relationship between thickness, moment of inertia and deflection, and disregarding the decrease in self-weight from spalling and the degradation of modulus of elasticity due to the elevated temperature, it could also be inferred that spalling of half of the deck thickness led to 87.5% reduction in the moment of inertia. This may result in increase in the immediate deflection of the deck by about 700% . In addition, concrete cracking and spalling may increase permeability thereby decreasing the resistance to corrosion of reinforcements, consequently compromising the long-term serviceability of the bridge.

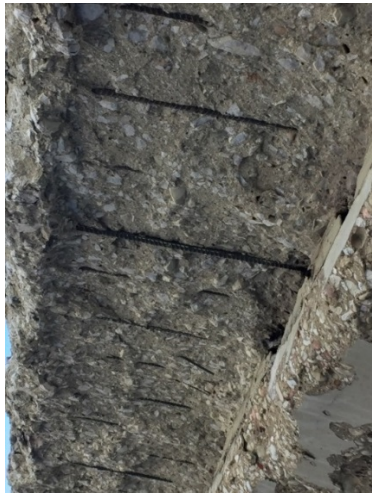
(a) Deck 1

Figure 14 shows the bottom of the CIP overhanging decks after the fire test. Deck 1 overhanging from girder 1 side sustained more severe spalling damage, as compared to Deck 4 overhanging from girder 3. The former lost an average of 38 mm concrete depth along for approximately 7.9 m length of the deck, while the latter did not experience any damage. The nominal flexural capacity of the spalled section of the overhang was 24 kN-m, a 27% reduction from the 33 kN-m flexural capacity of the undamaged deck section before fire exposure.

Despite the severe spalling on the bottom, Deck 1 showed no sign of cracking or distress at the top.
