Rehabilitation of the Boivre Viaduct — A Multispan Prestressed Box Girder Bridge

Synopsis

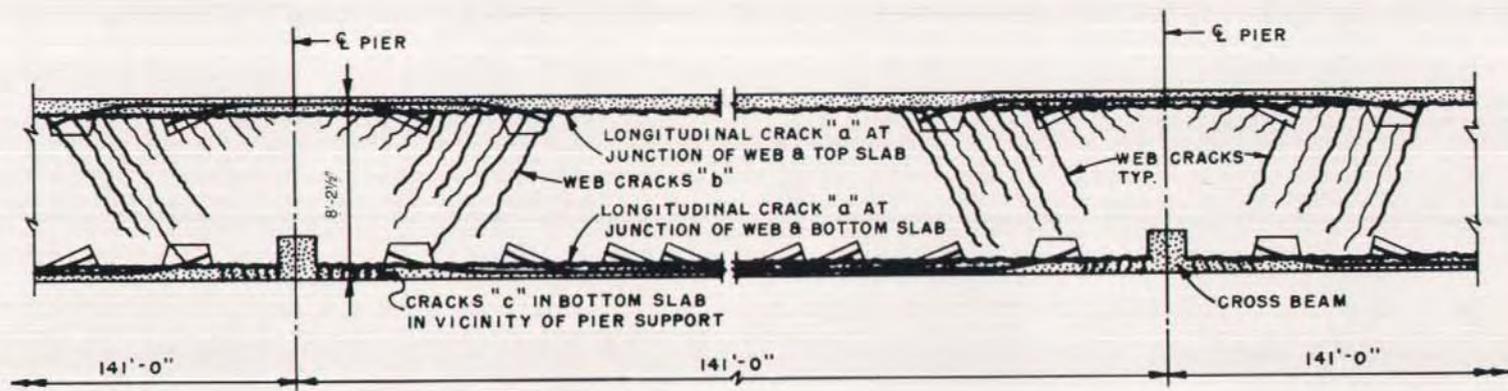
Fig. 7. Longitudinal section through box girder showing the types of cracks together with their location and direction [typical 141 ft (43 m) span].

The cracking patterns uncovered during the routine inspection of the structure are diagrammatically shown in Fig. 7 and can be categorized as follows:

Longitudinal Cracks — These cracks cross the concrete width at the juncture of the webs and the bottom slab, as well as at the juncture of the webs and top slab, almost completely separating the slabs from the webs (Cracks "a").

Inclined Web Cracks — In the webs, inclined cracks were found between the bottom and the top longitudinal tendons in the vicinity of the anchorages (Cracks "b").

Transverse Cracks — Transverse cracks in the bottom slab were found behind the anchorages of the longitudinal tendons (Cracks "c").

Vertical Cracks — Localized, midspan vertical cracks occurred in the webs of the interior spans, beginning at the bottom of the webs for variable heights [30 in. (76.2 cm) maximum height], and could only be detected when thermal response parameters such as solar radiation, ambient temperatures, or wind speed fluctuations were acting on the structure.

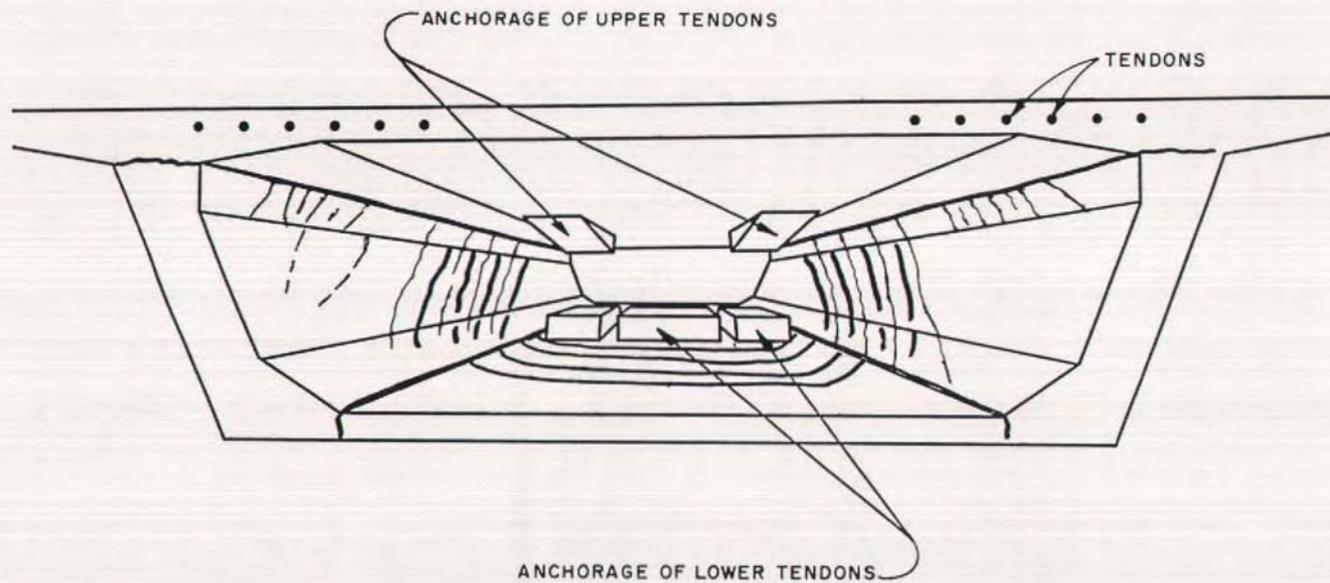
Fig. 11. Evolution of cracks in box girders from 1977 to 1981.

Both monthly and 6-monthly bridge inspections described above were made during a 4-year period in order to study and evaluate the long-time behavior of the structure (see Fig. 11).

1. Inclined Cracks — The size and width of the inclined cracks in the webs which had remained unchanged until 1979 began to increase. Furthermore, new cracks appeared.

2. New Cracks — New cracks of a different nature began to appear at the junction of the webs and the top slabs.
