Performance of Precast and Prestressed Concrete in Mexico Earthquake

Mark Fintel

Consulting Engineer
Chicago, Illinois

Note: This report is based upon the author's observations during a visit to Mexico, October 13-17, 1985, on behalf of the Prestressed Concrete Institute.

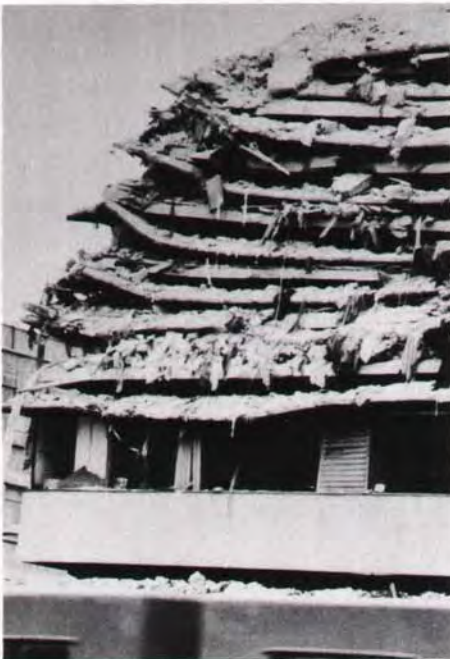
It appears that many frame buildings collapsed predominantly due to shear failures of columns resulting from large interstory distortions with the slabs "pancaking" one on top of the other (Fig. 3). In some flat slab buildings the primary failure appeared to be punching shear in the slabs around the column periphery with the columns protruding several stories high above the pancaked floors (Fig. 4).

Fig. 3. Pancaked multistory building.

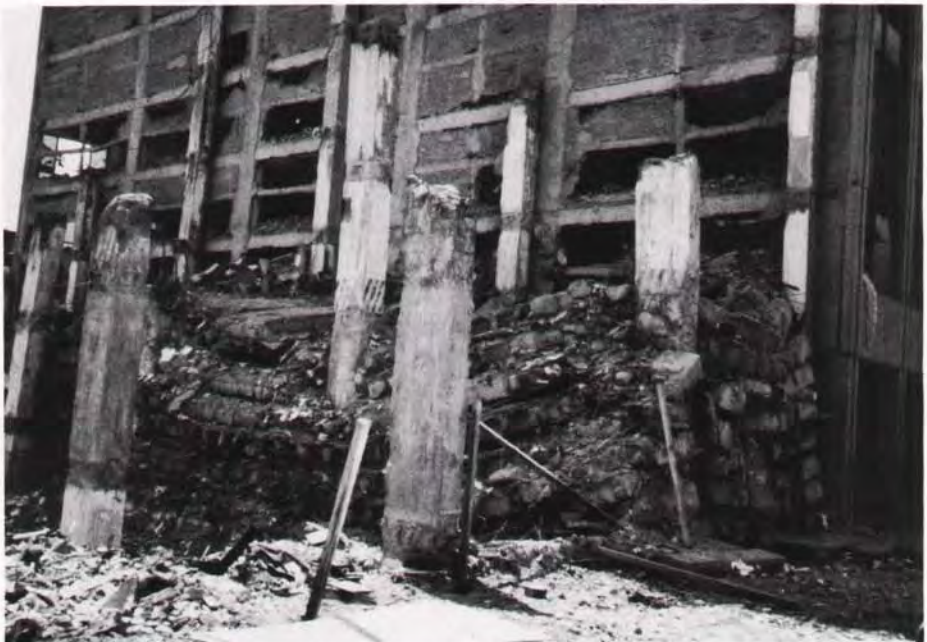
Fig. 4. Columns protruding above pancaked floors failed in punching shear of a flat slab multistory building.

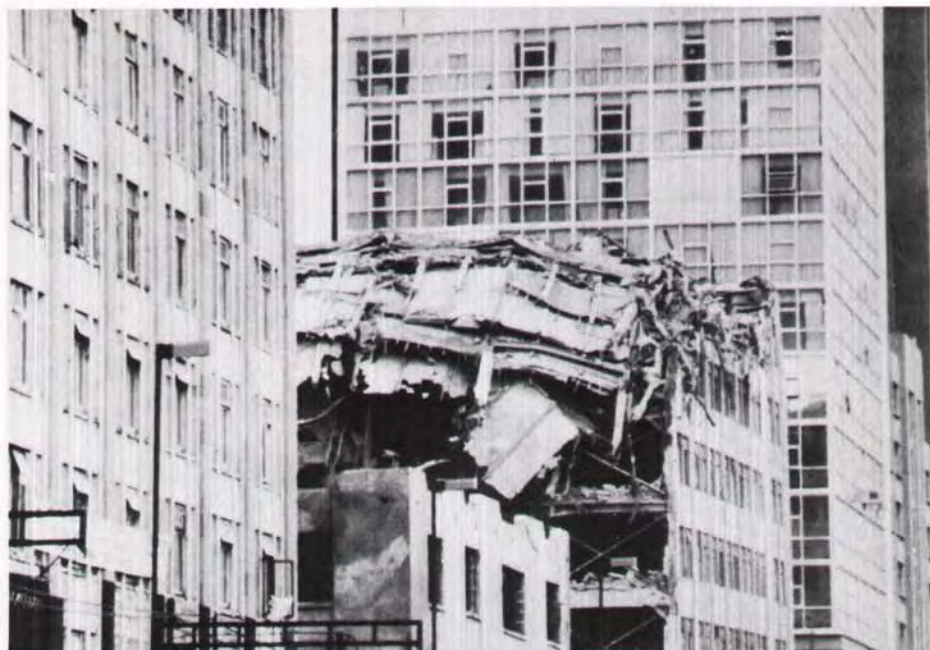
There were numerous instances of a group of upper slabs collapsing with the remainder of the structure left standing (Fig. 5). There were also cases where a group of stories

Fig. 5. Collapsed upper stories.

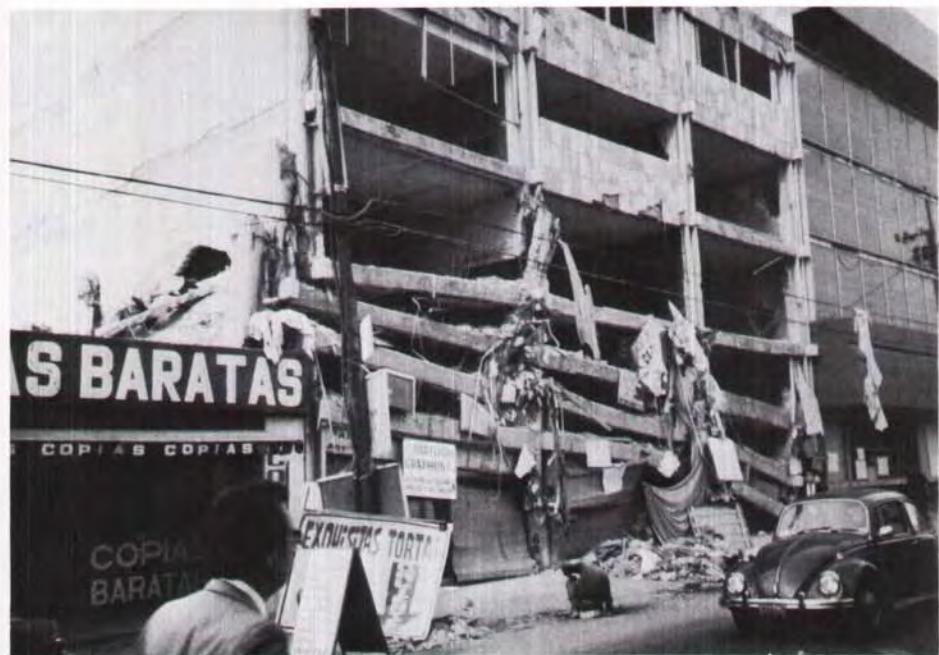
within the height of the structure collapsed while leaving intact several stories above and a number of stories below (Fig. 6).

Fig. 6. Collapsed middle stories.

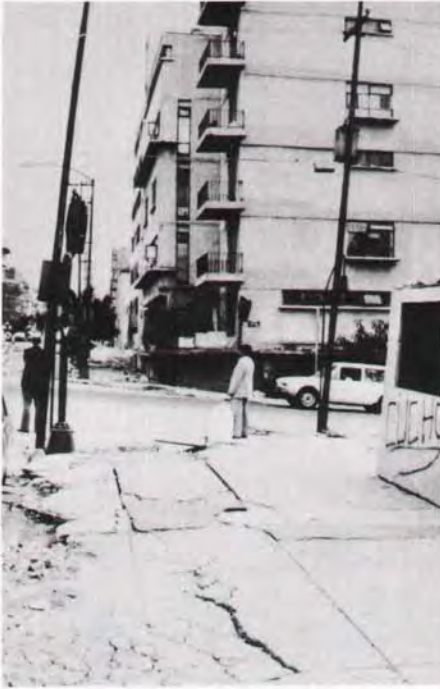
Fig. 7. Building sunk relative to sidewalk.

causing a building to settle as a block by about a third of its ground story (Fig. 7).

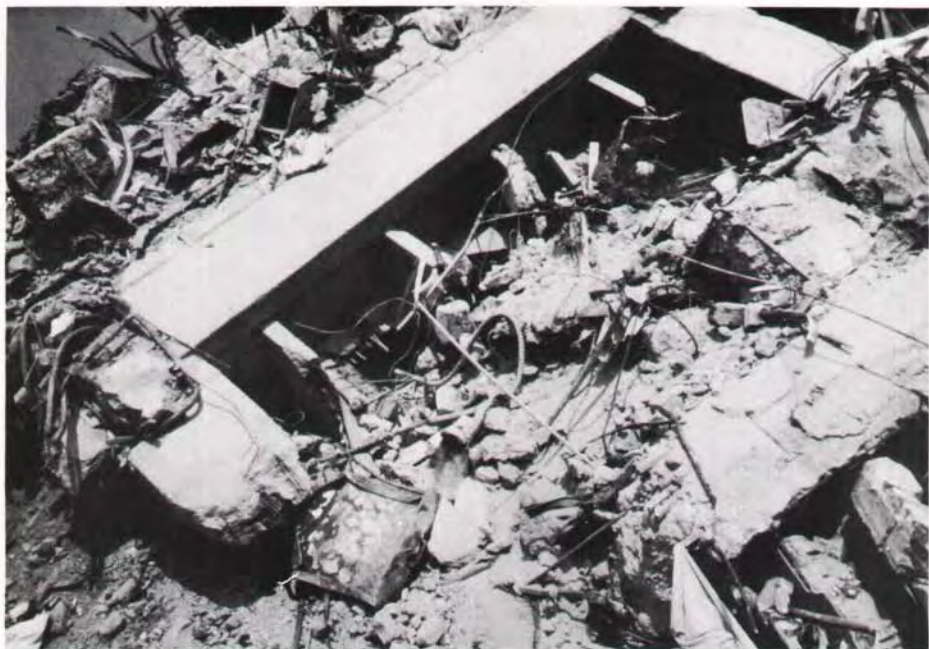
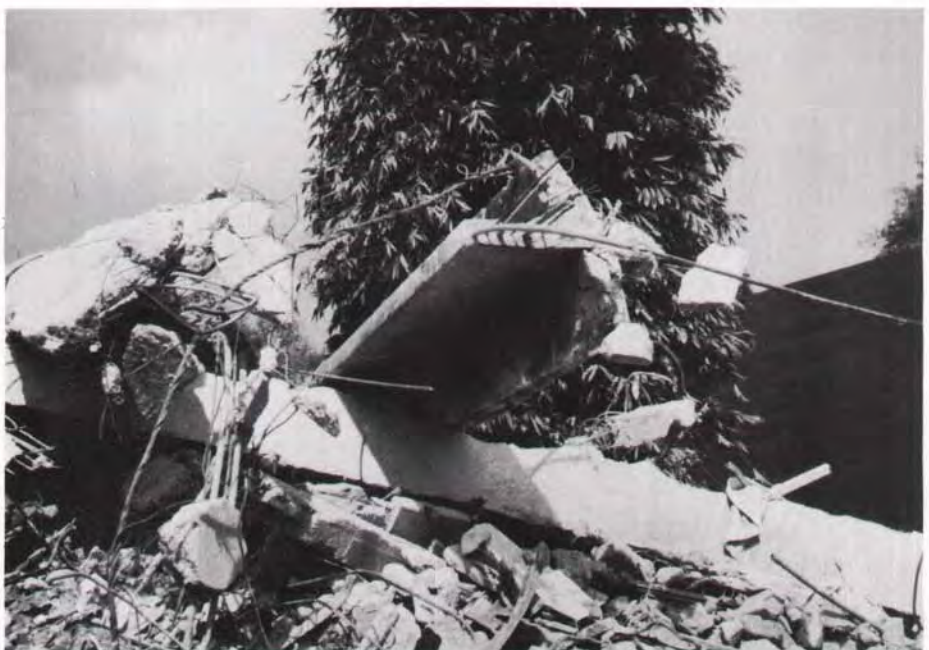
Inspection of the remains of two of these collapses — the six-story Maternity Ward at the General Hospital (Figs. 12 and 13); and the partially collapsed seven-story public parking garage at Carranza Street (Figs. 14 and 15) — showed many connections between columns and beams intact. The remains and positions of the pancaked slabs suggested that collapses were caused by failures unrelated to the precast elements or their connections. Thus, the earthquake performance of these buildings was similar to those of monolithic concrete frames.

Fig. 12. Remains of six-story Maternity Ward, General Hospital.

Fig. 13. Remains of six-story Maternity Ward, General Hospital.

As can be seen in the figures, the Maternity Ward used double tee slabs with 5 cm (2 in.) topping, while the parking garage used topped hollow-core slabs. The Maternity Ward was a free standing structure and column failures might have been the primary cause of collapse. The parking garage stood in the middle of the block squeezed in between neighboring structures; hammering against the adjacent structures might have caused the failure.

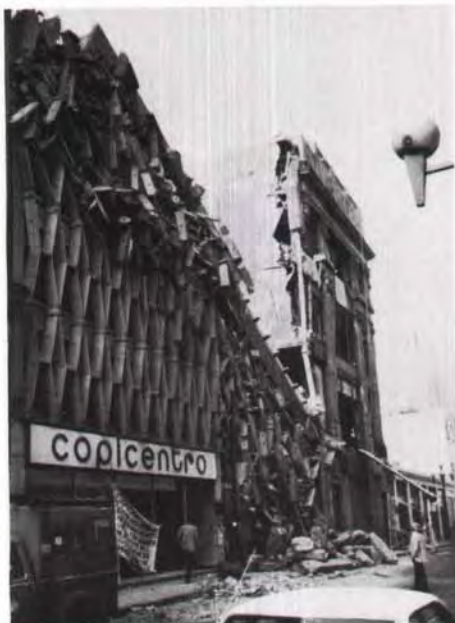
Fig. 14. Partially collapsed seven-story public parking garage at Carranza St.

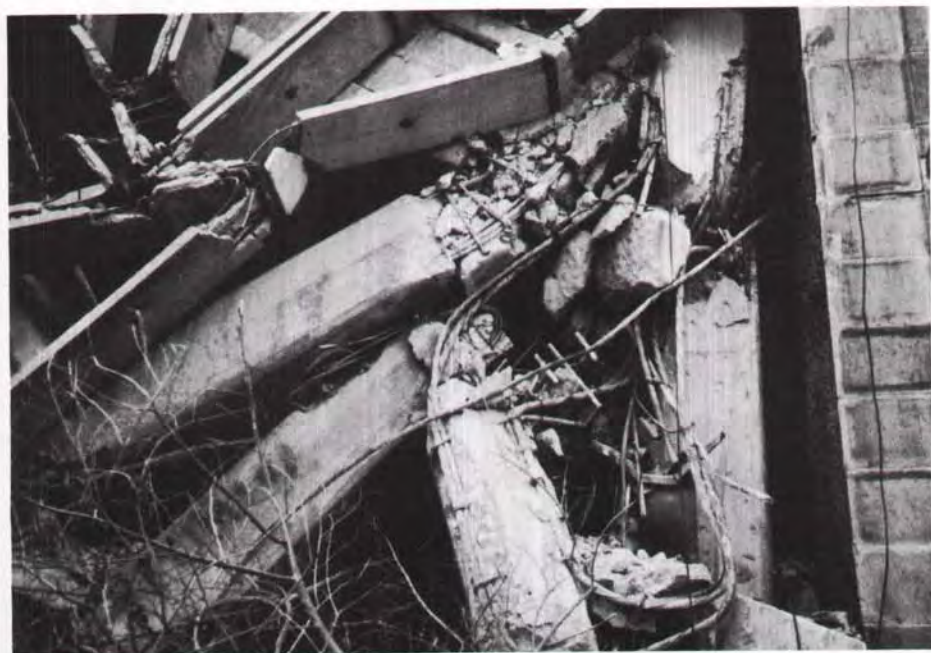
Fig. 15. Detail showing partially collapsed seven-story parking garage at Carranza St.

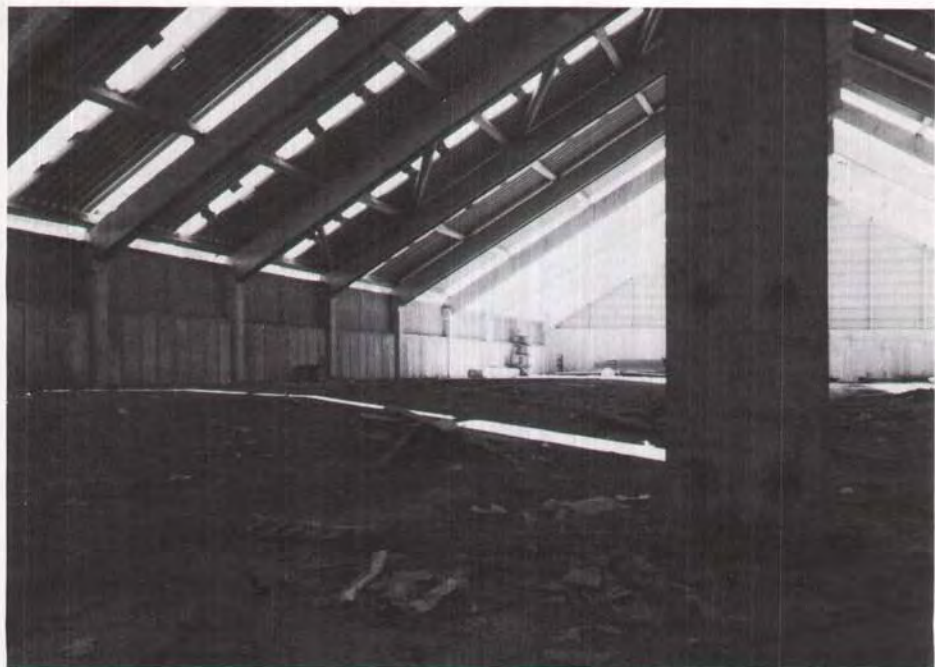
Within the two-bay building, the previously level, slab-on-grade became wavy (Fig. 19), inducing a difference in elevation of 1 m (3.3 ft) between the lowest and highest points. The middle row of columns settled relative to the exterior rows registering

Fig. 19. Slab waves 1 m (3.3 ft) high.

During the earthquake, the movement of the ground caused the initially horizontal slab-on-grade to become wavy with differentials from the lowest to the highest point of more than 1 m (3.3 ft) as can be seen in Fig. 19.

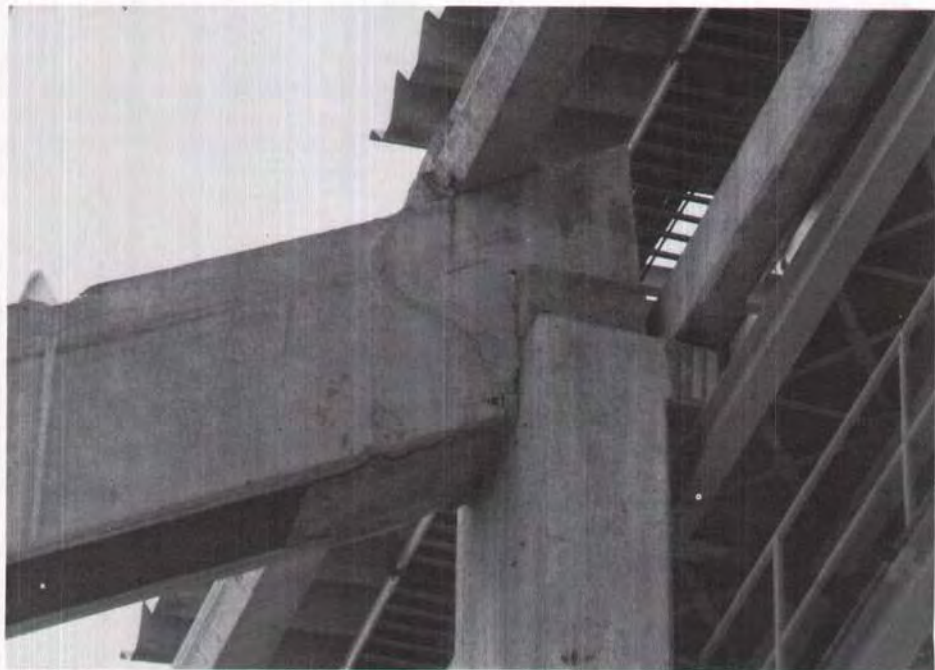
Both the giant silos and the plant buildings performed very well during the earthquake. Only a very few purlins had fallen off their supports in the silos. In the two plant buildings several beams shifted on their supports and only two beams (out of 60) exhibited slight shear cracking (Fig. 20) in addition to some minor repairable distress and dislocation.

Fig. 20. Shear crack in roof beam.

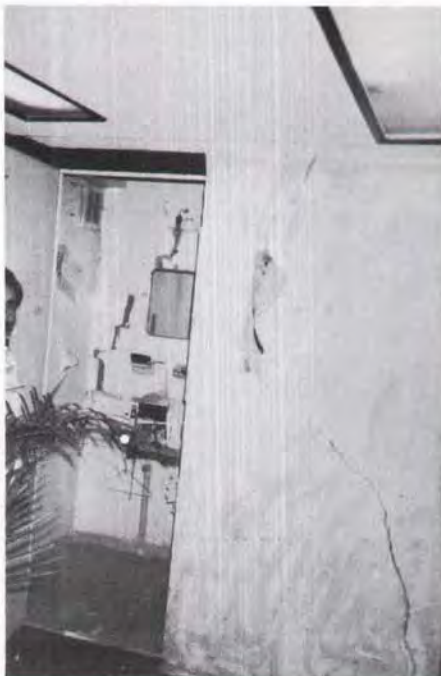
Fig. A2. Cracking of masonry partitions in adjacent building.

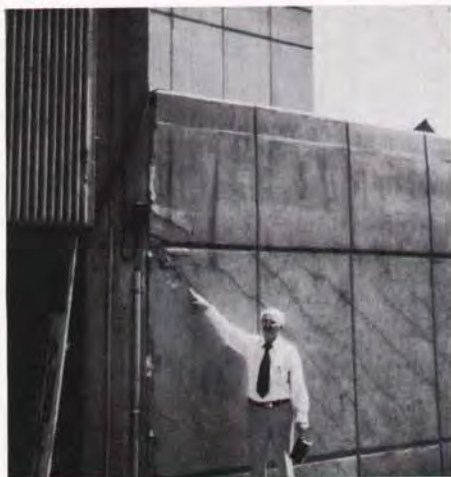
Architectural precast concrete spandrel panels are attached to the structure all around the periphery. There are no signs of distress in the garage, although there is ample evidence of distortions during the earthquake as seen in the cracked buttressing wall at the entrance to the garage (Fig. A4).

Fig. A4. Cracked buttressing wall at garage entrance.

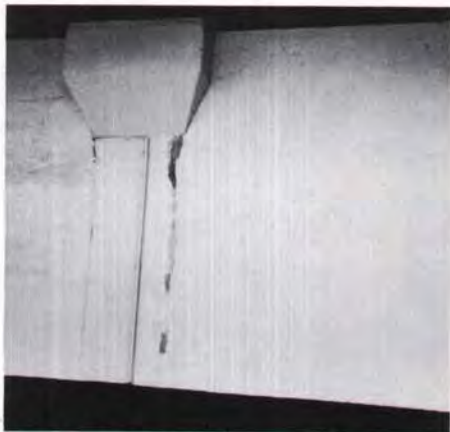
The fascias on all floors around the periphery of the parking garage are curved architectural precast concrete panels. Except for several very minor separation cracks in the ground story between the masonry filler walls and columns (Fig. A6), there is no sign of any structural distress in this structure which is located in an area of most severe damage.

Fig. A6. Separation between infill masonry and frame.

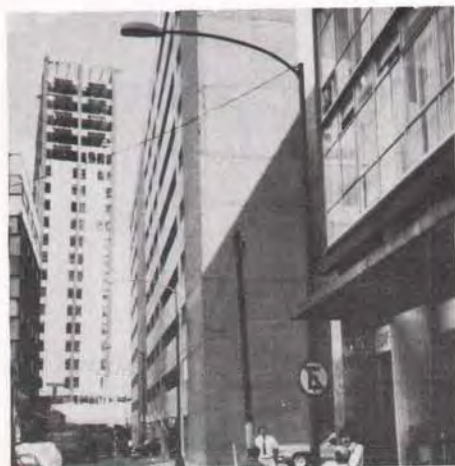
twenty-one and thirteen-story Pino Suarez Office Buildings) collapsed and their twenty-one-story steel neighbor is several feet out of plumb, as seen in Fig. A8. The structural slab of the garage consists of precast prestressed double tees with a 12.2 m (40 ft) clear span supported on 1 m (3.3 ft) wide inverted tees and cast-in-place concrete columns.

Fig. A8. Ten-story parking garage on Flamingo Avenue. In background is the tilted twenty-one story steel structure.

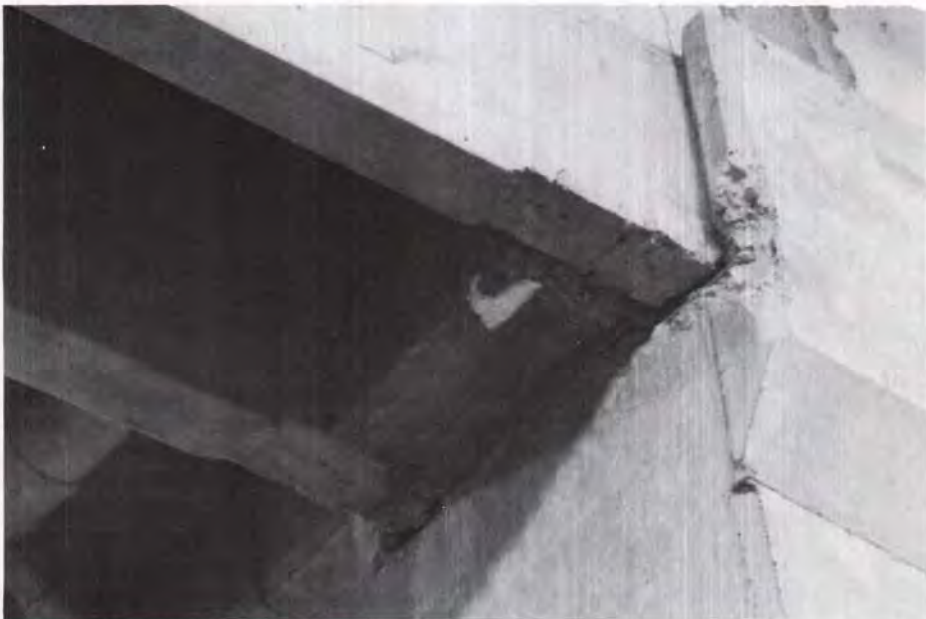
Fig. B4. Beam shifted 20 cm (8 in.) at top of column.

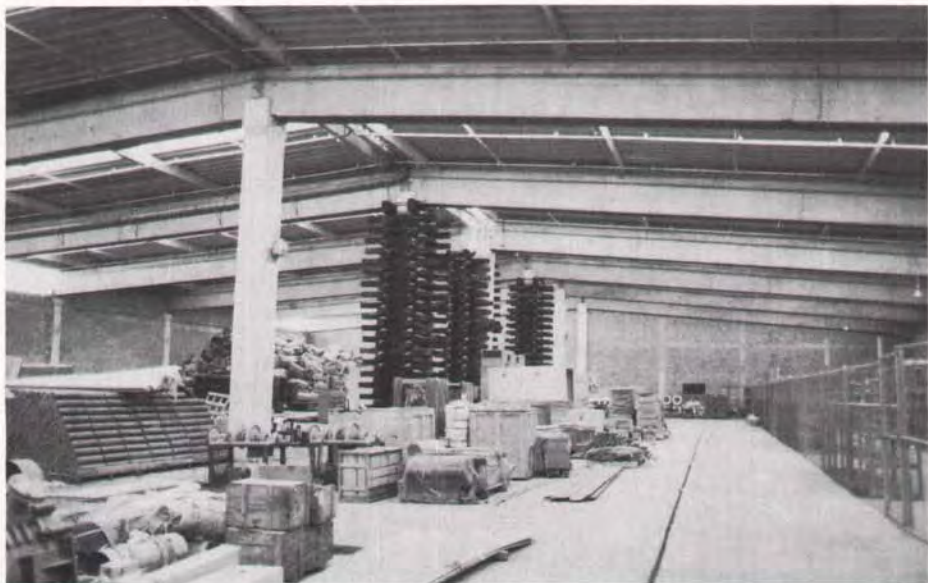
Fig. B5. Temporary cribbing for repair of support.

at three column locations required temporary cribbing (Fig. B5) so that the beam seating could be repaired. However, not a single structural element suffered serious distress or collapse.
