Precast concrete was used effectively to restore the deteriorated elements of this historic bridge.

Renovation of Albert Memorial Bridge

Regina's Albert Memorial Bridge was built in 1930 as a depression years make-work project. Built across Wascana Creek, the 850 ft (259 m) structure actually spans only about 40 ft (12 m) of water. In fact, it may hold a record for being the longest bridge spanning such a narrow stream.

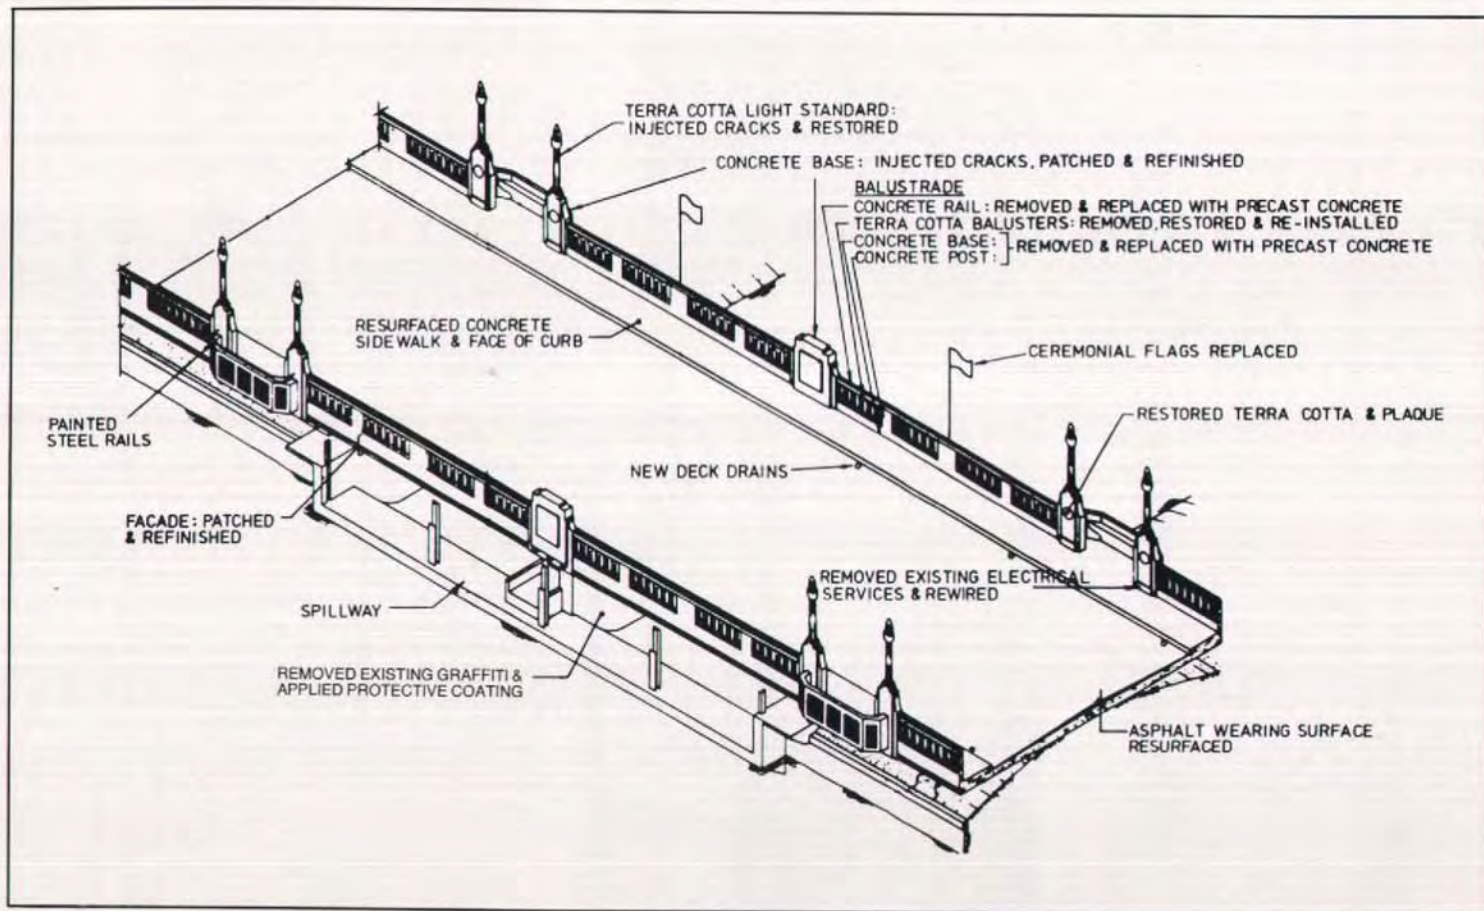
Fig. 1. Partial perspective showing restoration work.

By the early 1980s, the concrete balustrades of this designated heritage structure had deteriorated to the point where structural and architectural restoration were necessary (see Fig. 1). The high class structure incorporates some colorful and articulate terra cotta balusters and plaques which were manufactured by the Northwestern Terra Cotta Company of Chicago.

there was no heritage value given to the dilapidated concrete balustrade. The concrete top rail and base were initially cast continuously from one end of the structure to the other. Consequently, severe shrinkage cracks developed during the first winter that the bridge was open. Over the years, water and deicing salts had entered these cracks, leading to corrosion of the steel reinforcement and the embedded steel electrical conduit. Large pieces of concrete eventually spalled off.

During the design development phase, precast concrete was selected to replace

the deteriorated balustrade for a number of reasons:

- The jointed precast system would accommodate the thermal movements.
- Off-site fabrication would minimize on-site construction activity, thereby reducing the length of disruption to passing motorists and pedestrians.
- Better quality control.
- The precast top rail system could be easily dismantled to accommodate future repairs to damaged terra cotta balusters.
- The precast system would accommodate the reinstallation of the balusters with minimal risk of damage to the precious terra cotta pieces.
