# Field Performance of Full Depth Precast Concrete Panels in Bridge Deck Reconstruction

*There have been many applications of full depth precast and precast, prestressed concrete deck panels for bridge rehabilitation in North America. This paper presents the findings obtained through an investigation conducted in the United States to evaluate the field performance of bridge deck panels. The states included in the investigation were Illinois, Connecticut, Virginia, Maryland, Iowa, California, New York, Alaska, Ohio, Pennsylvania, and Washington, D.C. The investigation mainly consisted of a visual inspection of bridges selected through an*

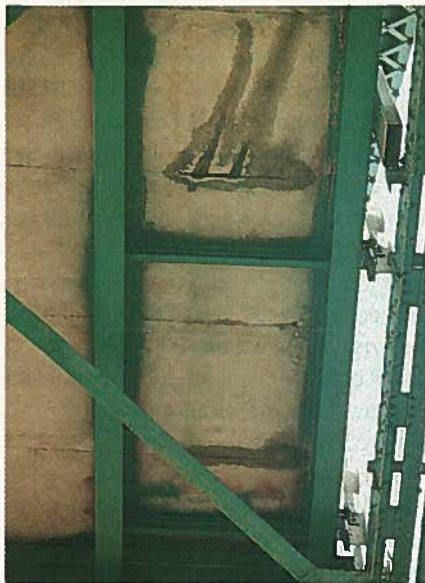
Fig. 2. Condition of bridge deck viewed from below, Seneca Bridge, LaSalle County, Illinois.

The bridge deck shows random cracks at the approach spans. The match cast joints between the precast, prestressed panels are leaking, as shown in Fig. 2. This type of joint is not effective in this type of construction. The limited contact area does not allow enough bond area in the joint for the grout. Signs of corrosion are also apparent on the steel supporting system.

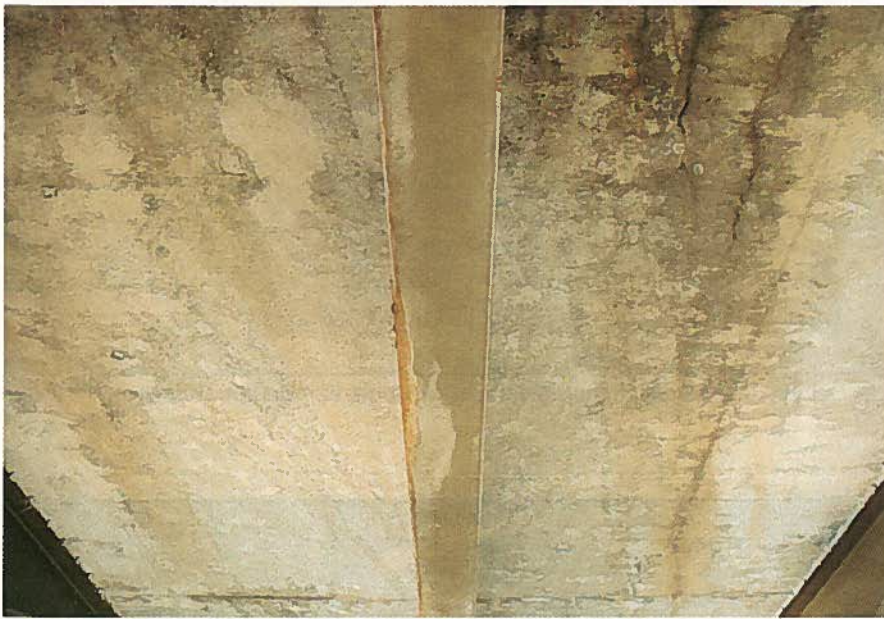
Fig. 6. Cracking and leaching in William Preston Jr. Memorial Bridge, Chesapeake Bay, Maryland.

Leaching through the joints between precast concrete panels is a major problem; numerous locations underneath the deck show deposits and stains (see Fig. 6). This problem is attributed to the type and configuration of joint used. The closed joint end (bottom) does not allow for any size irregularities in the panels or any dimensional growth. The problem is currently being treated by patching the openings in the joints with a caulking material.

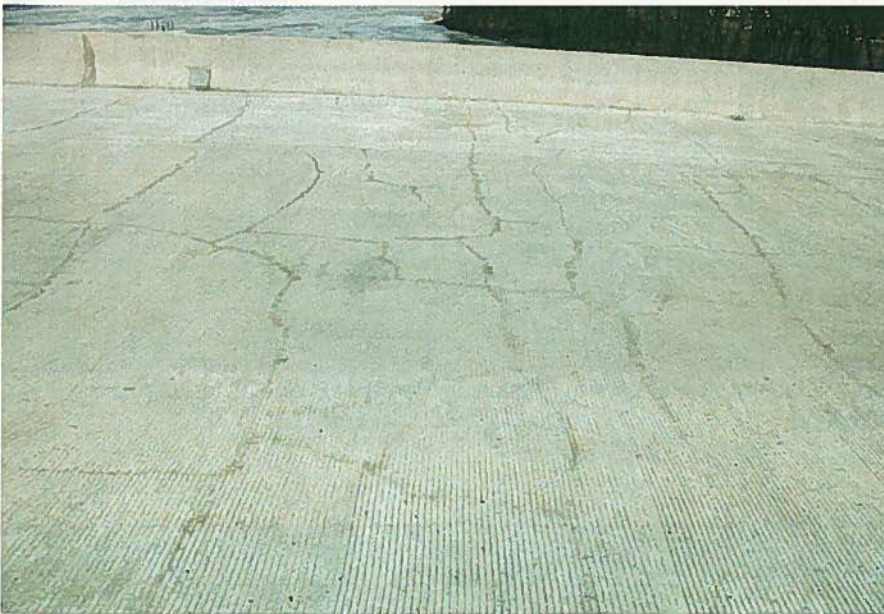
Fig. 7. Condition of overlay on Burlington Bridge, Iowa.

concrete, with basic absolute volumes of materials per unit volume of concrete as follows: 0.156 cement, 0.16 water, 0.06 entrained air, 0.312 fine aggregates, and 0.312 coarse aggregates. Because of superimposed loads, such as machines causing vibrations on the deck, fatigue cracking occurred. These cracks were sealed with methacrylate. The poor condition of the overlay is depicted in Fig. 7.

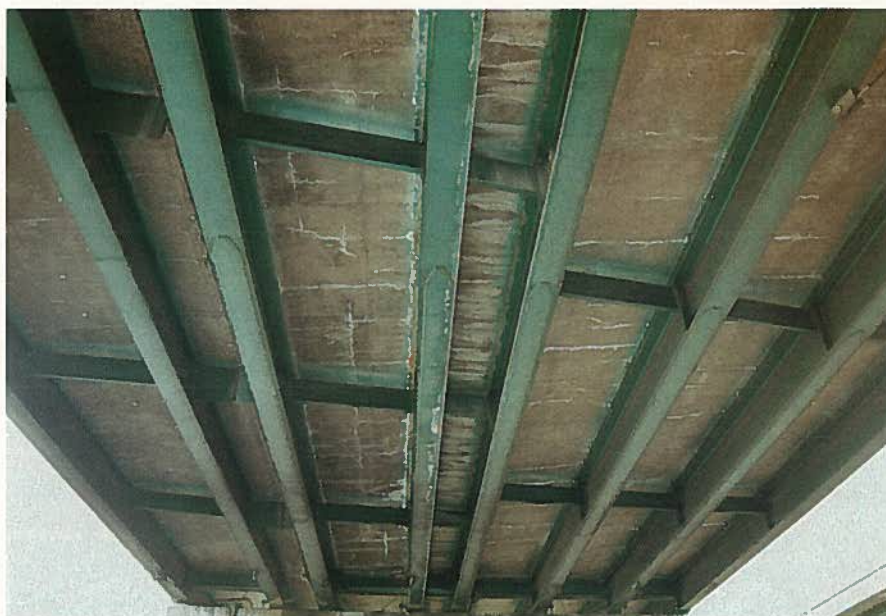
Fig. 9. Condition of deck and supporting system viewed from below, High Street Overhead Separation Bridge, California.

The structure is rated fracture critical. The deck (mainly the cast-in-place deck), shown from the underneath in Fig. 9, exhibits cracking,

leaking, leaching, and rusting. The deck has transverse cracks in addition to radial cracks emanating from the 12 x 4 in. (305 x 102 mm) shear connection pockets, as shown in Fig. 10. Typically, these blockouts are spaced 2 ft 6 in. (762 mm) apart. Spalling is also apparent, particularly between

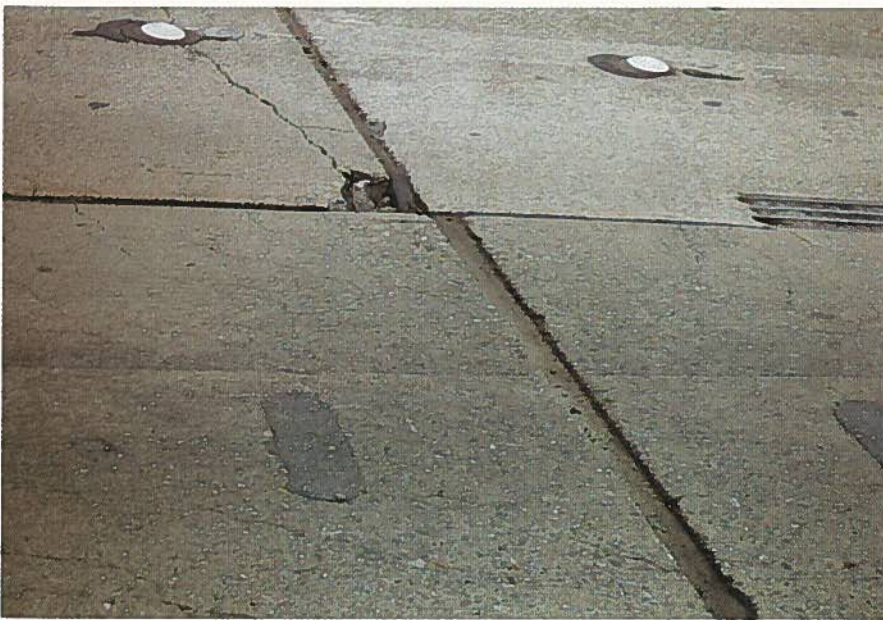
Fig. 10. Condition of deck and joints in High Street Overhead Separation Bridge, California.

Lanes 3 and 4, as shown in Fig. 10.

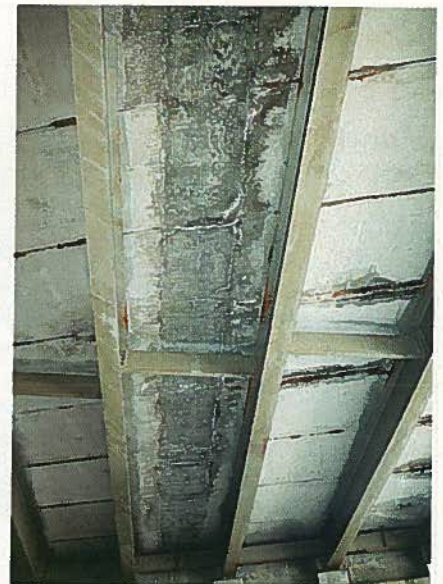
Fig. 13. Fracture and spalling at transverse joint in Krumkill Road Bridge, Albany County, New York.

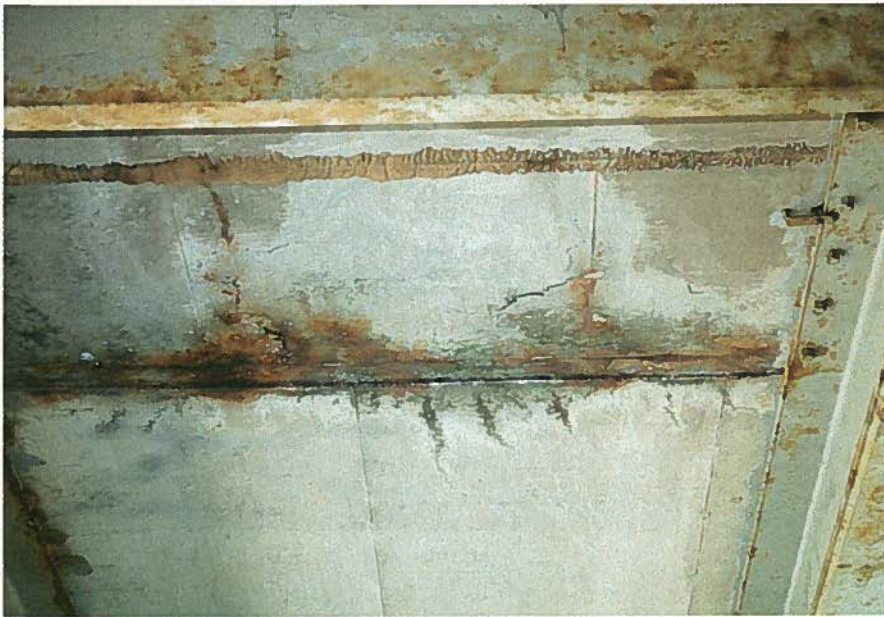
Fig. 17. Leaking and rusting in Amsterdam Interchange Bridge, Montgomery County, New York.

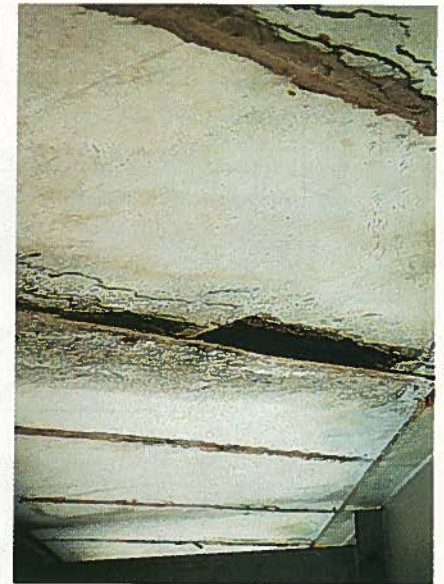
Fig. 19. Random cracking and spalling in Harriman Interchange Bridge, Orange County, New York.

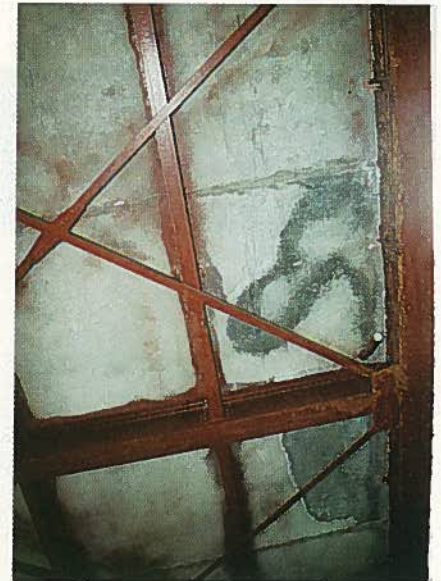
Fig. 20. Minor leaking in Vischer Ferry Road Bridge, Schenectady County, New York.

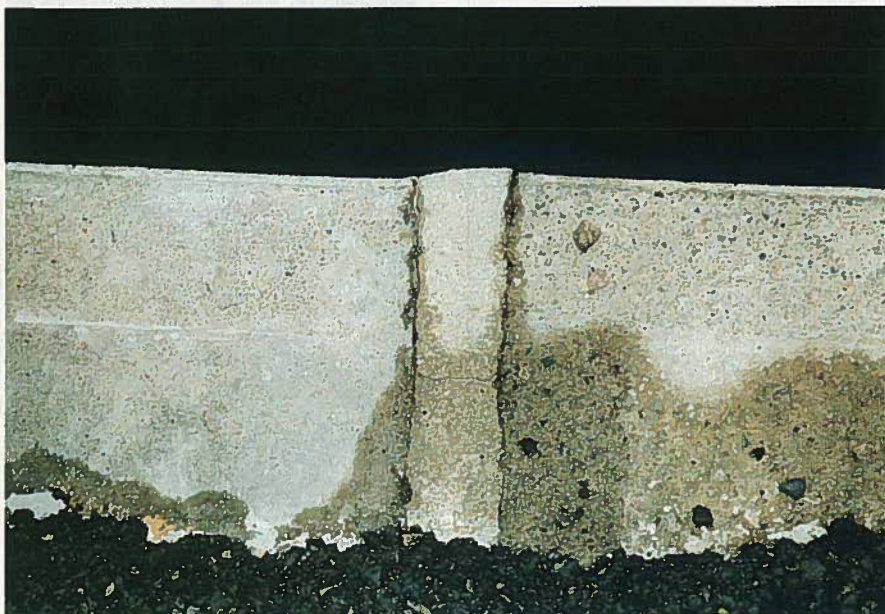
Fig. 22. Debonding in transverse joint in Batchellerville Bridge, Saratoga County, New York.

This structure is performing well. The only problem appears to be some minor debonding in the joints between the precast concrete panels and some cracking in the asphalt (see Fig. 22). The deck appears to be in good condition from the underneath and above. The community of Saratoga currently owns this 41-span bridge. However, the state will take over responsibility for the bridge prior to redecking or replacing the structure. The low traffic volume and load limitations have contributed towards keeping the structure in excellent condition.

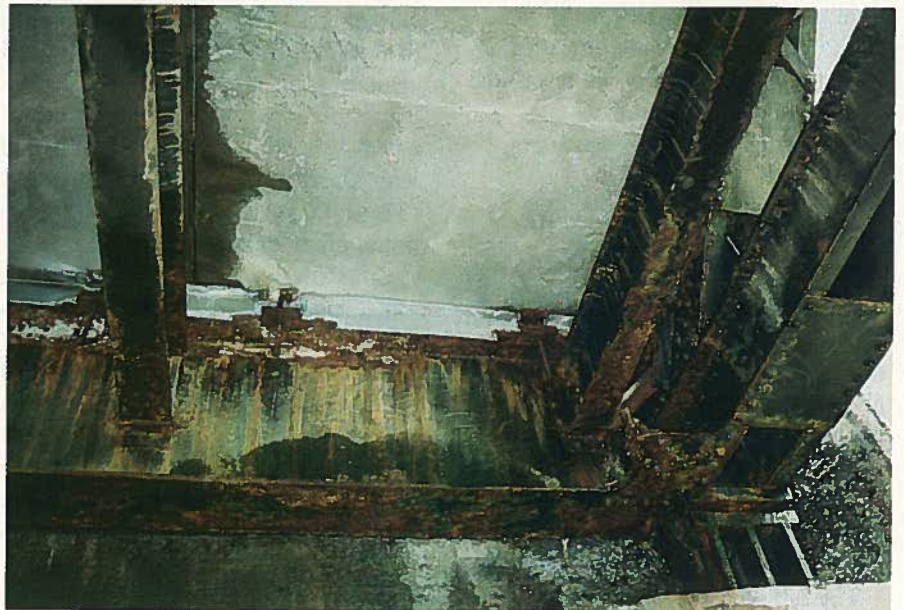
Fig. 24. Leaking at the transverse joints in Route 155 Bridge, Albany County, New York.

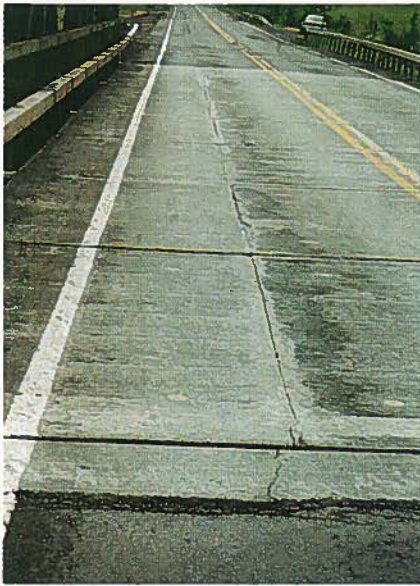
Fig. 25. Cracking in asphalt surface on Route 155 Bridge, Albany County, New York.

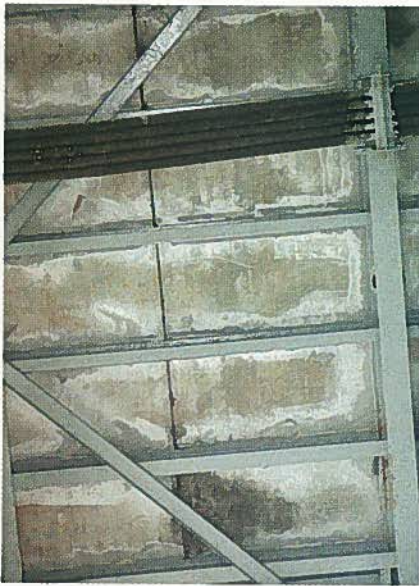
Fig. 27. Leaking underneath bridge deck, Kingston Bridge, Ulster County, New York.

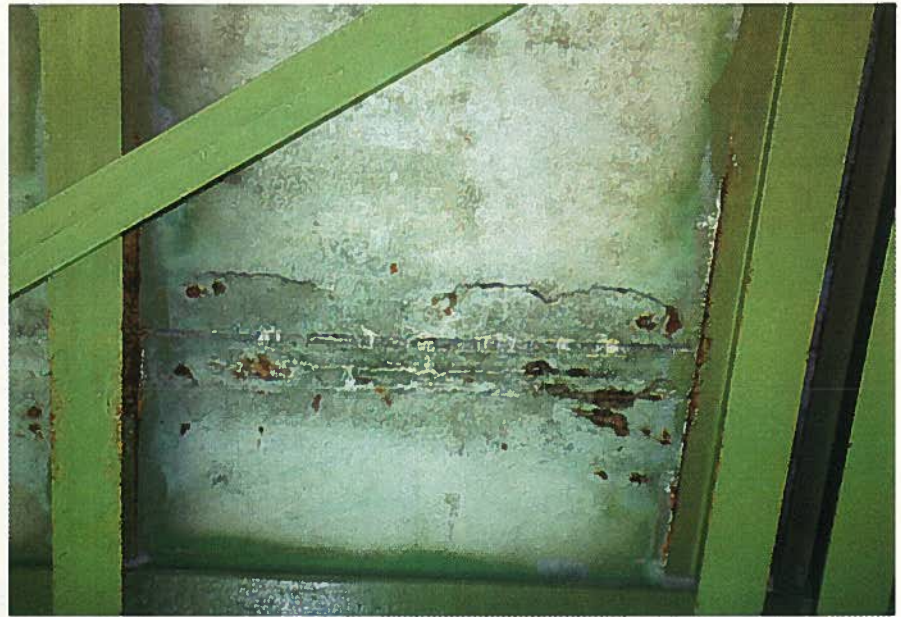
Fig. 30. Spalling underneath bridge deck, Cochection Bridge, Sullivan County, New York.

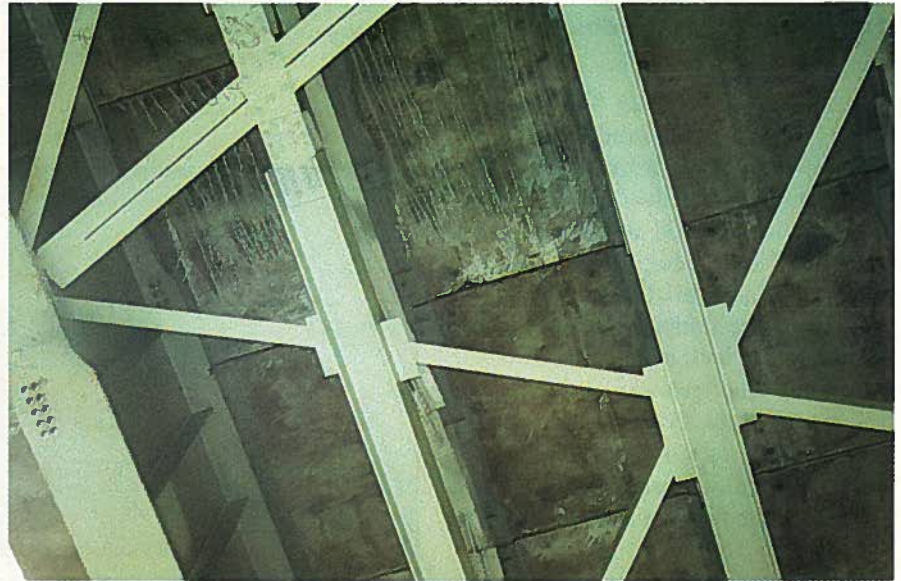
Fig. 31. Minor signs of leaking and leaching, Chulitna River Bridge, Alaska.

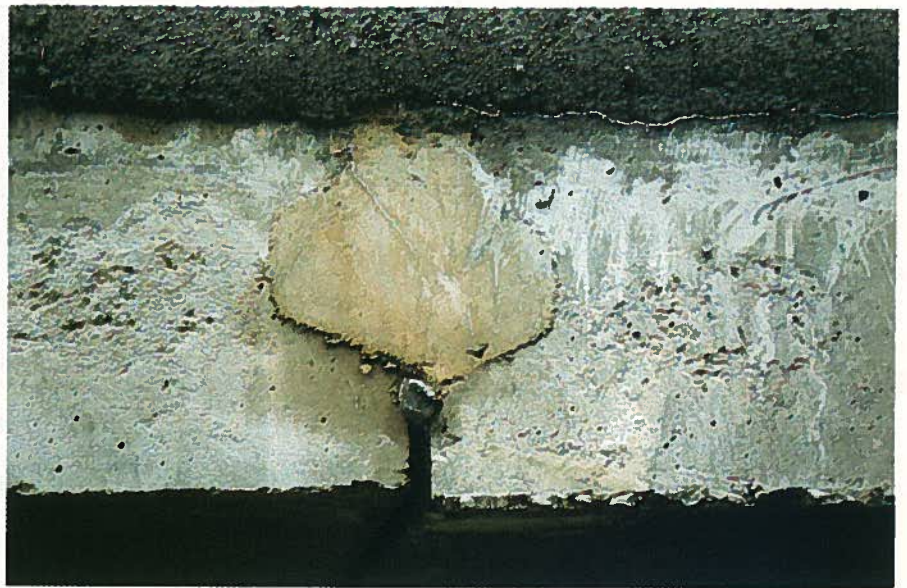
Fig. 32. Minor debonding at transverse joints, Chulitna River Bridge, Alaska.

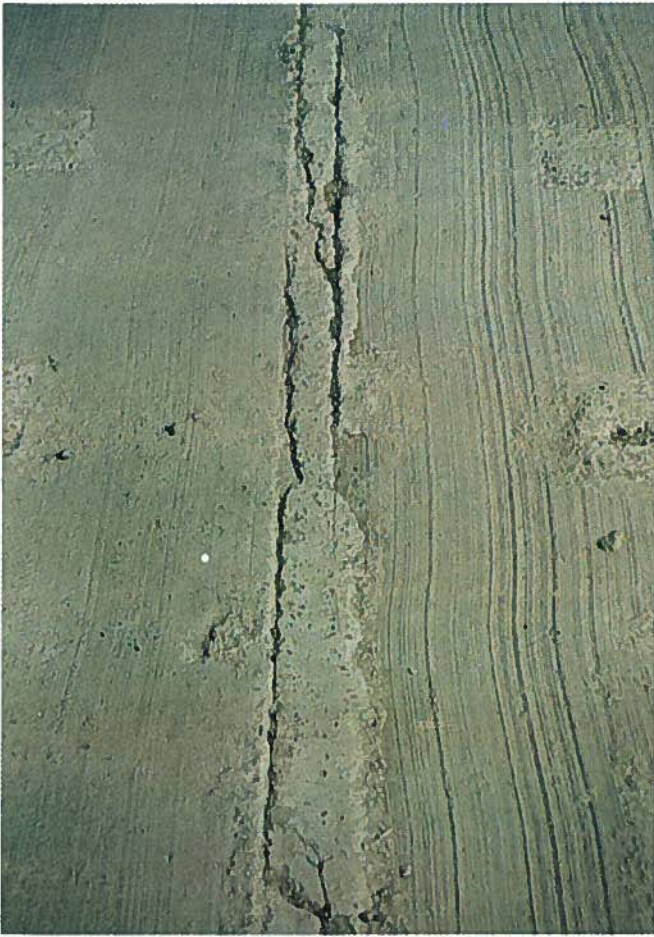
The transverse joint at the junction between the two 60 ft (18.3 m) spans is severely split, as shown in Figs. 34 and 36. The last two 30 ft (9.1 m) spans appear to be in good condition. The rubber material (stopper) that is provided to hold the grout is not efficient because it holds an undesirable volume. More grout and less stopper would contribute towards providing more composite action.

Fig. 36. Cracking and loss of material at transverse joints, Dalton Highway Bridges, Alaska.

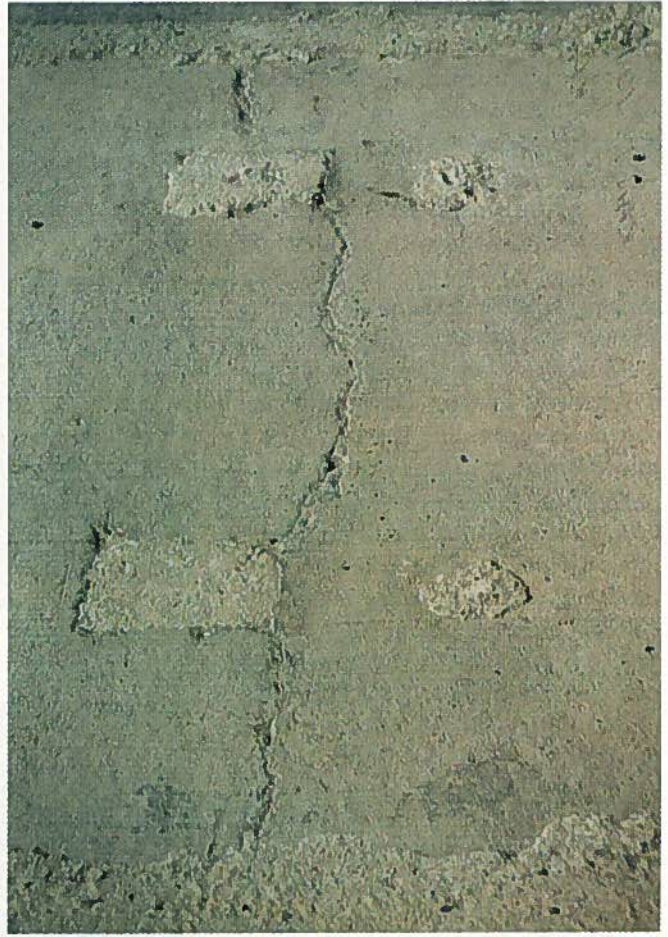
Fig. 37. Cracks between shear pockets, Dalton Highway Bridges, Alaska.

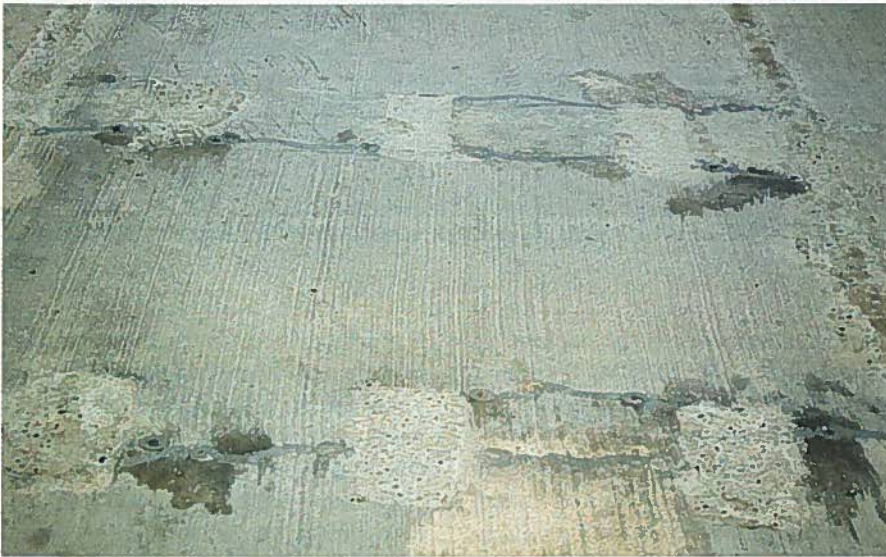
Fig. 38. Patching at shear connecting pockets, Dalton Highway Bridges, Alaska.

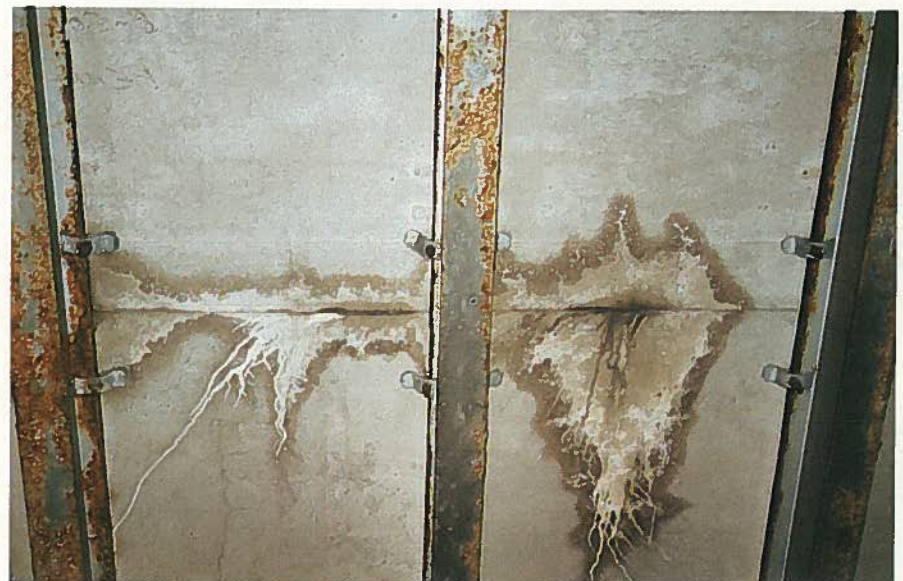
Fig. 44. Excessive leakage at transverse joints, B-501 Bridge, Somerset County, Pennsylvania.

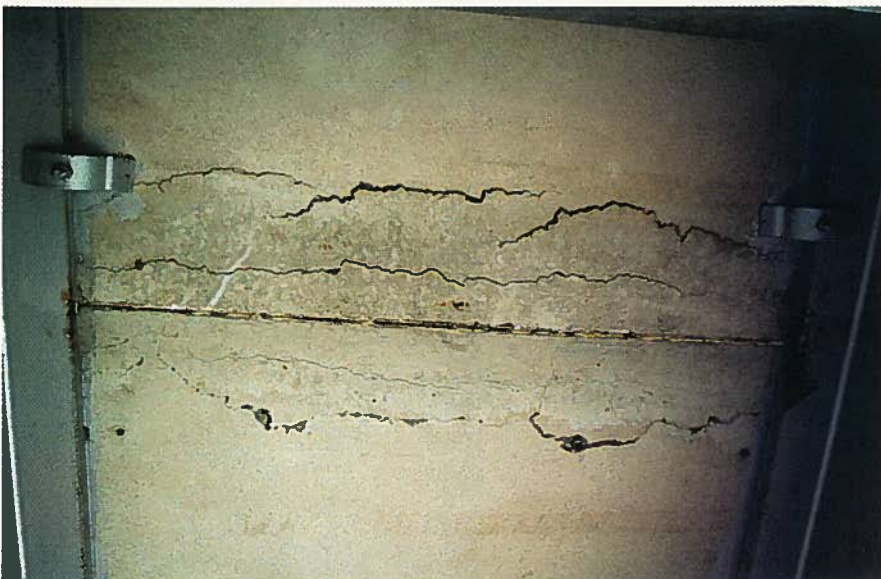
Fig. 47. Heavy spalling and cracking, NB-216 Quakertown Interchange Bridge, Bucks County, Pennsylvania.

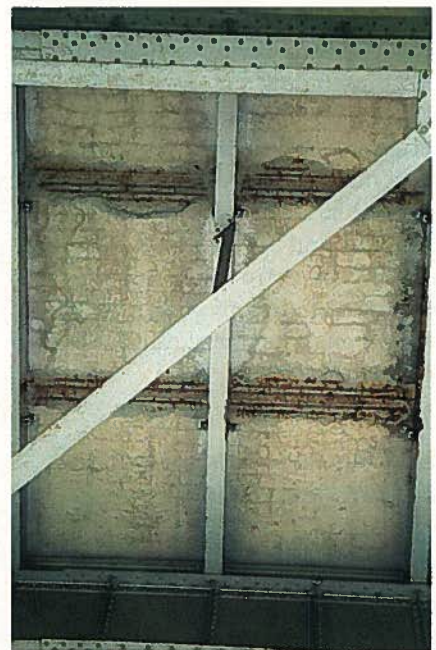
Fig. 48. Cracking and spalling, NB-750 Clark Summit Bridge, Lackawanna County, Pennsylvania.
