## **Reconstruction of the Historic Animal Bridge**

### **PROJECT OVERVIEW**

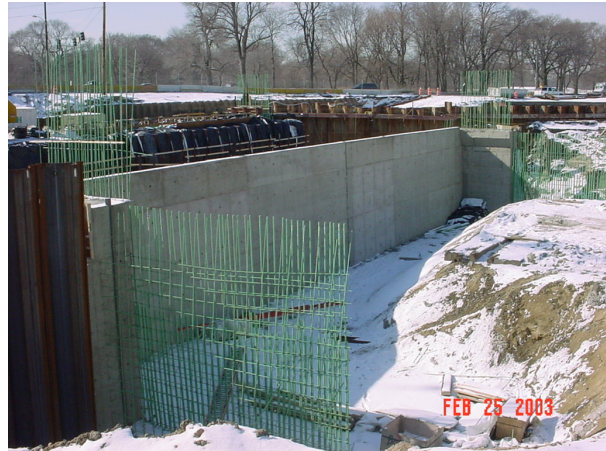
**Figure 12 Winter Construction**

Despite the fact the construction was proceeding at an accelerated schedule, the work described above took almost seven months. The intent was to construct the substructure, entire superstructure and finish the stone replacement before May 15, the beginning of the boating season, but the work over winter took longer than expected. Therefore, the day before the new boating season, cofferdams were pulled out and the channel was flooded back. From May 15 to October 15, roadwork and construction of wing walls continued with the channel open. At the end of the boating season, cofferdams were installed again. Cut-off walls and seawalls were reconfigured, the enclosed area was drained, false work installed and stone placement work resumed.

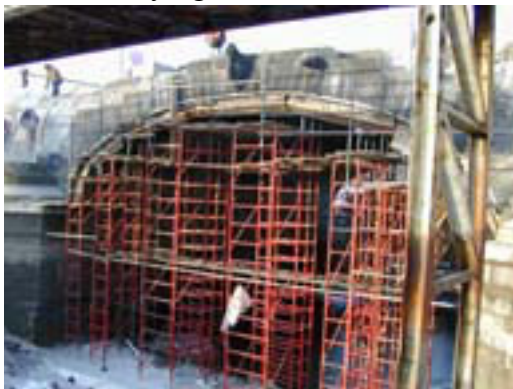
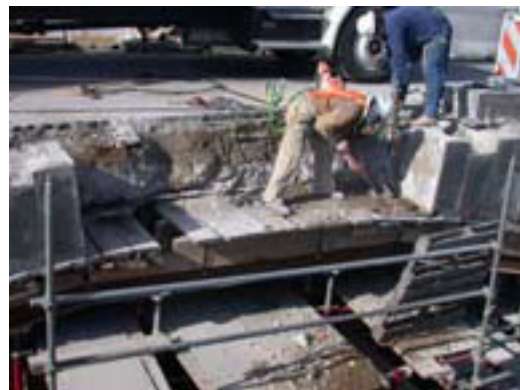
**Figure 1 Stone Disassembly**

The contractor was also required to provide close-up photographs of all the stone surfaces in order to document any stone defects and provide a record of the conditions prior to disassembly. The architect's specifications for disassembly of stone structures typically prohibit the use of impact methods such as hammering and chopping, due to the risk of damaging the stone. These methods could not be avoided in the case of the Animal Bridge. Because the sandstone facings served as formwork for the sides of the original bridge with concrete poured directly against the stones, their removal needed to be accomplished largely by saw cutting and breaking off the concrete from behind. The soffit stones of the arch and stone coursing of the wing walls were of two alternating depths that formed a keying action with the concrete,

complicating this work. No metal anchors or supports were used in the original construction. The removal work had to be accomplished on a tight schedule while traffic was maintained over the bridge and W. B. Weis, the stone subcontractor, took great care not to damage the stone.

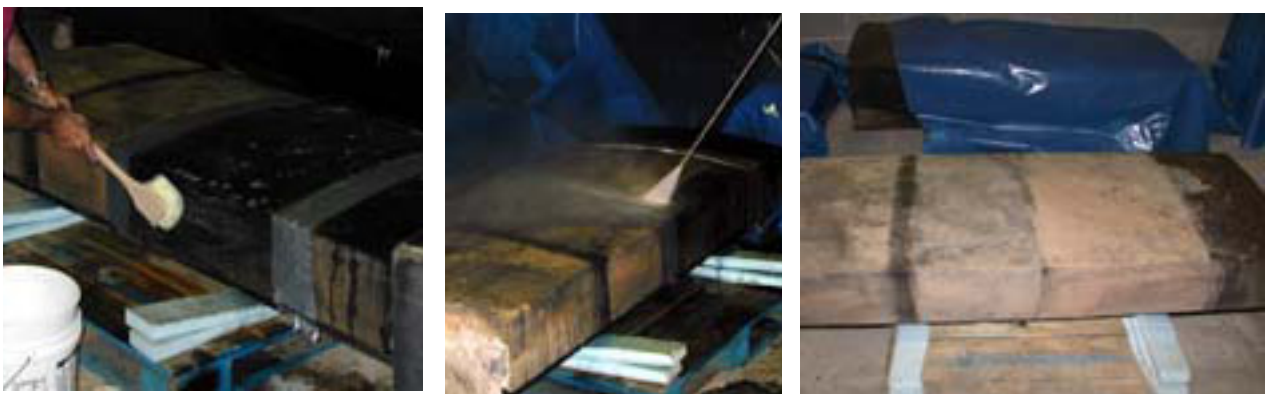
The bridge presented several cleaning challenges. In addition to being exposed to soiling from a century of vehicular traffic and deicing salts, the bridge was subject to pollutants from the nearby former United States Steel complex. Burning coal in the early 20th century also contributed to the heavy carbon deposits and dark staining that covered the bridge. On top of this were layers of graffiti and painted signs. A cleaning regimen would be developed to improve the appearance of the bridge and to remove the salt and contaminants that were detrimental to the stone and would adversely affect bonding of mortar repairs. Care had to be taken to avoid etching or discoloring the stone or damaging the distinctive surface textures which were remarkably intact after nearly a century. Despite extensive research the architects were unable to locate anyone who had successfully cleaned this type of sandstone. After the specifications were written they were able to travel to Minneapolis to look at buildings constructed of this stone. One had been cleaned “effectively” by sandblasting which had removed the stone surface, destroying detail and exposing swirling grain patterns that were not evident in the tooled stone. The other had been cleaned in the past by unknown means but the results were very uneven. **Figure 3 Cleaning Tests**

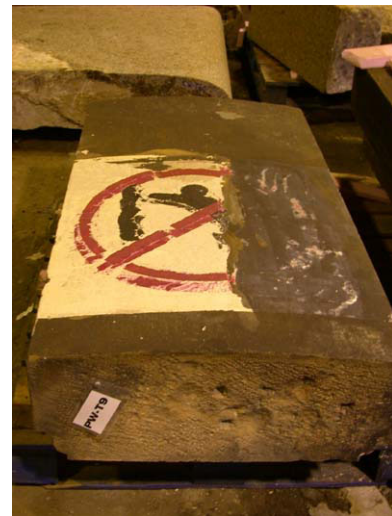
**Figure 4 Paint Removal**

Once all the stones had been brought to the storage warehouse further cleaning tests were performed on both the granite and sandstone to determine the exact cleaning procedures to be used. The light duty cleaner specified for the granite performed as expected. For the sandstone, a double application of chemical with adjustments to dilution and dwell times was established and a second water rinse was added following drying and brushing off the stone, in order to more fully remove the salt that came to the surface. Paint removal was conducted next. Both methylene chloride and sodium hydroxide type paint removers were used to remove the different types of paint after it was determined through testing that they would not have a harmful effect on the stone. Multiple applications were often required with dwell times dependent on ambient temperature. Some deeply-absorbed types of spray paint resisted complete removal by any method, leaving faint shadows on the stone.

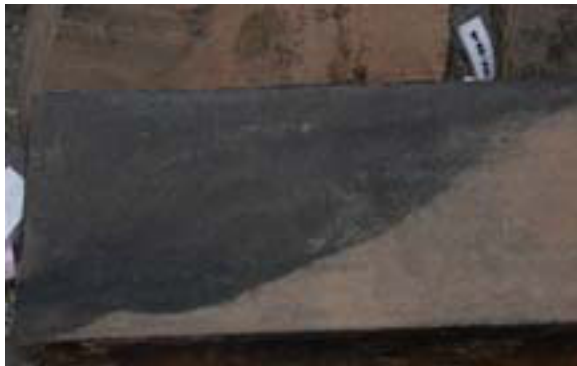
**Figure 5 Differential Cleaning Results**

After the cleaning of the disassembled stone was underway it soon became evident that the stones on which previous tests had been conducted were not representative of the full range of conditions that would be encountered. Although newly cut sandstone exhibited a remarkable consistency of color, the cleaning results were highly variable from stone to stone and sometimes from one part of a stone to another. The patterns of sediment deposition in the stone were highlighted as surface layers with different densities or absorption characteristics reacted differently to cleaning. In many cases the soiling that was proving difficult to remove was more like a stain that had been absorbed into the surface of the stone. Every stone was examined and rated according to the degree of cleaning achieved. From this a map was prepared in an attempt to identify patterns to the soiling. As might be expected, the inner parapet stones along the roadway were typically less clean and parts of stone that were covered by the earth were cleaned as if they were new. The majority of residual soiling, however, was randomly distributed across the stones. A second round of cleaning tests was conducted, in one case with a product that was under development, and while more effective, the results were still somewhat variable. Those stones requiring supplementary cleaning were identified and re-cleaned using the most effective of the new methods.
