Rollover stability of precast, prestressed concrete bridge girders with flexible bearings

Jonathan B. Hurff and Lawrence F. Kahn

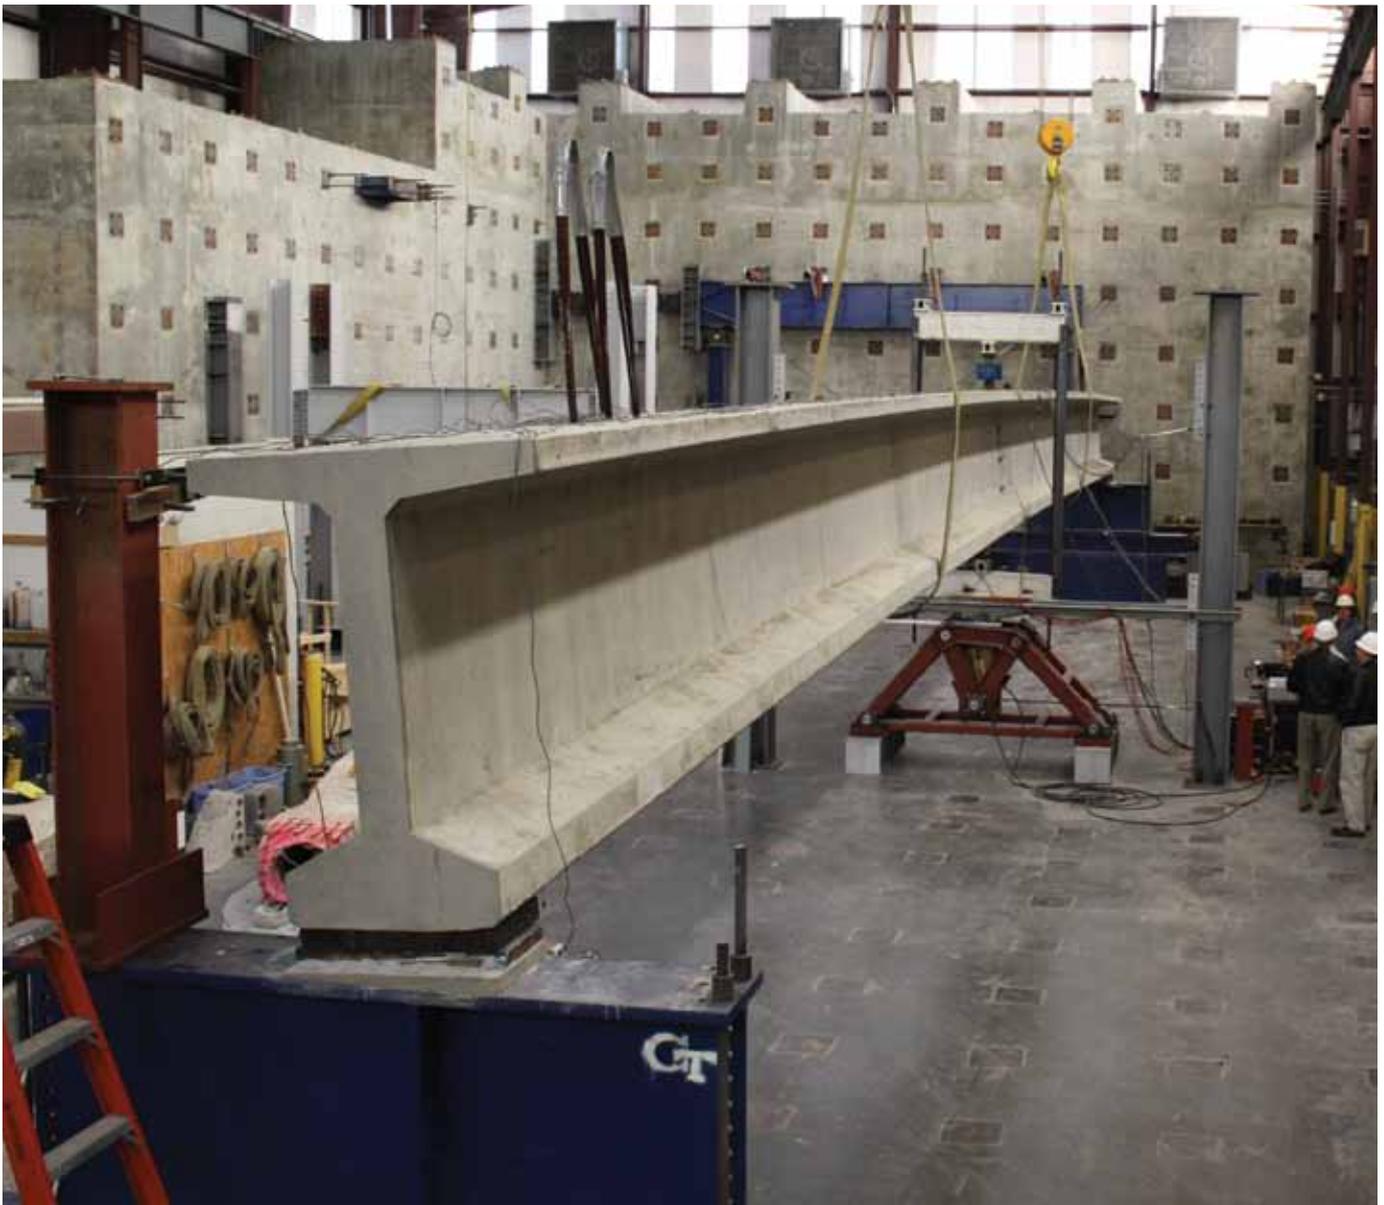
Figure 1. PCI BT-54 rollover stability experimental setup.

The 100 ft (30 m) span PCI BT-54 was prestressed with forty 0.6 in. diameter (15 mm) prestressing strands, each having a jacking force of 43.940 kip (195.47 kN). It was supported to replicate actual bridge end conditions without temporary supports. The girder was placed on 24 in. × 14 in. (610 mm × 360 mm) steel reinforced elastomeric bearing pads (**Fig. 1**). The pads were $2\frac{7}{8}$ in. (73 mm) thick with four internal steel shims. The strong- and weak-axis rotation depended on the stiffness, width, and length of the bearing pads. No bracing or restraints to lateral displacement or rollover were provided.

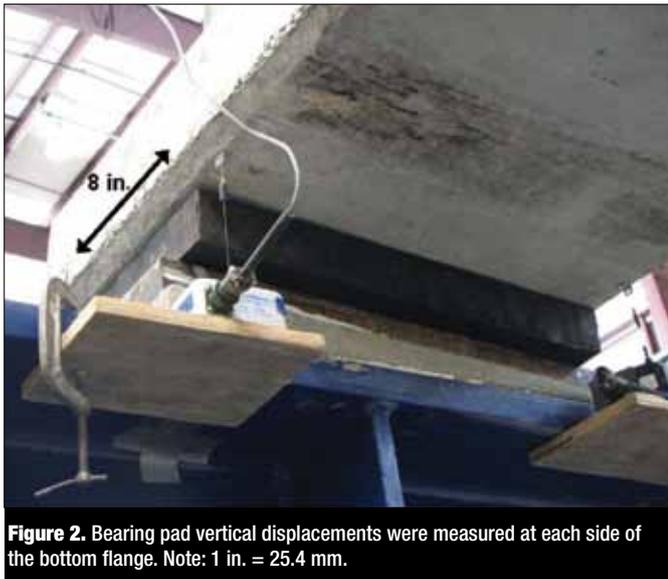
Figure 2. Bearing pad vertical displacements were measured at each side of the bottom flange. Note: 1 in. = 25.4 mm.

Vertical, lateral, and torsional displacements, as well as surface strains, were recorded at midspan. Similar displacements were recorded at the supports (**Fig. 2**) to monitor the compressive deformation of the bearing pads. Initial lateral displacements were measured at nine points along the beam at both the top and bottom of the cross section, thus allowing the calculation of initial rotation along the length. Concrete material testing was performed at the time of testing.

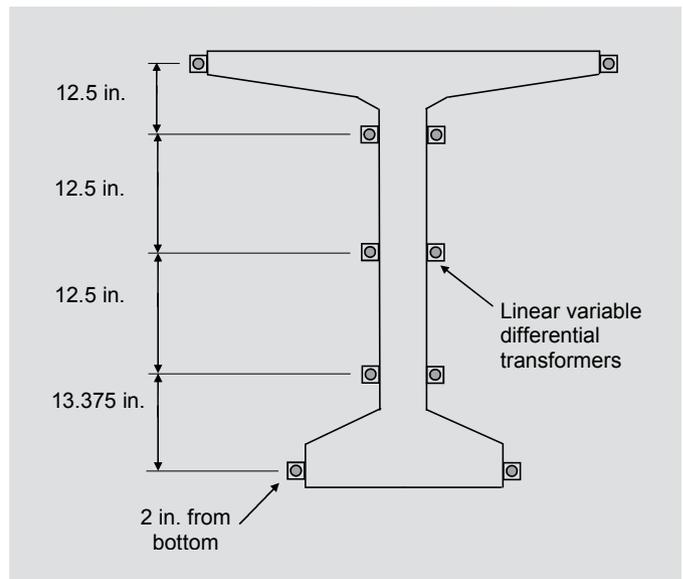
Figure 3. Linear variable differential transformers on PCI BT-54 measure longitudinal strains at these midspan locations. Note: 1 in. = 25.4 mm.

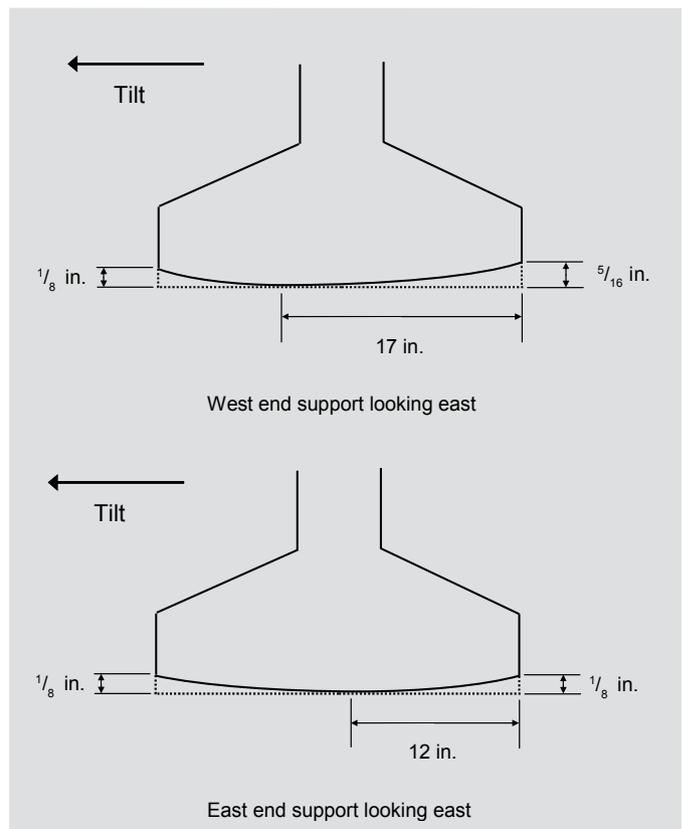
Figure 4. Bottom flange profiles for west-end support and east-end support show the lack of flatness of the BT-54 flange. Note: 1 in. = 25.4 mm.

When the PCI BT-54 was first tested with the sloped bearing, loading was halted at 29 kip (129 kN) because the end rotation observed was substantially larger than anticipated. At 29 kip, the end rotation was expected to be on the order of 0.00072 rad; however, the measured end rotation was 0.0042 rad (six times larger than expected). There was a significant lack of flatness of the bottom flange of the girder (**Fig. 4**). The lack of flatness allowed the girder to roll on the elastomeric bearing pad as opposed to having the full width of the bottom flange create a resisting moment. The *Tolerance Manual for Precast and Prestressed Concrete Construction*¹² does not give a specific tolerance for the flatness of the bottom flange; however, the tolerance for the local smoothness of any surface is $\frac{1}{4}$ in. (6 mm) over 10 ft (3 m).

Neither the nonlinear geometric analysis¹ nor the rollover analysis⁵ considers the effect of a lack of flatness of the bottom flange. Both analyses require an appropriate prediction of the rotational stiffness provided by the couple between the bottom flange and elastomeric bearing pad. High-modulus epoxy was placed on the bottom of the girder to provide a flat bearing surface for further testing.

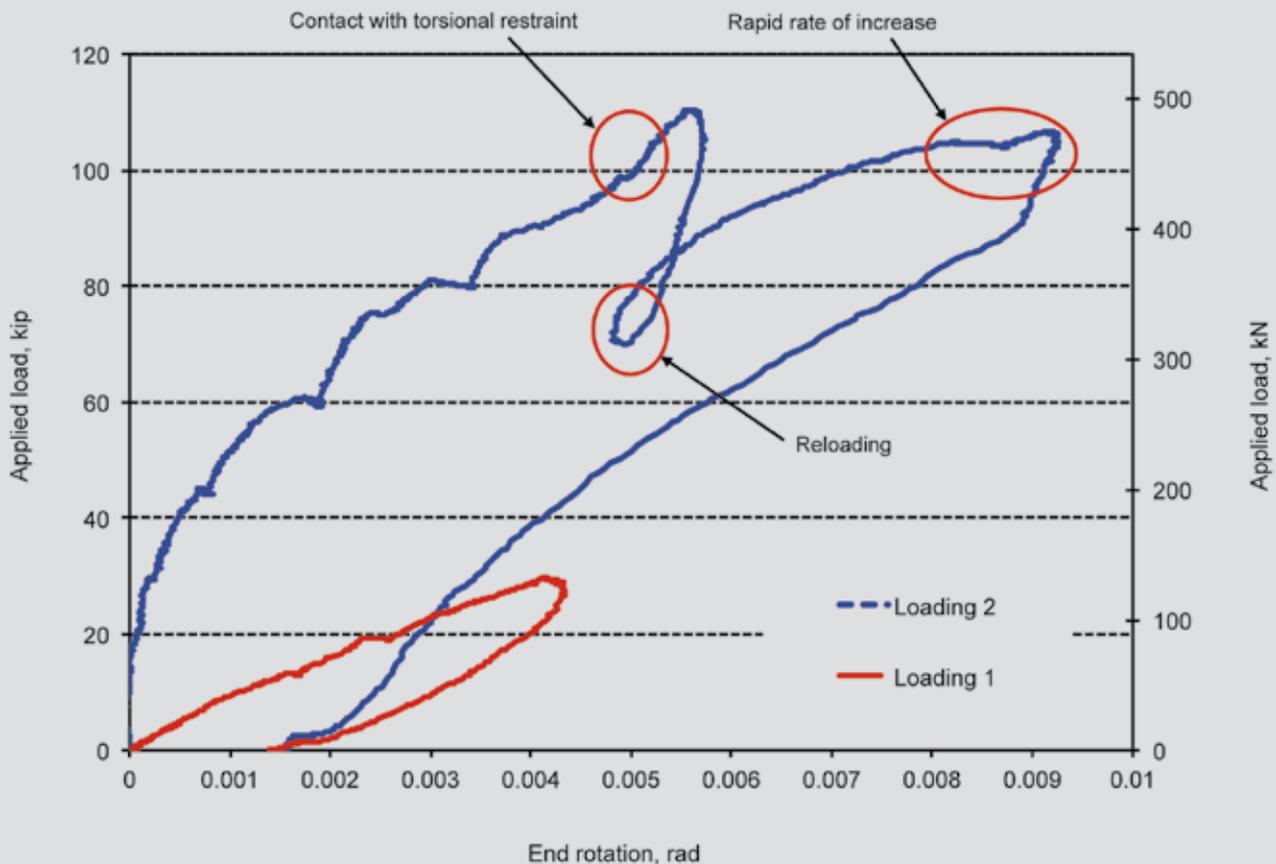
Figure 5. The rollover end rotations for loading 1 were larger at lower loads than for loading 2 due to the lack of flatness of the bottom flange during the loading 1 test.

Figure 5 compares the rollover end rotation of the first loading and the second loading. With a flat bottom flange, the end rotation at approximately 100 kip (445 kN) was equivalent to the end rotation at 29 kip (129 kN) for the experiment with rounded bottom flanges. Therefore, ensuring a flat bottom flange at the supports is important for providing rollover resistance.

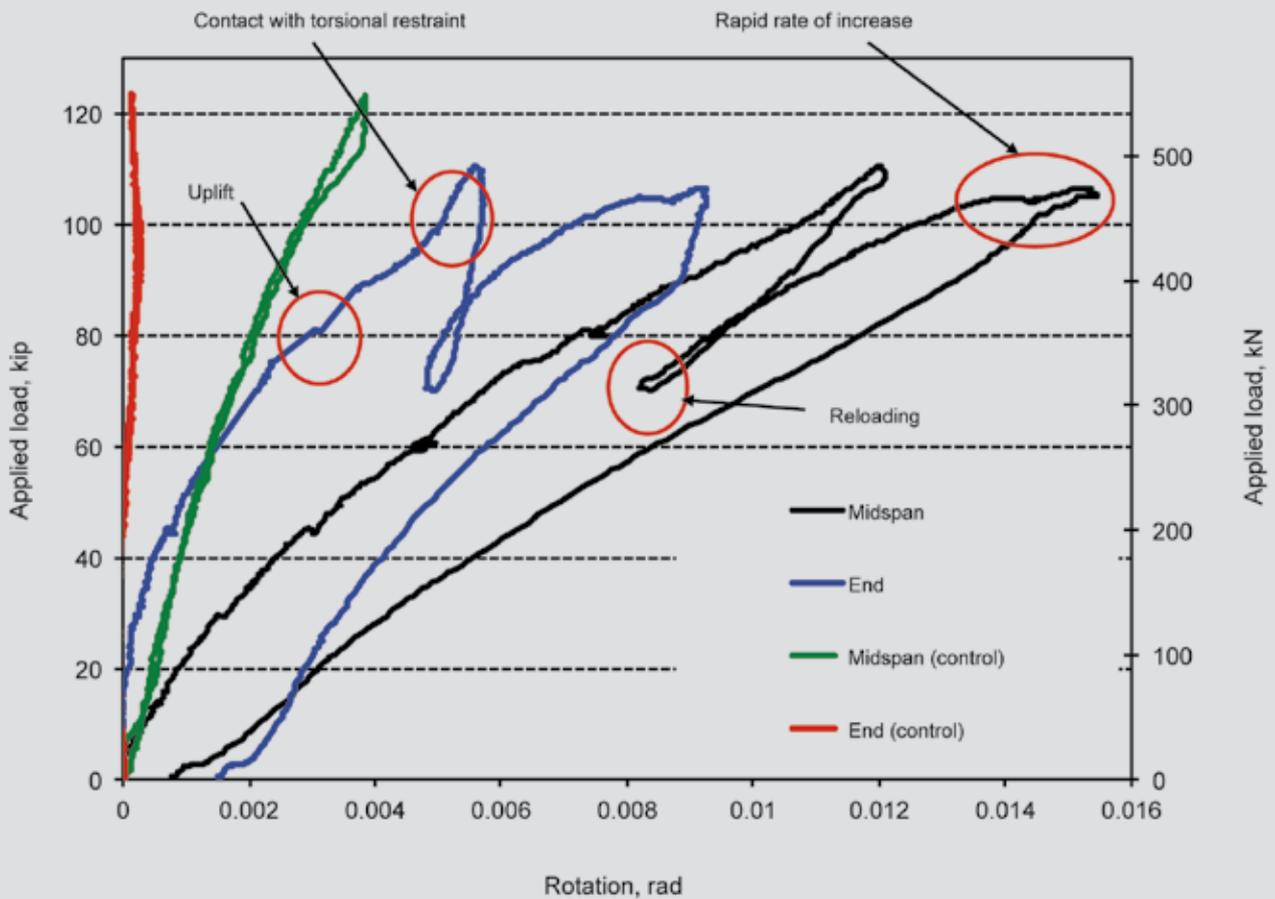
Figure 6. Load versus midspan and end rotation for sloped and level (control) supports.

Figure 6 shows the load-versus-rotation curves at midspan and ends. It is apparent that the slope of the curve was similar between initial loading and reloading between 70 kip and 100 kip (310 kN to 440 kN). However, the reloading curve was offset from the initial loading curve due to residual deformation and rotation, primarily at the supports. When the load reached 104 kip (463 kN), the lateral displacement and rotation began to increase rapidly

with little to no increase in load. The midspan rotation was a summation of the end rotation or rigid body rotation and the elastic torsional deformation of the girder along its length. Comparison of the midspan and end rotation shows that more than half of the midspan rotation was due to rigid body rotation as opposed to elastic deformation.

Figure 6 also shows the applied load versus rotation for the control loading, which involved placing the girder on level supports. The control shows almost negligible end rotation. There was rotation at midspan due to the elastic torsional deformation of the girder; however, the magnitude was approximately 50% of that for the test with initially sloped supports. The experiment with level supports was loaded to 123 kip (547 kN), 18% higher than the second loading, with no sign of unstable behavior. That is, initially sloped end supports significantly altered the behavior of the girder and reduced the factor of safety against rollover stability.

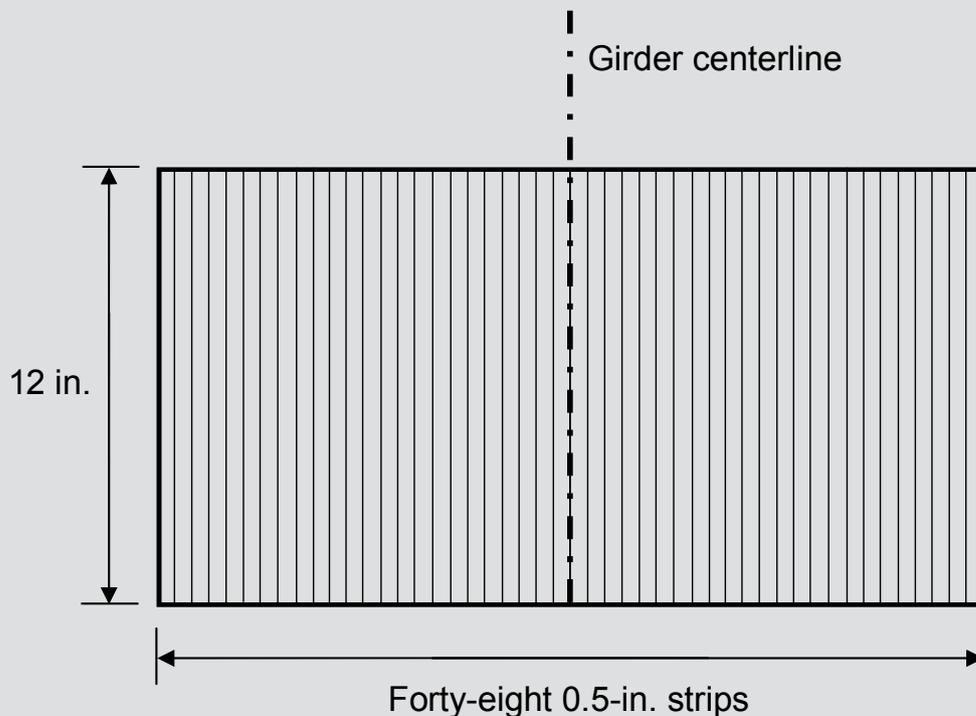
Figure 7. Plan drawing of the bearing pad strip model layout that was used to determine the vertical and rotational deformation of the bearing pad.
 Note: 1 in. = 25.4 mm.

Accuracy was determined by running the program at several load increments until convergence was apparent. In the bearing pad model, the vertical load and torque at the ends of the girder were used to determine the vertical and rotational deformation of the bearing pad. The bearing pad model divided the pad into forty-eight 0.5 in. wide (13 mm) strips oriented parallel to the centerline of the girder (Fig. 7). The analysis iterated axial (vertical) deformation and bearing pad rotation until both force and torsional moment equilibrium were satisfied. The forces in each bearing pad strip were determined using a bilinear material representation of the experimentally determined load versus vertical displacement curve. The strips that underwent tensile forces (uplift) were taken as zero force

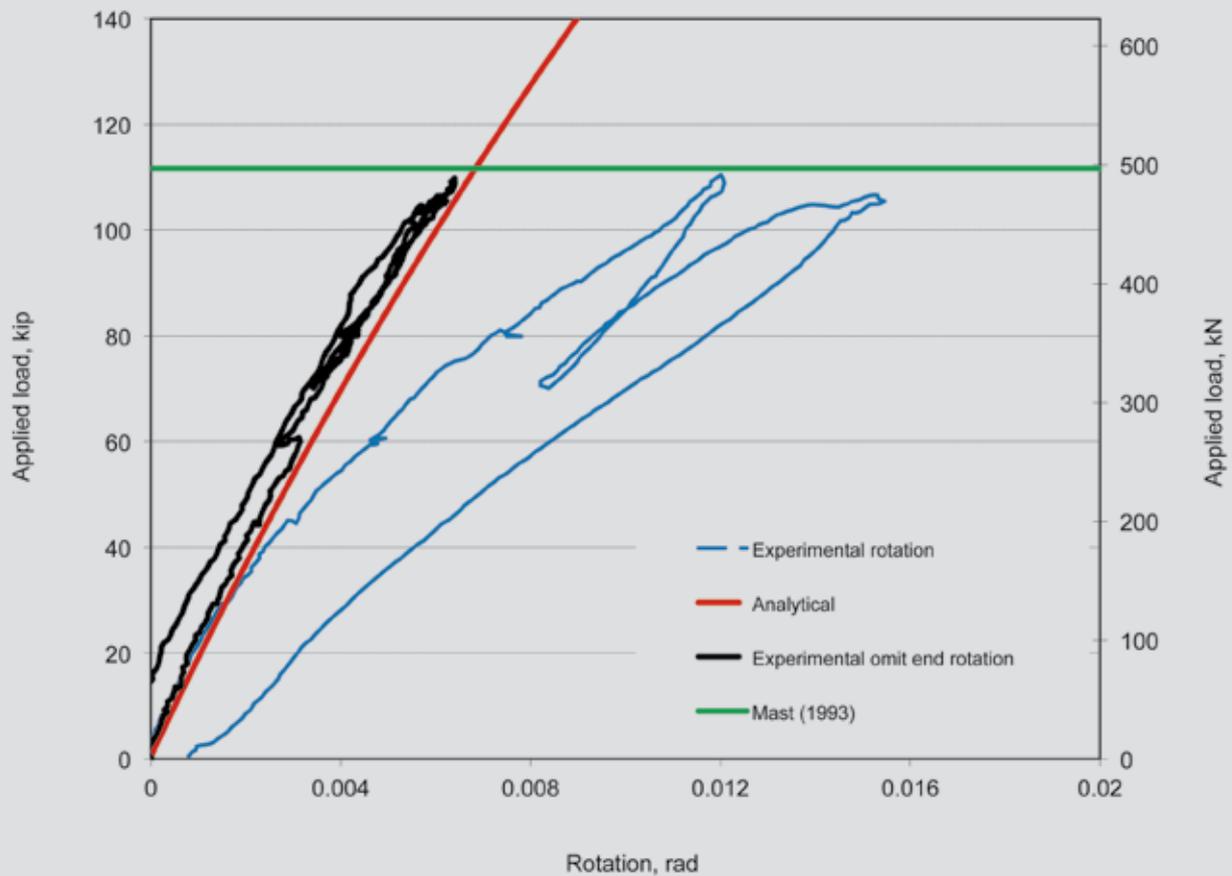
Figure 8. The experimental and analytical load versus midspan rotation shows good correlation between the experimental results and the method by Mast.⁵

The prediction for the rollover load from Mast⁵ for the experimental PCI BT-54 was superimposed on the experimental and analytical data in Fig. 8. The predicted rollover load was 112 kip (497 kN), which showed good correlation to the experimental rollover load of 104 kip (463 kN).

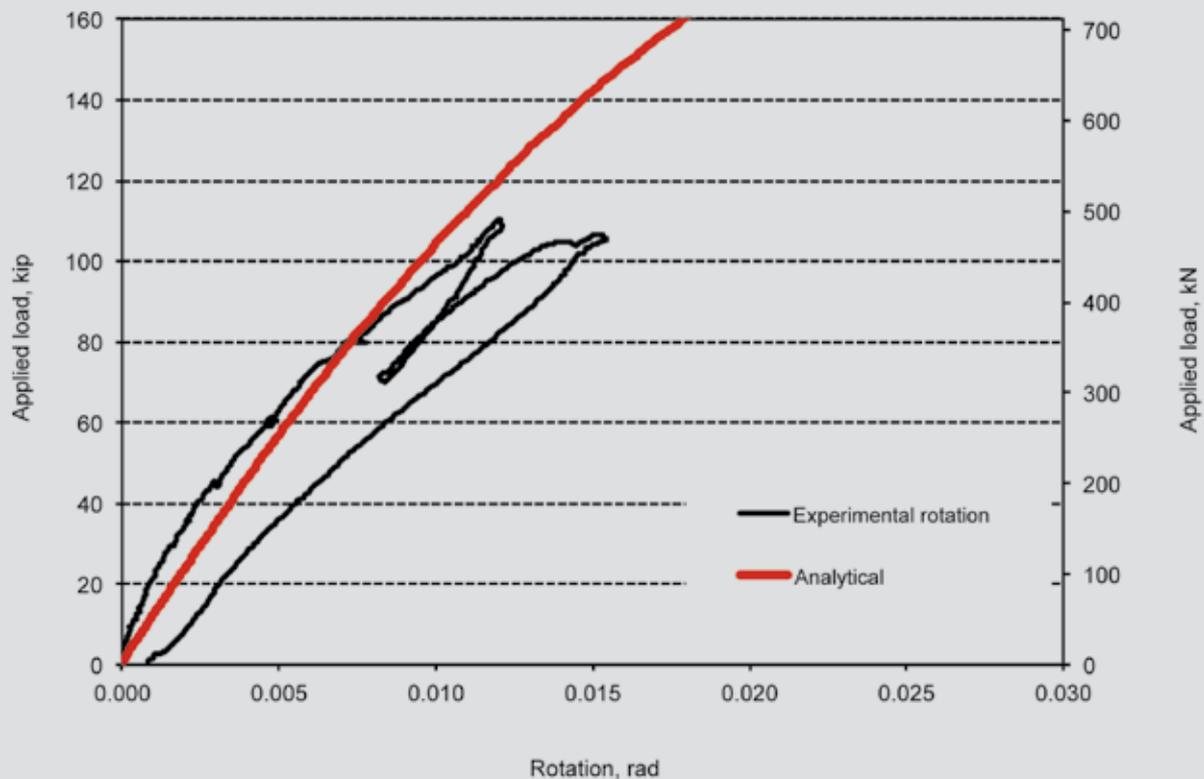
Figure 9. The applied load versus total rotation (girder rotation + end rotation) at midspan shows the deviation between the experimental and analytical results due to the bearing pad deformation.

Figure 9 compares the analytical and experimental rotation at midspan, which includes the effect of the rigid body rotation at the supports. The analytical model predicted larger rotations at loads up to 60 kip (270 kN), thus underestimating the rotational stiffness of the bearing pads in that load range. However, at loads higher than 60 kip (270 kN), the analytical model began to overestimate the rotational stiffness provided by the bearing pads. Further-

more, the analytical model did not show the full unstable rollover behavior until a load on the order of 180 kip (800 kN) that was 70% higher than the experimental rollover load. The significant difference in the rollover load was due to a significant overprediction of the bearing pad rotational stiffness at loads above 60 kip (270 kN).

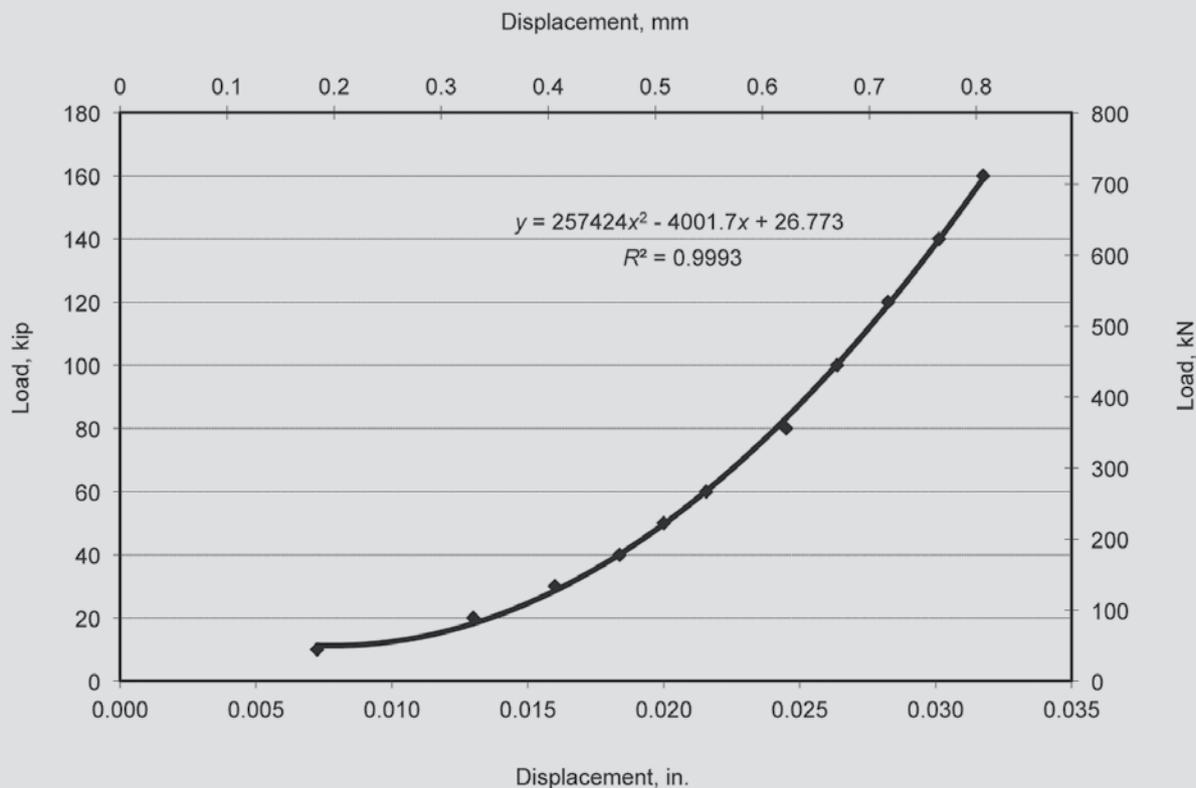
Figure 10. The load versus axial (vertical) displacement of bearing pad with second-order polynomial fit shows the nonlinear nature of the bearing pad deformation.
