**MONITORING OF THE 4500 SOUTH POST-TENSIONED SPLICED GIRDER  
BRIDGE ON I-15**

**ABSTRACT**

**Keywords:** Bridges, Diaphragms, Losses, Monitoring, Post-tensioning, Spliced Girders

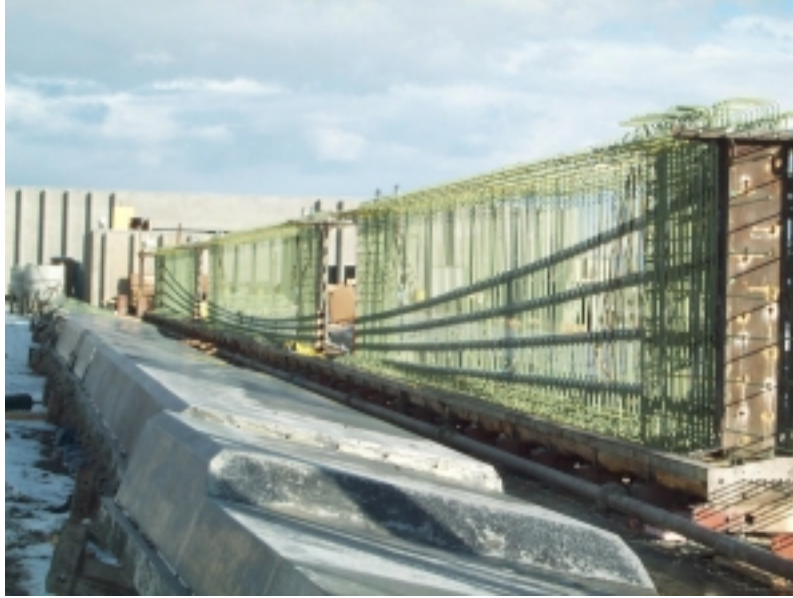
Fig. 1. Casting of Girder A

On December 13, 1999, 21 VW gages were installed on the eastern-most girder of the bridge (Girder A). On December 18, 1999, three segments of a second girder (Girder B) were instrumented with 21 VW gages in a manner nearly identical to the first. Strain readings from the VW gages were taken prior to casting. Both girders were then cast in December of 1999 shortly after the instrumentation process. The girders were each cast in three separate segments at Basic Precast in Salt Lake City, with each girder having four PT tendon ducts as shown in Fig. 1. The sequence of events pertaining to the instrumentation, casting, and erection of the girders is shown in Table 1.

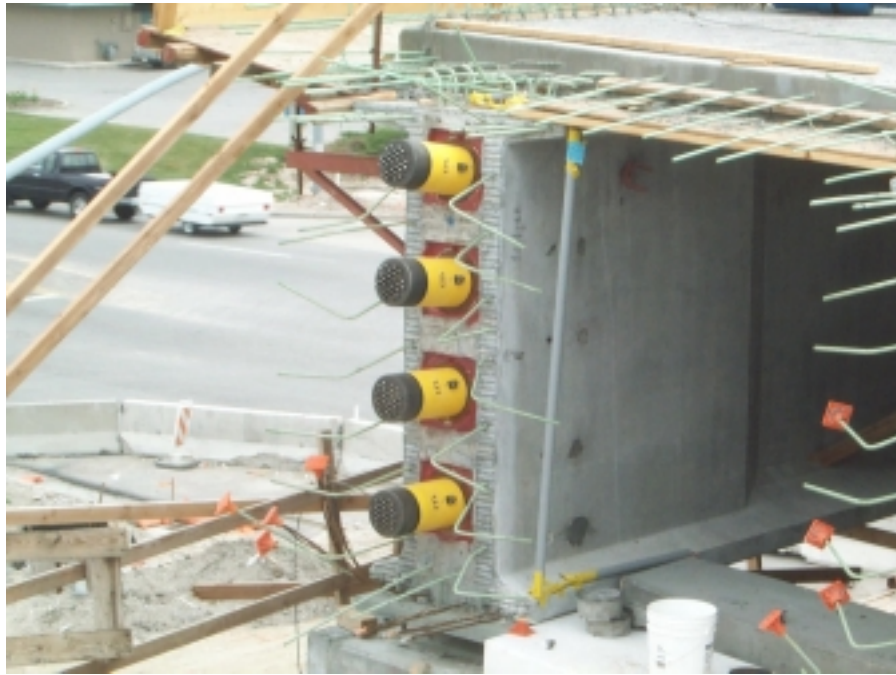
Fig. 5. Load Cells 1 thru 4 on the North End of Girder A after post-tensioning

Eight load cells were used in the study, custom manufactured by CTL, Inc., and installed on both ends of Girder A in the latter part of April, 2000. The load cells were numbered 1 through 4 from top to bottom on the north end of the girder, and 5 through 8 on the south end in the same manner, thus instrumenting every tendon at both ends. The metal bearing cap, which is normally placed at the face of the girder was placed on the outside of the load cell; the PT strands were then locked at the time of tensioning, which was from the north end of Girder A at load cells 1 through 4. Figure 5 shows load cells 1 through 4 during the construction process just after post-tensioning; the load cells were sealed and isolated from the concrete of the end diaphragms by encasing them in specially constructed tubes.

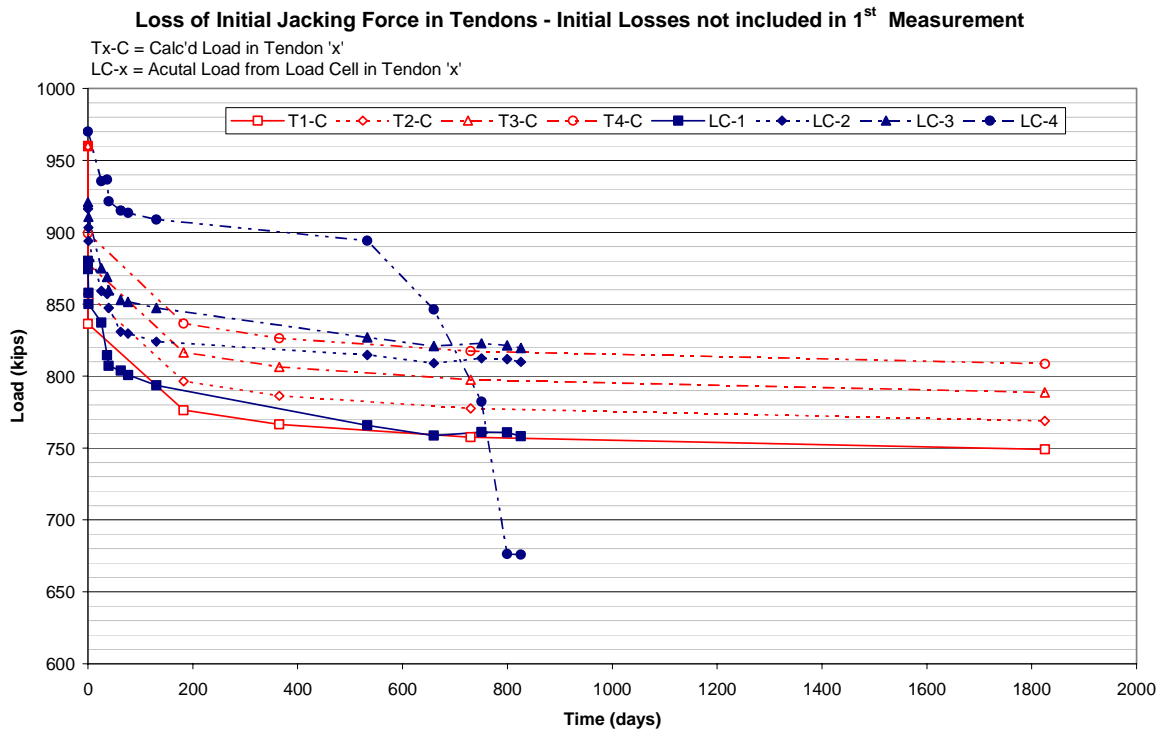
Fig. 6. Calculated Load in Tendons Compared to Actual Load from Load Cell

For comparison of losses, the average of the measured load from the load cells at the two ends of a given tendon (average of load cells 1 and 5 for example) was plotted against the

theoretical values of Table 2. One exception was load cell 8, which had not been functioning properly. In this instance, the values of load cell 4 only were used for comparison. Plots comparing actual load to calculated load are shown in Fig. 6 for all data recorded and in Fig. 7 for the first 200 days only. Load cell 4 has also given questionable data recently, which may be due to malfunctioning. It is observed that there is reasonable agreement between experimental data and the theoretical prediction of PT tendon losses for Girder A.

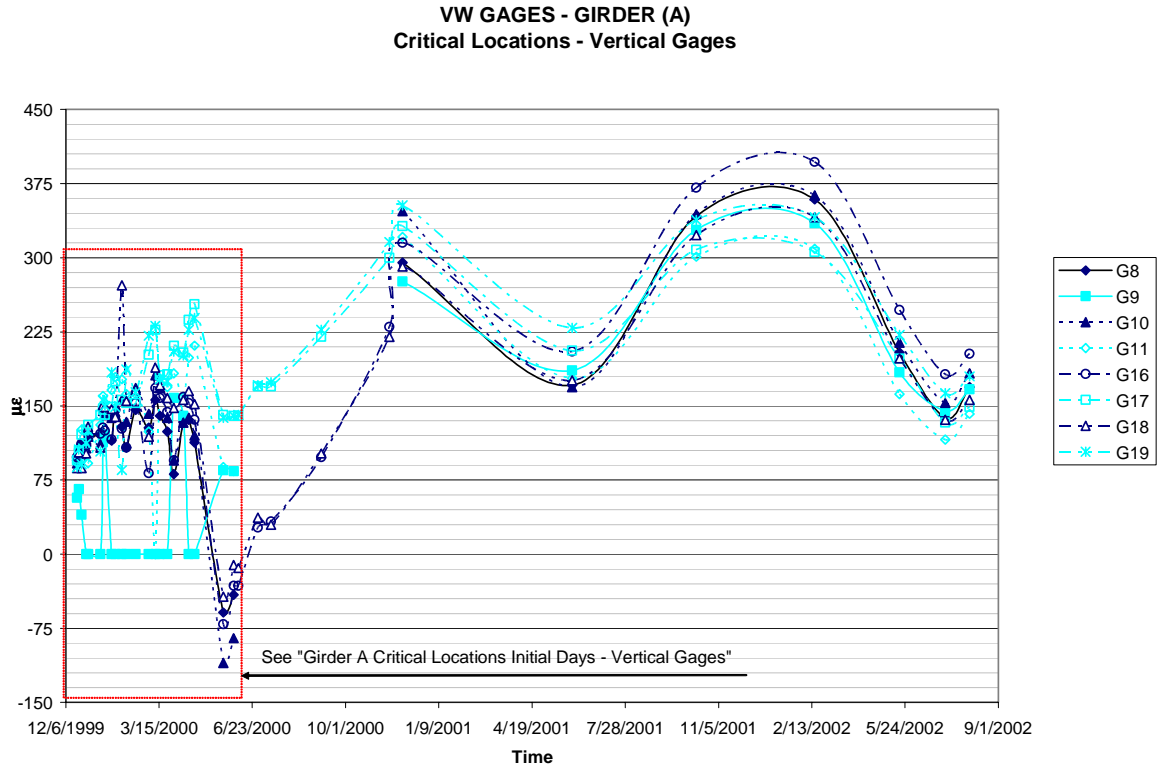
Fig. 8. Strain Readings of Selected Vertical VW Gages – Girder A

Figure 8 shows the uniformity of the measured strains and seasonal variation of the readings throughout the span for Girder A; more detailed views of these graphs are given in Figs. 9–11. The strain readings for Girder A are more closely grouped than those of the segments of Girder B, which are not shown for brevity. The diaphragm splices are performing well in their task of holding the precast girder segments together between the various girders of the bridge, as shown by the pairs of gages G8 with G10 and G9 with G11. This uniformity and consistency among the various girders would also indicate a lack of differential rotation at the diaphragm splices.

On December 17, 2000, the northbound overpass was opened to traffic. At this point the loading on the bridge was changed due to the presence of live load from automobiles and trucks on the bridge. The data for the north or south diaphragms at this time, show that a separation occurs between the readings of VW gages at similar locations on opposite sides of the diaphragms. In Fig. 11, gages G16 and G17 that are at the top flange on opposite sides of the north splice diaphragm, give a differential reading of 30 microstrain. This behavior is also seen in Fig. 10, for gages G8 and G10, which are placed at similar locations at the south splice diaphragm, with a differential reading of 50 microstrain. This behavior is due to the added live load from traffic acting across the diaphragm, which resists this action thus inducing a small differential strain. In both cases, the compressive strains at the gages near the upper flange are greater for those gages closer to midspan (gages G10 and G16 in the middle girder segment G-A-2) than for those gages on the two end girder segments G-A-1 and G-A-3 (gages G8 and G18). The gages near the centerline experience the opposite effect. The gages closer to midspan (gages G11 and G17) have smaller compressive strains than those gages located on the end girder segments (gages G9 and G19). These gages are located below the neutral axis of the girder/slab unit and therefore experience the opposite strain.

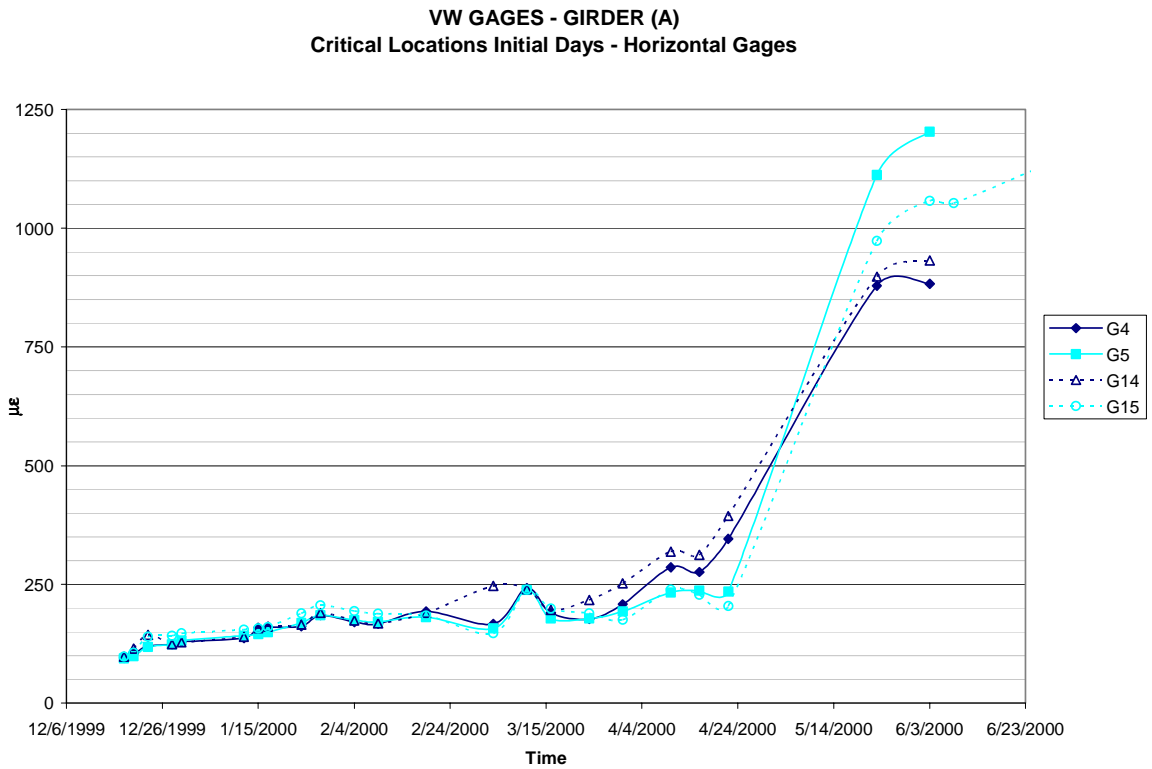
Fig. 13. Strain Readings of Selected Horizontal VW Gages During Initial Days – Girder A

Inspection of the gage readings in Fig. 13 shows that, just prior to post-tensioning (April 27-28, 2000), gages G4 and G14, which are located at the top flange of Girder A in the end segment G-A-1 and middle segment G-A-2 respectively, show larger compressive strains than their counterparts at the bottom flange, gages G5 and G15. This is consistent with the behavior of a simply supported beam under gravity loads. Further, it is seen that the compressive strain is larger at the top of the girder at midspan than at the end segment, as would be expected. This is also the case with the tensile strains at the bottom flange – the midspan shows larger tensile strain (or smaller net compressive strain) than the end segment. It should be noted that the girder segments were placed on temporary supports during erection until after post-tensioning; the girder segments were constructed with some pre-tensioning strands for dead load moment during transportation and erection and therefore never experience net tensile stresses in any of the readings during the erection stages.

At the time of post-tensioning (April 27-28, 2000), all gages indicate a large jump in compressive strain as was the case with the vertically oriented gages. Figure 13 shows that Girder A becomes cambered, concave up, after post-tensioning; this was confirmed from the survey of girder deflections. VW gages G4 and G14, which were previously reporting the largest compressive strains, report the smallest compressive strains after post-tensioning. VW gages G5 and G15 at the bottom flange report the largest compressive strains with the gage at midspan (gage G15) reporting a smaller compressive strain than the gage at the end segment, mainly due to the self weight stresses inducing a larger tensile stress at midspan. Figure 12 shows that this trend is continuing even with the seasonal fluctuations due to temperature variations. This behavior is similar for the segments of Girder B.
