## Applications for Galvanic Anodes in Prestressed Concrete

David W. Whitmore, P. Eng., Vector Corrosion Technologies, Winnipeg, MB, Canada

### Abstract

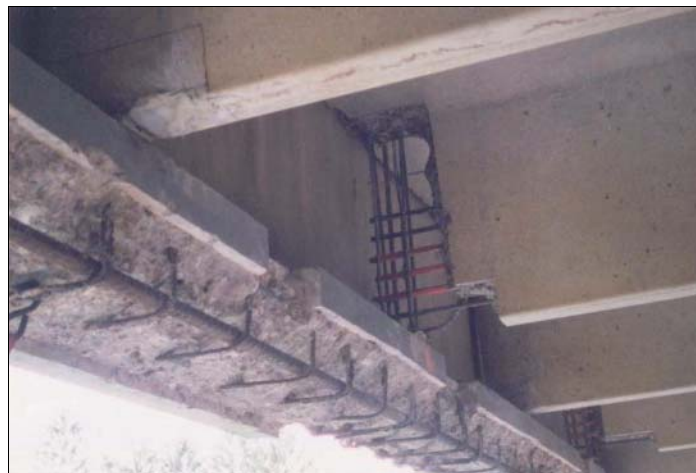
**Photo 1** Precast/prestressed double T beams ends suffering from chloride-induced corrosion.

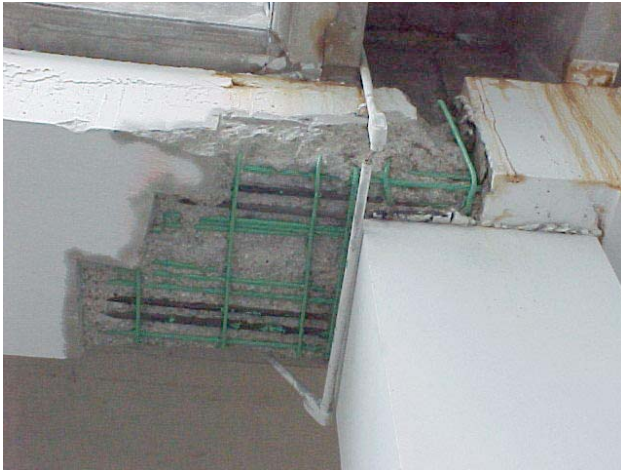
**Photo 2** Precast/prestressed beam repair. Delaminated concrete cover removed but strands remain partially embedded in chloride-contaminated concrete.

Because of this concern, the repair of precast/prestressed concrete members in practice may only include the removal of the delaminated concrete cover to keep the steel partially bonded in an attempt to prevent the loss of additional prestress force. Following these repair procedures, patch accelerated corrosion can be more severe since new corrosion activity can take place throughout the base of the repair (where the steel is in contact with both chloride contaminated and fresh concrete) instead of just around the patch edges.

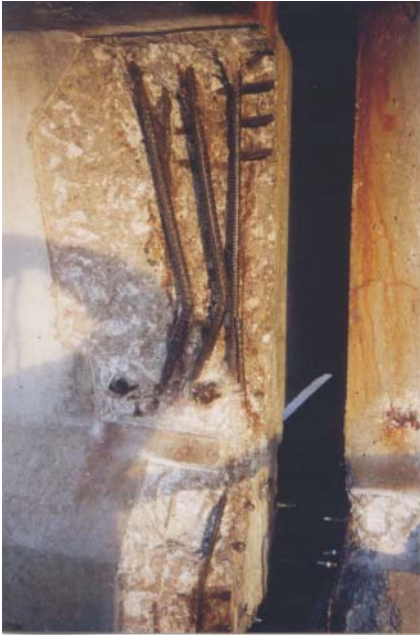
**Photo 3** Prestressed beam end subject to corrosion

In 1998, Iowa Department of Transportation was experiencing corrosion problems on the exposed ends of precast/prestressed AASHTO girders due to the leakage of chloride contaminated water at the bridge deck joints. Recognizing that continued corrosion activity in this location may put the structure at risk, the Department utilized embedded galvanic anodes in addition to the required concrete repairs to rehabilitate and provide localized corrosion protection to a total of 84 beam ends.

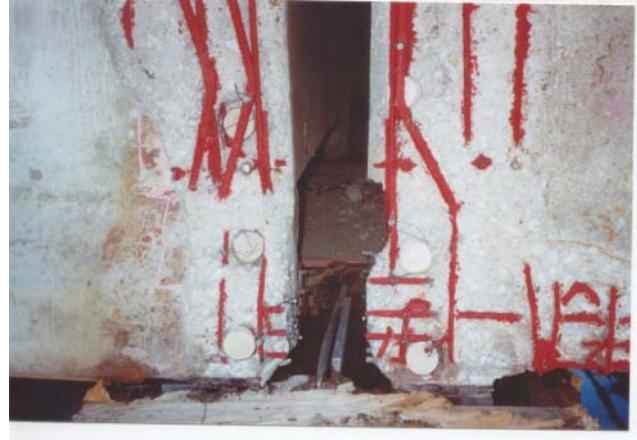
**Photo 4** Prestressed beam end with galvanic anodes and rebar coating installed prior to concrete replacement.

Six embedded galvanic anodes were installed in each beam end with one in the top flange, one in the web section and four in the critical bottom flange. The anodes were tied to the stirrup steel. Per the Iowa DOT specification, an anti-corrosion rebar coating was applied to the exposed steel surfaces taking care not to coat the surface of the anode or the concrete.

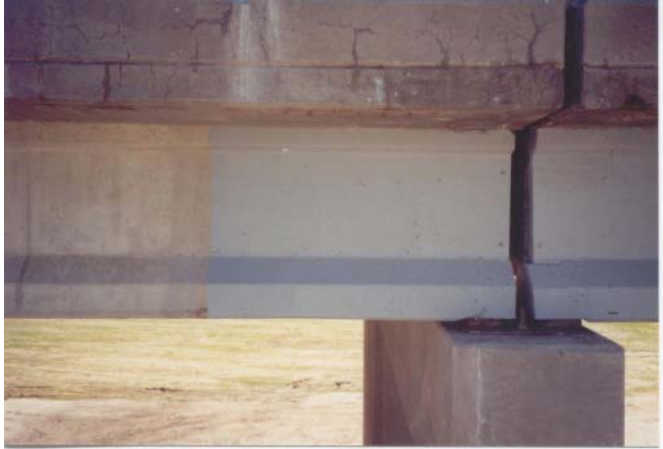
**Photo 5** Completed prestressed beam end repair with embedded galvanic protection

The repair was completed using an Iowa DOT approved form and pour concrete mix. After sufficient cure time of the repair material, a pigmented sealer was applied to protect from future chloride penetration and to improve the aesthetics of the repaired precast/prestressed beams.

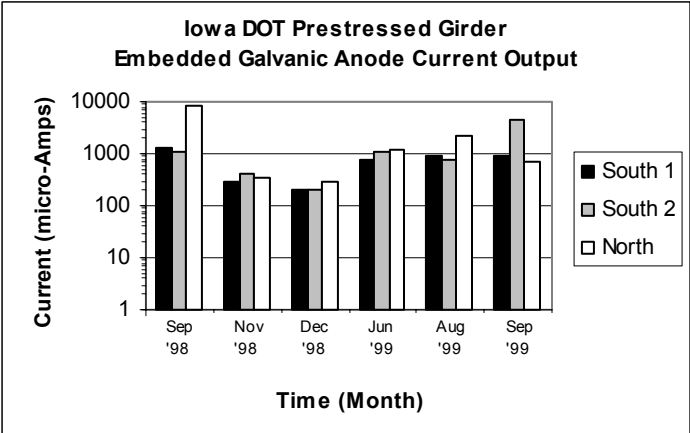
Anode current outputs are significant and vary with the weather. Based on the limited repair area on the end of each beam, the current density to the steel in these areas is significant.

**Figure 4** Embedded anode current output for three monitored anodes.

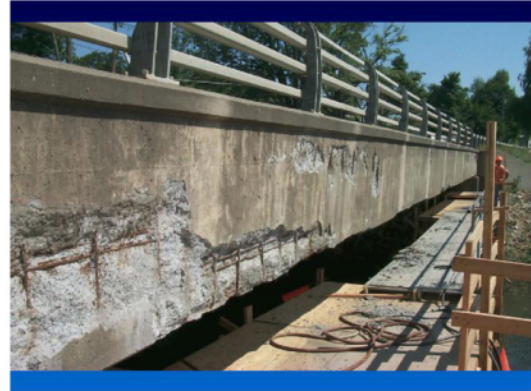
**Photo 6** Condition of Precast beams prior to rehabilitation program.

In 2001, the New York State Department of Transportation had a corrosion problem with the Route 37 Bridge over Little Salmon River in Fort Covington, NY. This structure, built in 1977, consisted of single span precast/prestressed concrete box beams approximately 100 feet in length. The bridge deck sloped to the south fascia and allowed drainage of water down the face of the outside beam. Over time, chloride penetration had caused concrete spalling and delaminations.

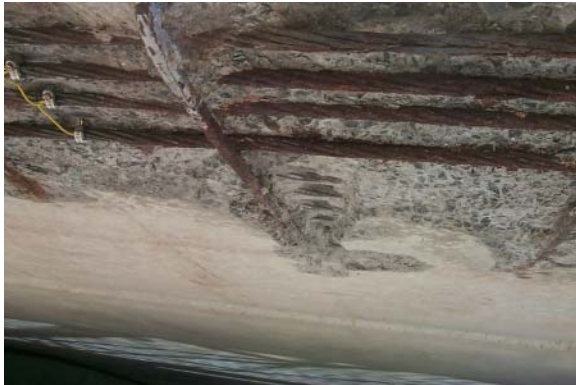
**Photo 7** Electrical continuity established between the exposed strands

To provide longer-term repair of the affected areas, the NYSDOT specified the installation of cylindrical shaped embedded galvanic anodes. After the loose concrete was removed, individual prestressing strands were made electrically continuous.

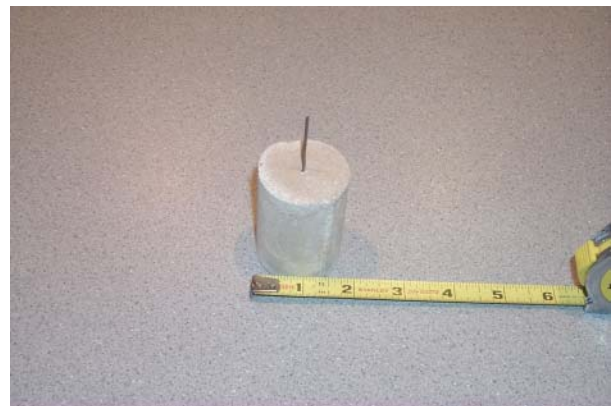
**Photo 8** Embedded Galvanic Anode Prior to Installation

Three rows of anodes were installed into 2 inch diameter holes approximately 18 inches on center. Two of the rows were on the vertical face and one row was on the bottom near the outside surface. The individual anodes were grouted into the prepared holes using low resistivity mortar and connected to a central wire using sealed button-type connectors. The string of anodes was attached to the strands at the beam ends.

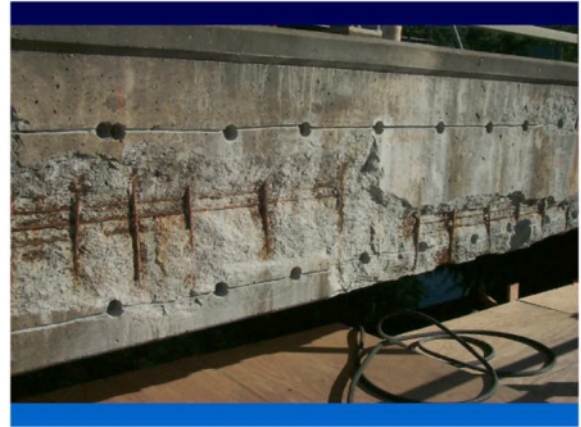
**Photo 9** Layout of the galvanic protection system prior to installation.

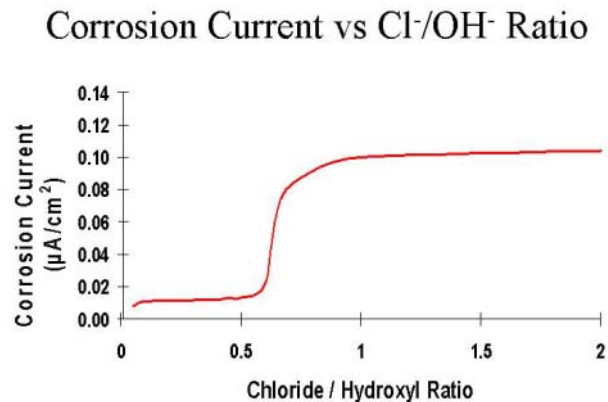
- The reaction at the cathodic site also generates hydroxyl ( $\text{OH}^-$ ) ions which increase the alkalinity around the reinforcing steel. The residual affect of years of anode activity would be to increase the pH around the steel thus raising the chloride threshold necessary to initiate corrosion (see table below) (Hausmann, 1967).

**Figure 5** Corrosion activity is a function of chloride content and alkalinity.
