BRISSACK BRIDGE WIDENING
EXTERNAL POST-TENSIONING TO
INCREASE CAPACITY OF EXISTING GIRDERS

David K. McMullen, P.E., KPFF Consulting Engineers, Seattle, WA
Shyi-Shyong (Stephen) Jiang, P.E., King County Department of Public Works,
Seattle, WA 98104

ABSTRACT

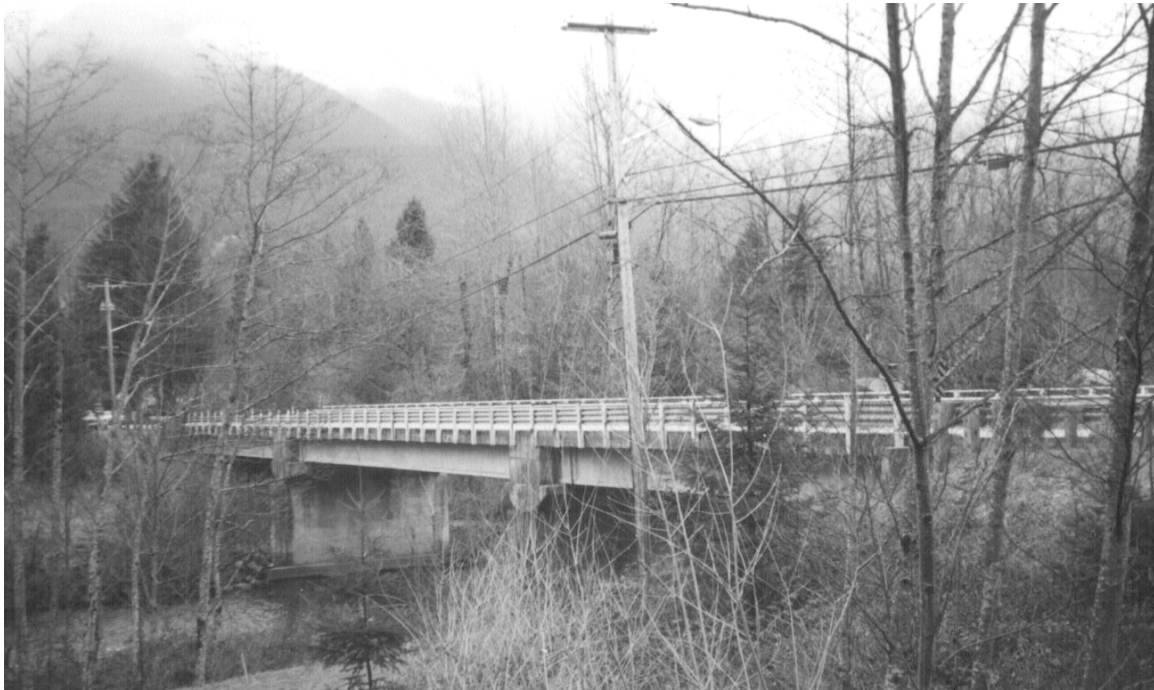
Brissack Bridge
Figure 1

Located on Cedar Falls Road SE in Tanner, Washington, the Brissack Bridge is a three-span bridge totaling 266 feet in length with a 30-foot roadway width. The superstructure consists of five simply supported prestressed concrete girder lines with a cast-in-place composite deck in a three-span arrangement. The north and south approach spans are approximately 78 feet long, and the main span of 110 feet crosses the South Fork of the Snoqualmie River.

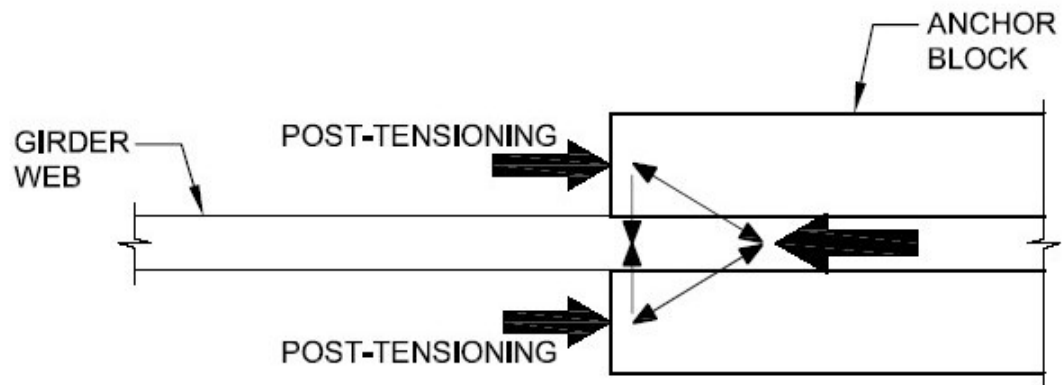
Figure 9

The compressive force is transferred to the girders via an external anchorage block attached to each end of the girders. The team designed the anchor block utilizing research done by David H. Sanders and John (Jack) E. Breen of the University of Texas at Austin. Their study verified the use of the strut-and-tie model approach for designing anchorage zones. The team used reinforcing ties within the anchor blocks in accordance with the strut-and-tie design method to accommodate the bursting forces at the face of the anchor blocks (see Figure 9).

Strut-and-Tie Model

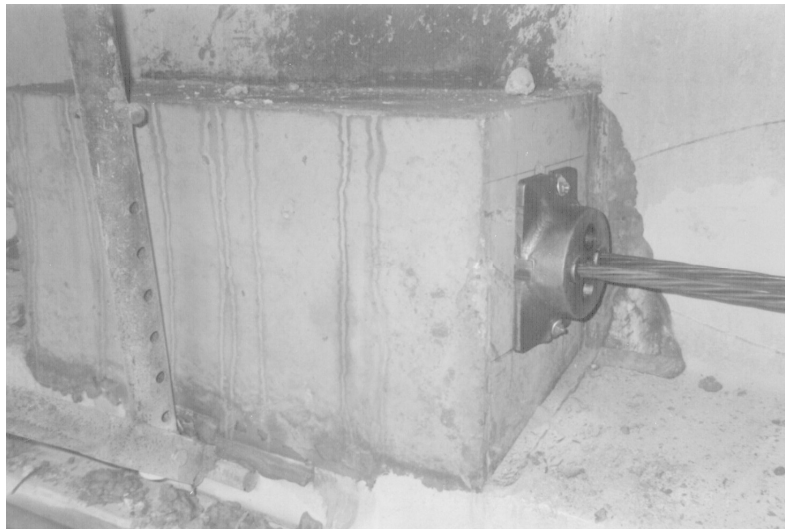
Figure 10

The anchor blocks were sized to fit above the bottom flange of the girder while allowing enough area to adequately handle the bearing stresses from the post-tensioning anchor plate. The post-tensioning forces were design to be transferred into the girders via shear friction between the concrete anchor block and the precast girder along with shear through reinforcement that was placed through holes drilled in the girder webs. An epoxy resin was used to bond the reinforcement in the holes in the girders, then the rebar cage was encased within the anchor block.

Anchor Block with Post-tensioning Strands
