## **BUILDING A PRECAST BRIDGE IN 19 DAYS**

The Ohio Department of Transportation (ODOT) created Strategic Initiative #9 to “Build Bridges Smarter, Faster and Cheaper”. One project undertaken by ODOT was to use a precast, post-tensioned slab bridge in place of a cast-in-place slab bridge. The bridge was longitudinally post-tensioned for continuity and also laterally post-tensioned. To accommodate school schedules and a festival, the bridge was to be completed in 16 days. The bridge was actually completed in 19 days. Delays were due to weather, equipment problems and confusion over plans/specifications. This project was generally considered a success and this paper highlights issues which lead to success. Among these were a successful partnering between ODOT and the contractor, a high level of up-front planning, using precast members so that the deck could be fabricated without closing the bridge and moving tasks within the schedule so that they could be completed before the bridge was closed or after the new structure was opened. The paper also details the problems and suggests remedies. One problem was that the contractor overlooked special provisions in the specifications. It is

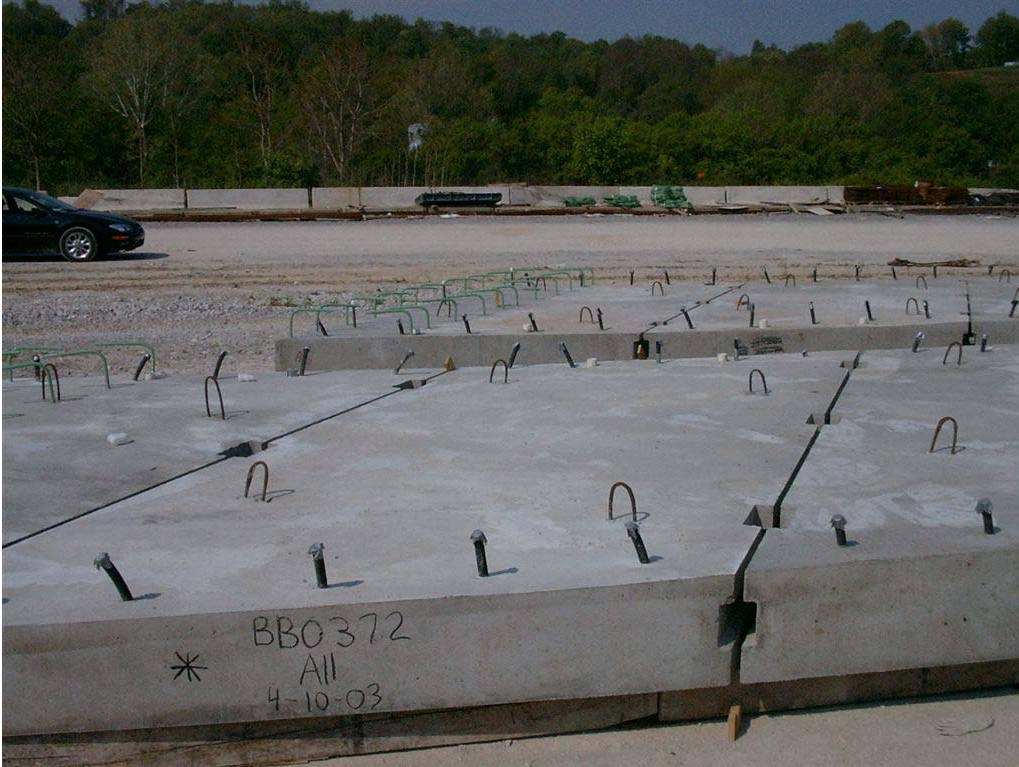
**Figure 6 - Panels in the Yard – Mock-up Test**

3. The plans required the contractor to conduct a mock up test fit on the modular slab units in the precasting yard (Figure 6). This was to assure the correct alignment of the ducts for the post-tensioning strands. The mock up test would also help in checking the basic fit of the beams as any problems which occurred once the installation began at the site would be difficult to resolve within restricted time frame.

Special provisions in the contract provided for a full mock up test for the bridge assembly in the yard before the final assembly on the site (Figure 6). This requirement was included to check for proper fit-up and alignment, and to verify that every beam unit was constructed in compliance with all plan requirements. The contractor was to use blocking to stimulate the beam seats elevations at the abutments and pier. Unfortunately, no one remembered that the bridge had a slope and the blocking was not sloped. This became an important issue during construction. Post-tensioning cables were installed in all the decks (but not tensioned) to verify duct alignment.

7. As noted in the section about the mock-up, a problem occurred during the placement of the beams. The mock up test was carried out on flat ground, but the abutments were sloped and this was not accounted for in the mock-up. Significant adjustments were needed for the correct alignment of the beams on site, requiring some “field engineering” of the shims. In the end, wood shims were used, which ODOT normally would not allow. This points out a significant risk in accelerated construction. When problems occur, the owner must often choose between delays or less than optimal solutions to problems. The alignment problem also occurred with the PT ducts. The ducts were aligned perfectly during the mock up, but on site it took some effort and time to get them in line.

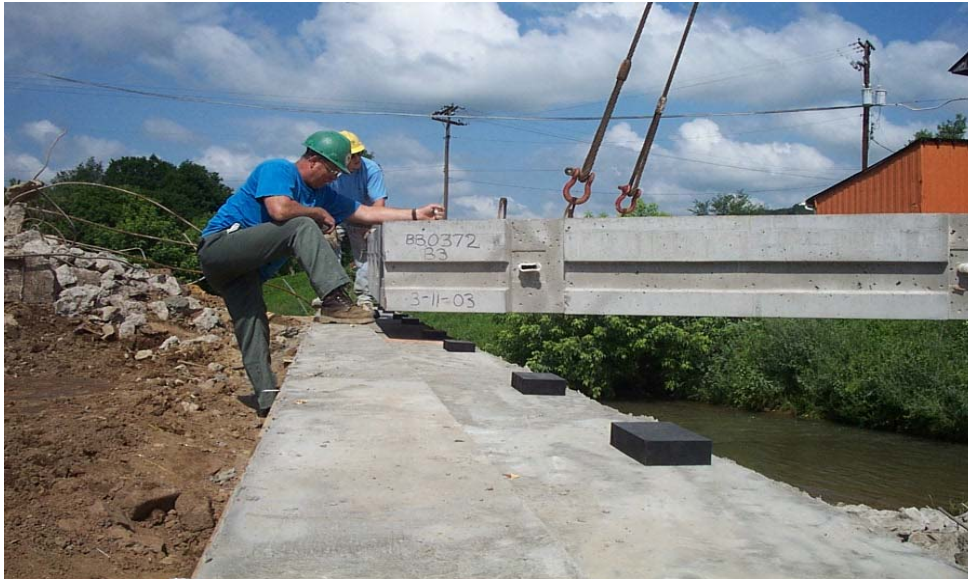
**Figure 7 - Placing the Deck Slabs, Transverse PT Ducts are Visible**

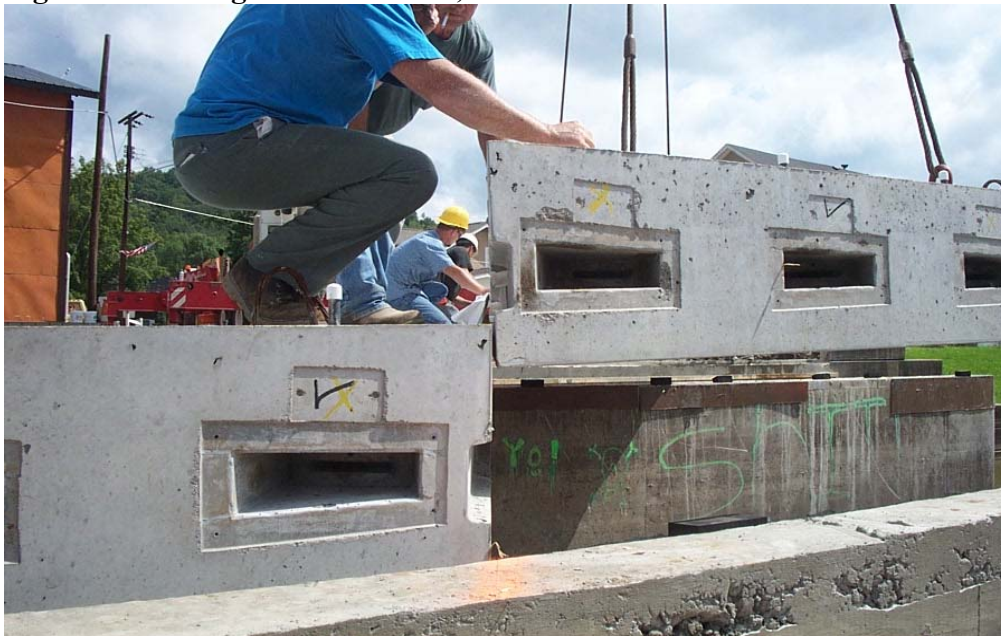
**Figure 8 - Slab Placement - Longitudinal PT Ducts Are Visible**

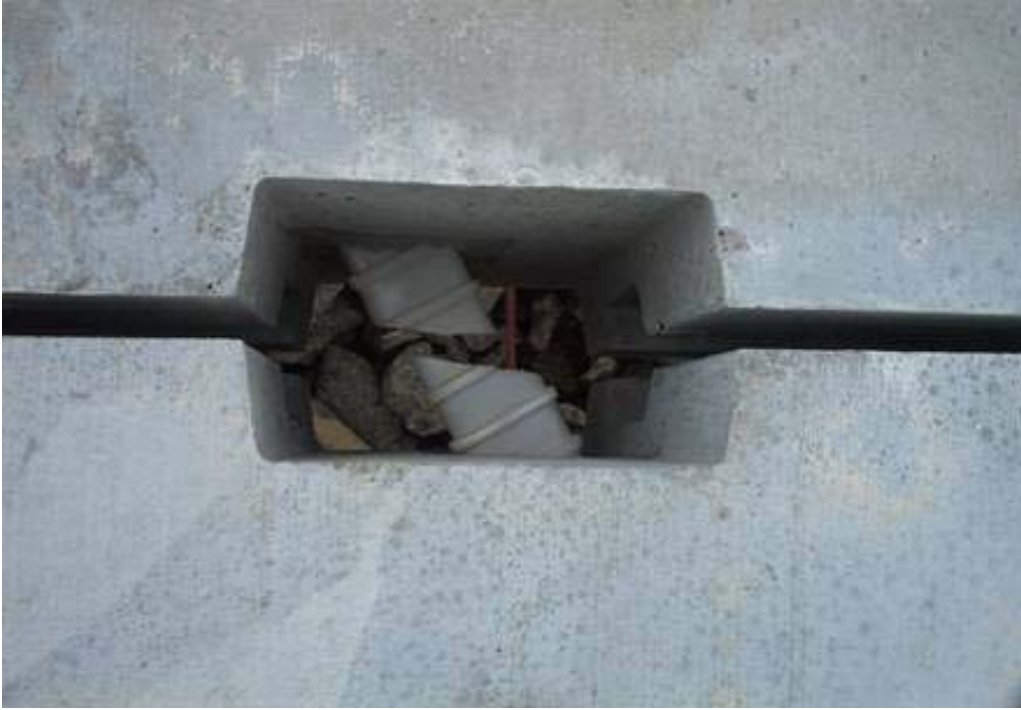
**Figure 9 – PT Ducts**

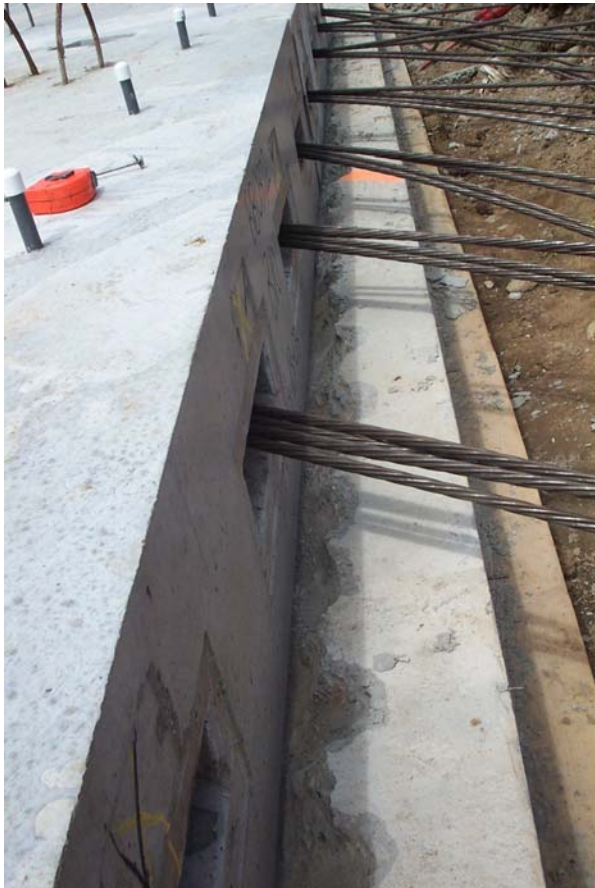
**Figure 10 – PT Tendons**

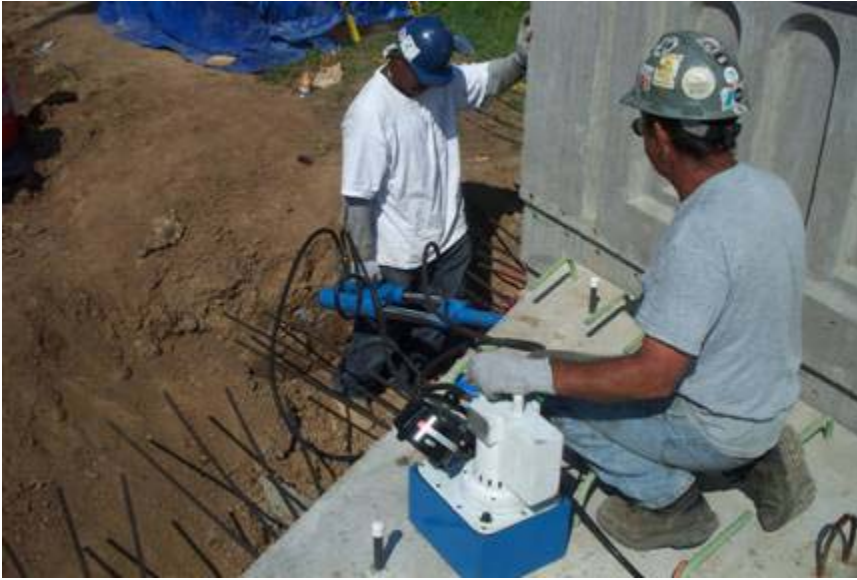
**Figure 11 – Post-tensioning**

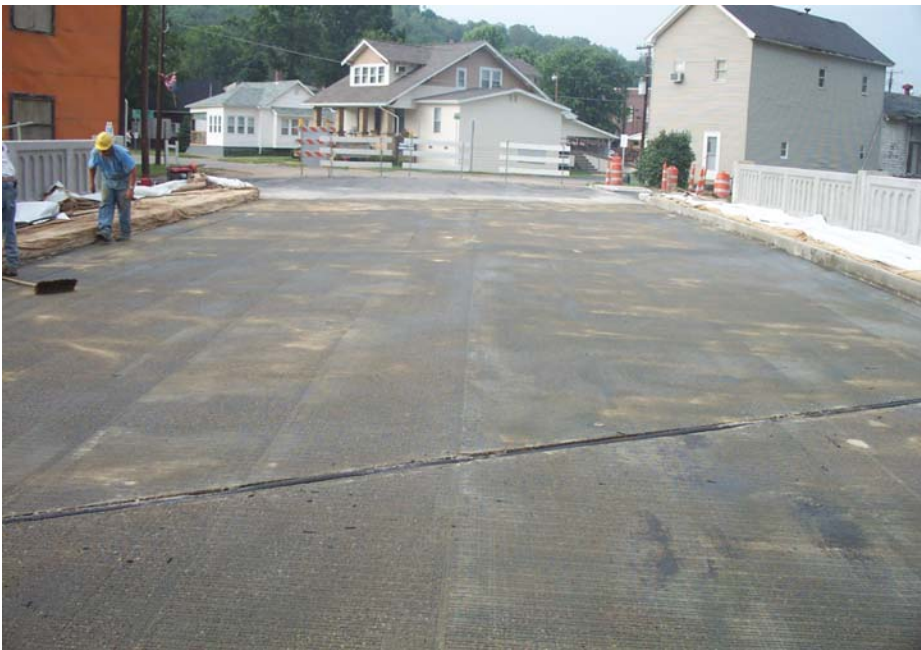
**Figure 12 – The Completed Bridge**

The completed bridge is shown in Figure 12. An essential part of the SI-9 project was to hold a post-construction meeting to determine what worked and what needed to be improved. This meeting was attended by representatives of the ODOT, the prime contractor, various sub-contractors, the design engineer and the research agencies.
