Davis Narrows Bridge in Brooksville, Maine: Fast Track Solution to an Environmentally Sensitive and Tourist Location

M. Asif Iqbal, P.E.

Maine Department of Transportation

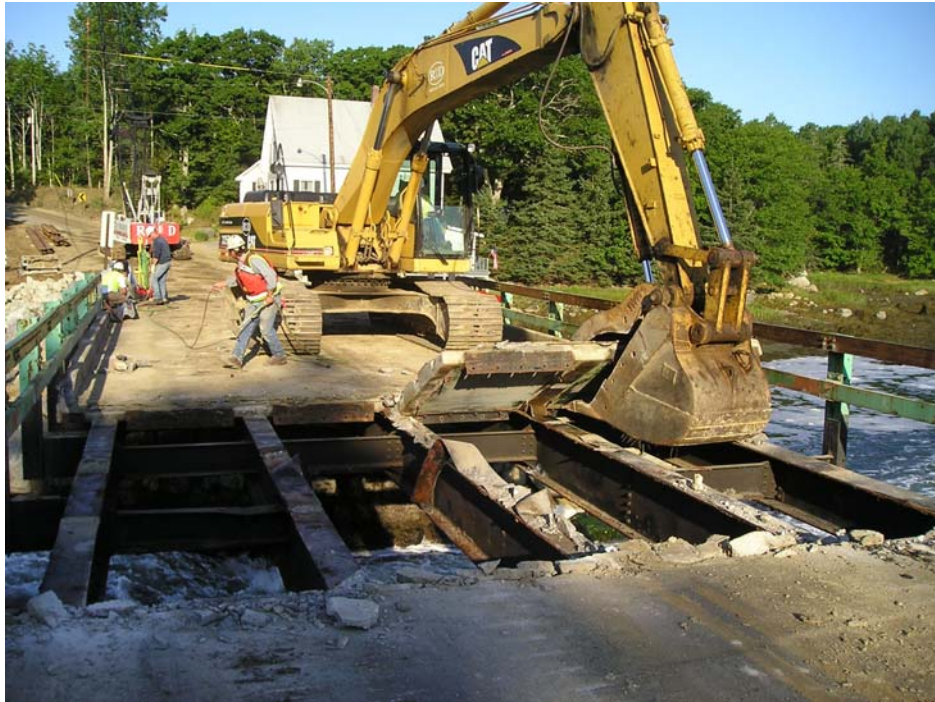
Photo 1: Removal of Existing Steel Girder Bridge.

The first week of closure was used to remove the tops of the existing abutments followed by excavation at the new abutment locations. The second week was used for driving the piles and erecting the abutments. Some time was lost when two of the pile locations were blocked by large boulders in the excavation. The contractors did not claim addition time because the presence of boulders was clearly indicated in the boring logs. The contractors brought in a larger excavator to remove the large boulders. The four precast units that make up an abutment took only two hours to erect and post-tension. The grouting operation was done the following day at low tide. During the third week, the beams were erected using a steel launching beam structure and a crane on either end. The curbs were constructed as soon as the first fascia beam and an adjacent beam were in place. The wingwall tops were cast early fourth week followed by installation of bridge rail and application of the high performance membrane. The heavy cranes were also disassembled during this week and removed from site. Pavement was applied during the last two days leading to bridge opening. The bridge was opened to traffic on October 5th, 2005. The approach guardrails were installed during the two days following the bridge opening and no lane closures were needed due to the low traffic volume at that time. The contractors also left the site four days after the bridge was opened to traffic.

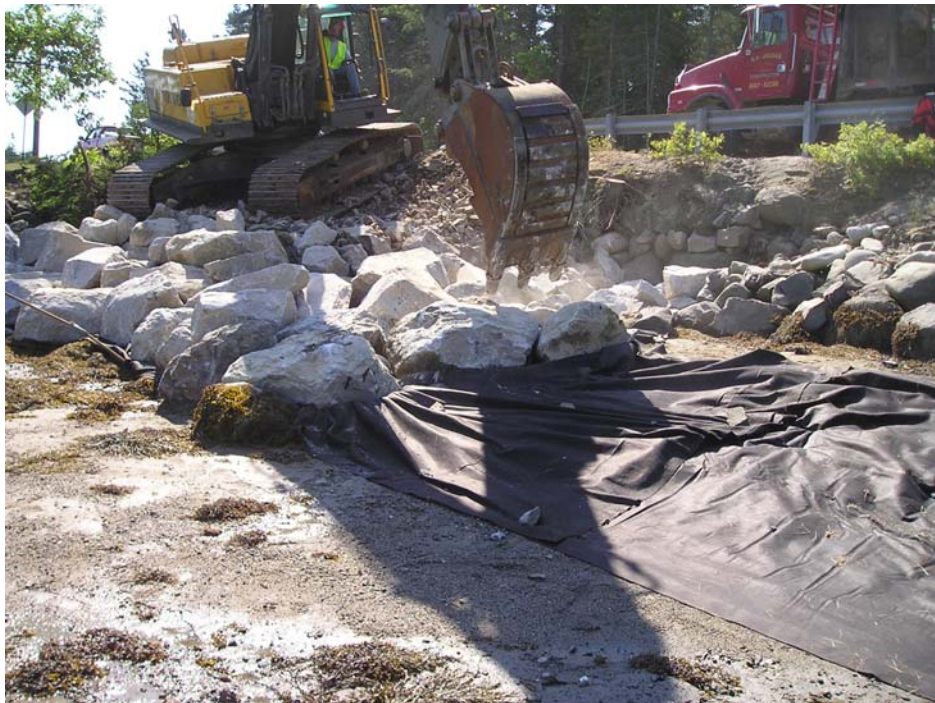
Photo 2: Extensive use of Geotextiles to stabilize Causeway.

decided to work on causeways leading to the bridge first and then close the bridge for completing the rest of the project. The causeways were built back in 1941 with massive rocks and boulders that allowed significant flow of water through them. To reduce impact to existing flow characteristics, the new approach roads on the causeways were built on choke stone layers stabilized with high-flow geotextiles. This took three weeks to complete followed by the bridge closure on September 6th, 2005.

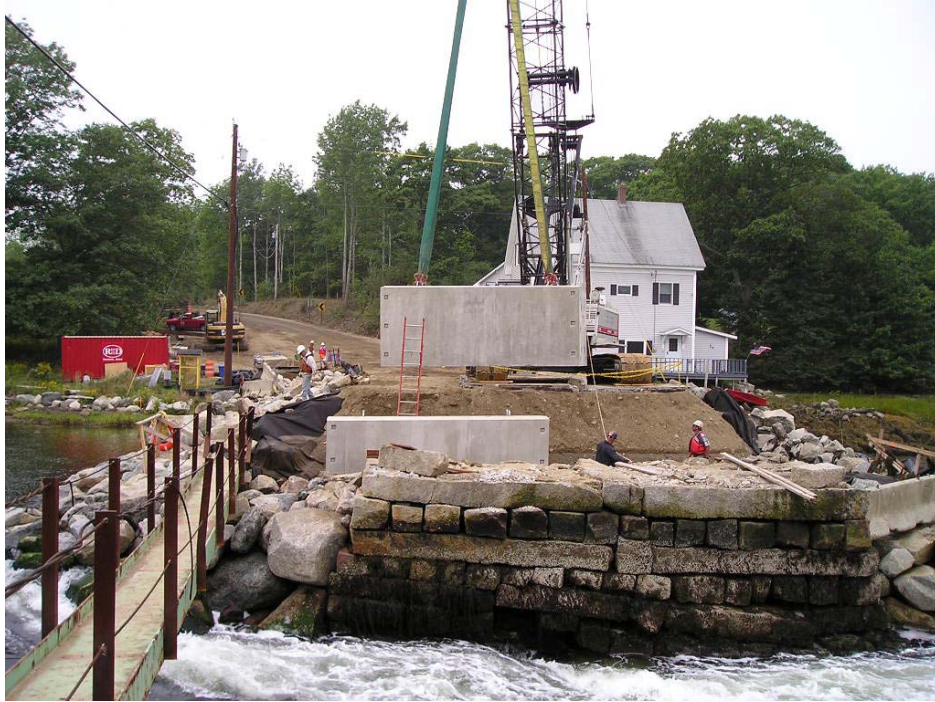
Photo 3: Placement of Center Precast Abutment units.

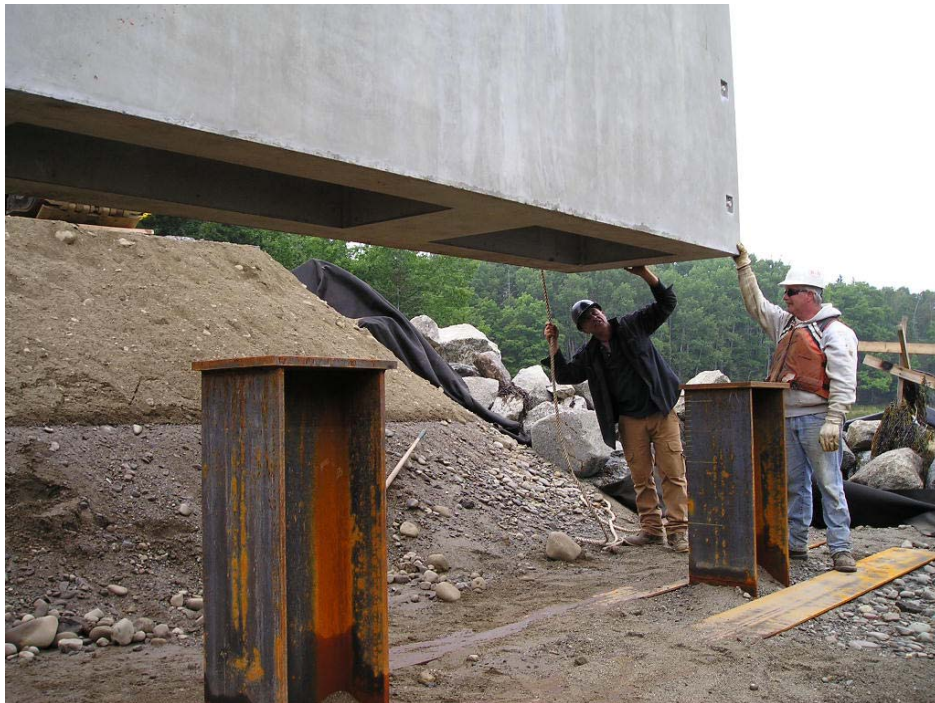
Photo 4: Precast Abutment voids being aligned with Pile tips.

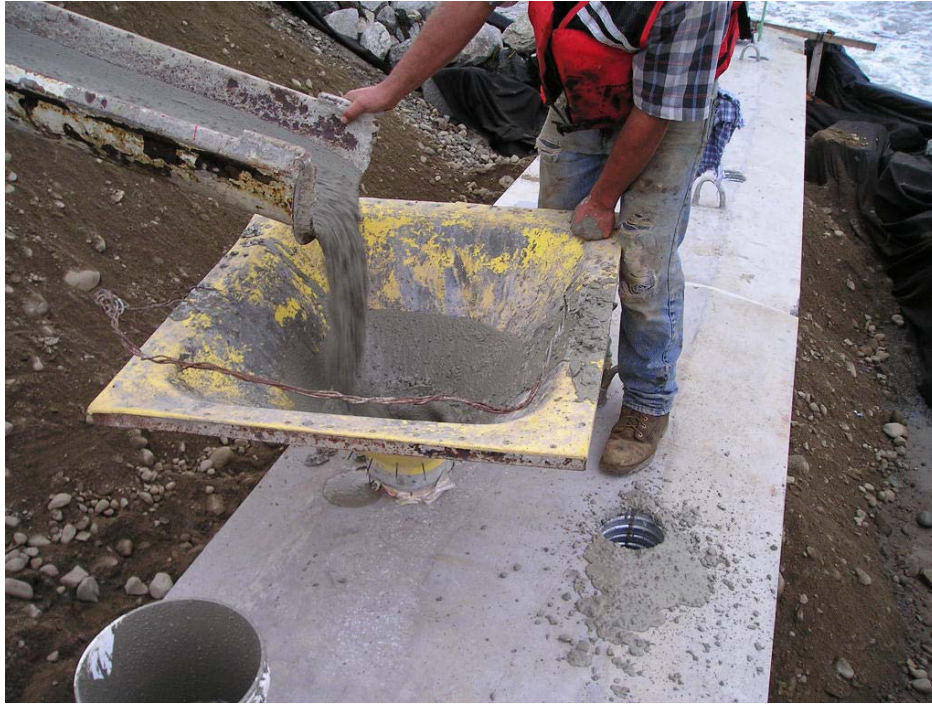
Photo 5: Self-Consolidating Concrete poured into the voids.

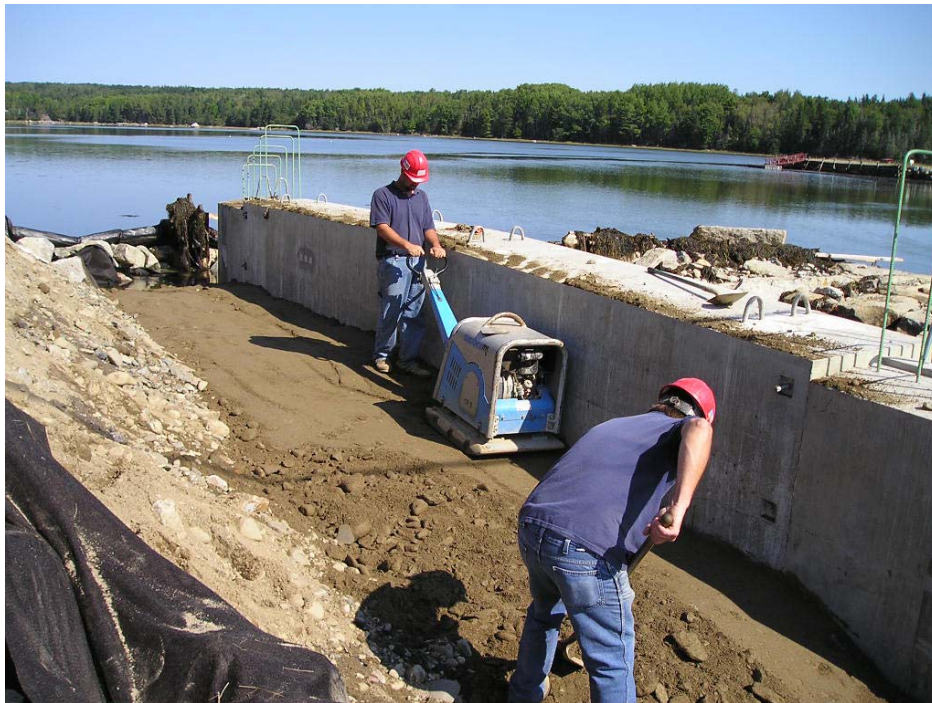
Photo 6: All four Precast Abutment units in place

abutments consist of two 16 foot long precast center units and two 4 foot long precast extended wing wall units. All contact surfaces were specified to be match cast at the precasting plant and coated with epoxy concrete adhesive just prior to post-tensioning in the field. All four units are post-tensioned (PT) together with six threaded bars. The PT bars were designed to resist biaxial loads on the center units from traffic and earth pressure, and cantilever loads on the wingwalls due to earth pressure. The match cast joints also consisted of four shear keys to help align the precast units during erection. Voids were designed into the abutment units to receive the piles. These voided areas were enlarged to reduce the shipping weight of the precast units. Once the abutments were lifted into place and the post-tensioning was completed, the voids were filled with Self Consolidating Concrete (SCC) through six inch ducts on top of the abutment units. The six PT ducts were pumped with conventional grout. The final lock off tension in the PT bars was designed to prevent any cracks due to Service Loads. Although the PT bars provided bending resistance, the steel reinforcement in each unit was designed for deep beam bending action, and punching shear resistance over the voided areas. All steel reinforcement in the abutment units were epoxy coated.

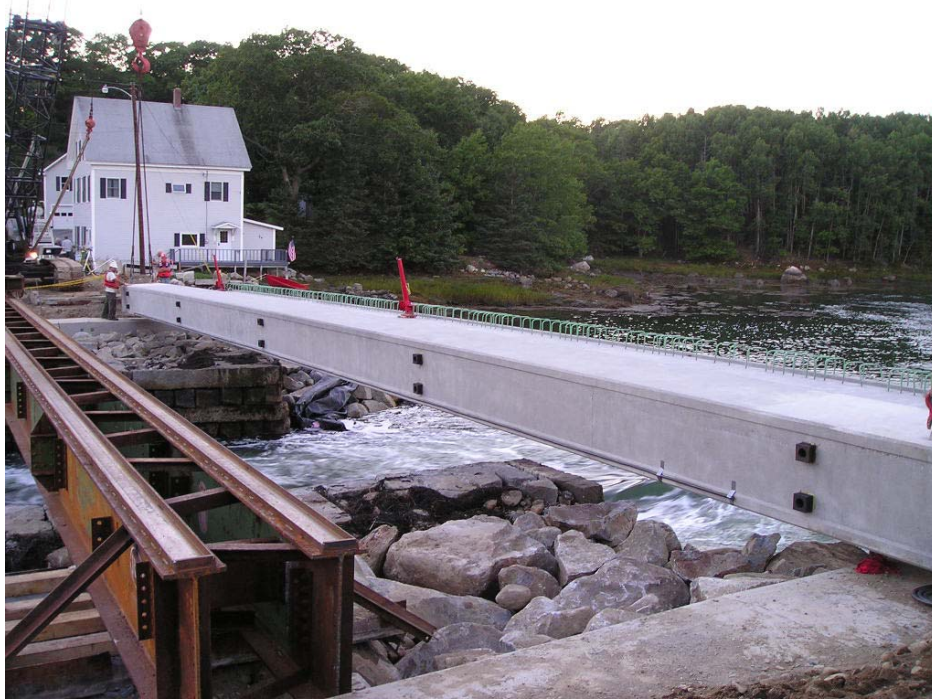
Photo 7: Launching Beam and first Precast Box beam in place.

beams would have required widening the causeways with temporary fills to swing the beams into place and thereby causing significant impact to the natural habitats. This was eliminated by the use of custom made steel launching beam with a trolley supported on Hilman rollers. The contractors used the truck that brought the beams to back-up the beams across the channel thereby eliminating the need to lift an entire beam off the truck with one crane. The use of pea stone concrete mix in the shear keys instead of the conventional sand grout reduced the possibility of discharging material into the river. As an additional measure, the foam backer rods in the shear keys were bonded to the beams prior to erection and then compressed into place during erection of adjacent beams.

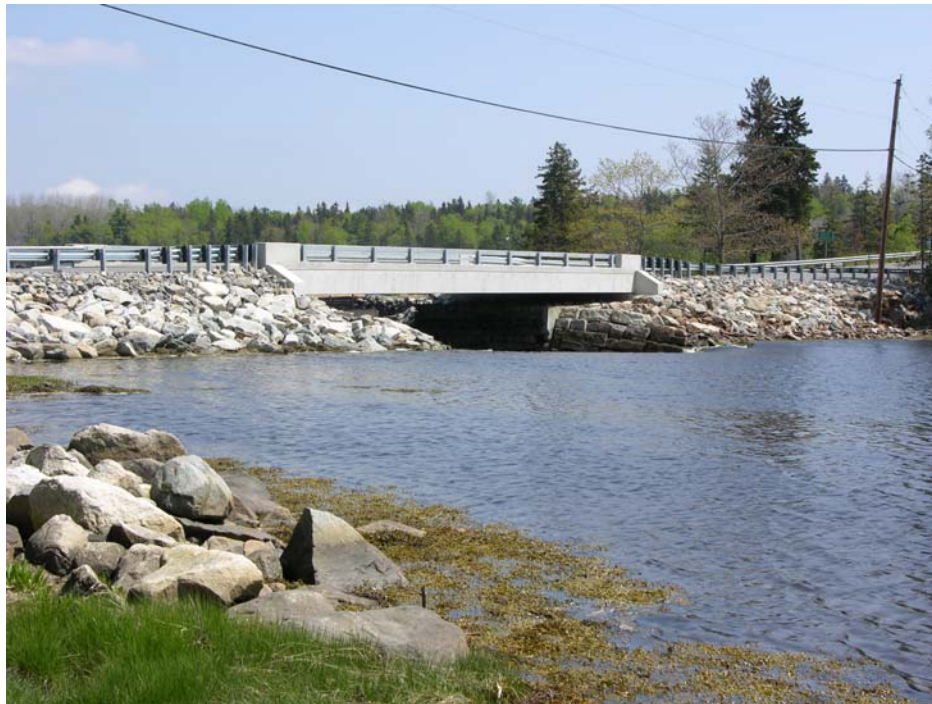
Photo 8: Completed Bridge showing causeways.

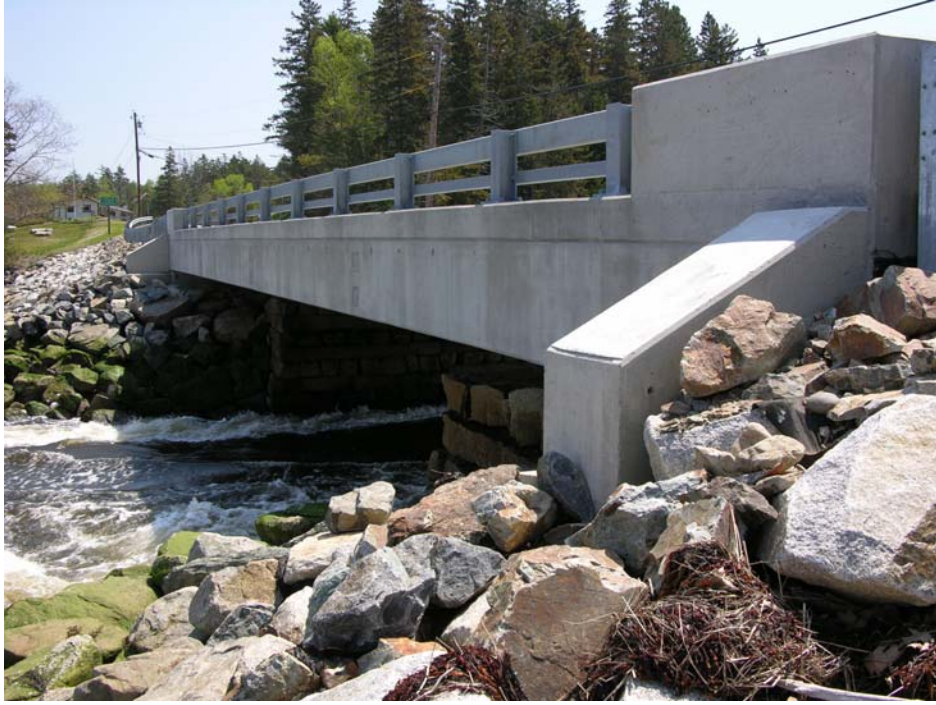
Photo 9: Completed Bridge photo taken 9 months after completion.
