PRESTRESSED CONCRETE BOX BEAM BRIDGES – Two DOTs’ EXPERIENCE

ABSTRACT

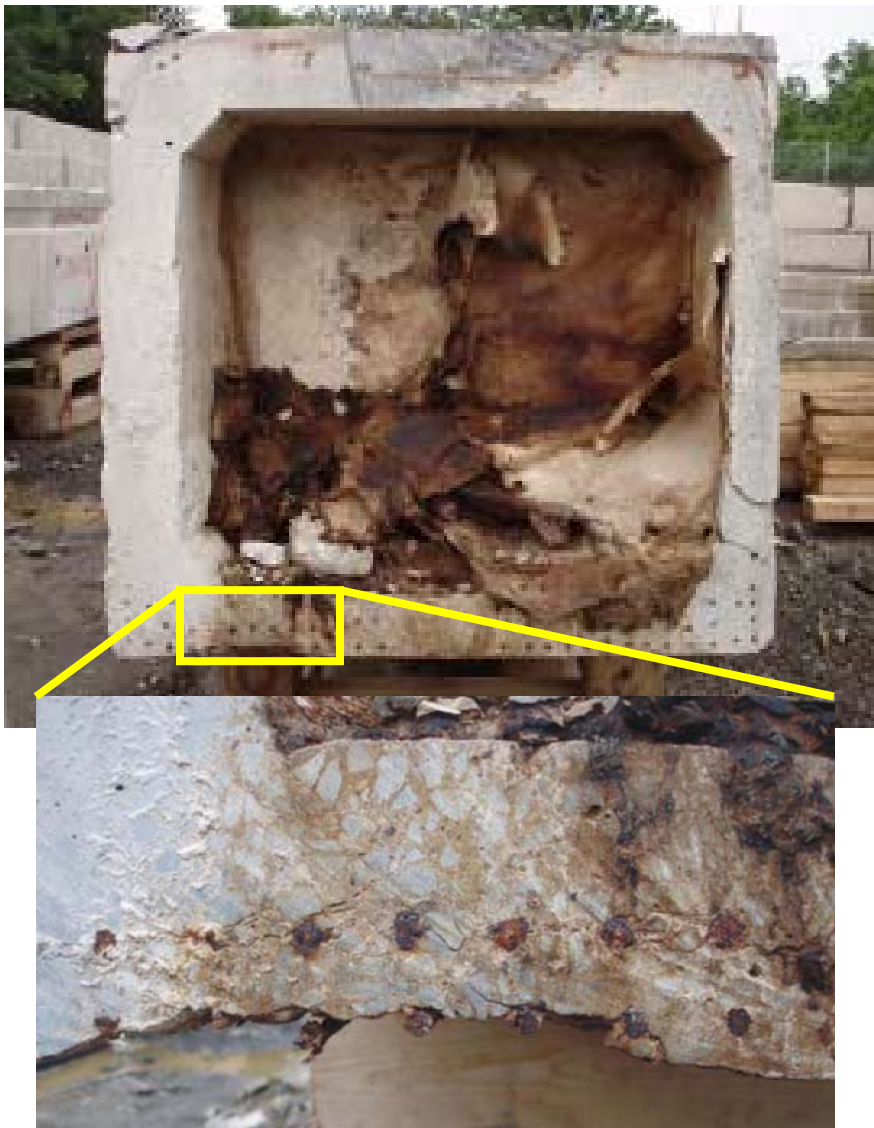
Figure 5 - Cross Sectional Slice of Test Beam¹

Studies conducted by the University of Pittsburgh¹ and Lehigh University² demonstrated the complexity of detecting corrosion in prestressed concrete box members. Through a combination of cross sectional slices, coring and chipping of concrete troughs, the researchers were able to document corrosion of prestressing strands. Figure 5 illustrates the corrosion of the upper layer of prestressing strands directly above a region of the beam of exposed bottom layer strands. The extent of corrosion in top layer or unexposed areas can be more significant than visual inspection indicates. The length of the prestressing strand which is corroded is limited to the exposed region. Beyond the regions of exposed strand, the passivity of the concrete protects the strand from corroding.

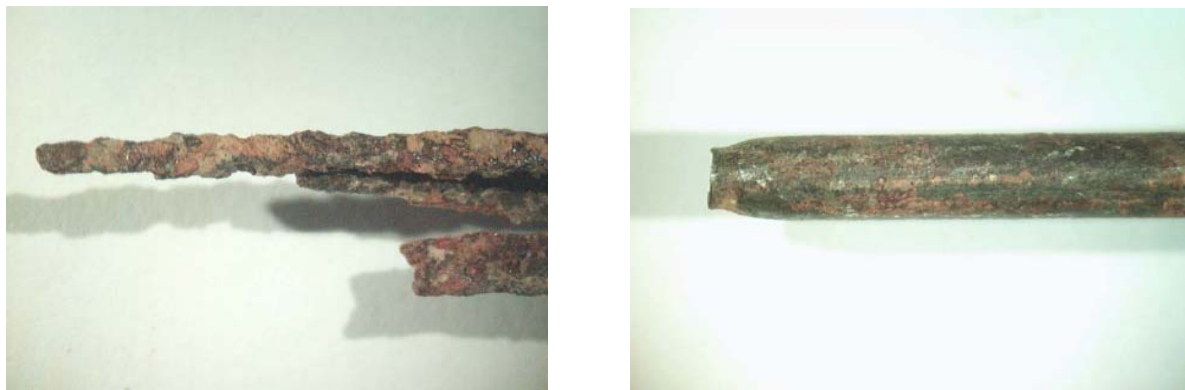
Microscopic examination of prestressing wires reveals the difference between a corrosion related failure versus a tension related failure as shown in Figure 7. Wires and strands that fail due to corrosion have minimal structural capacity and ductility. Corroded strands do not have the ductility to offer advanced indication of pending failure.

Figure 7 - Prestressing Wires Corrosion Failure (left) and Tension Failure (right)

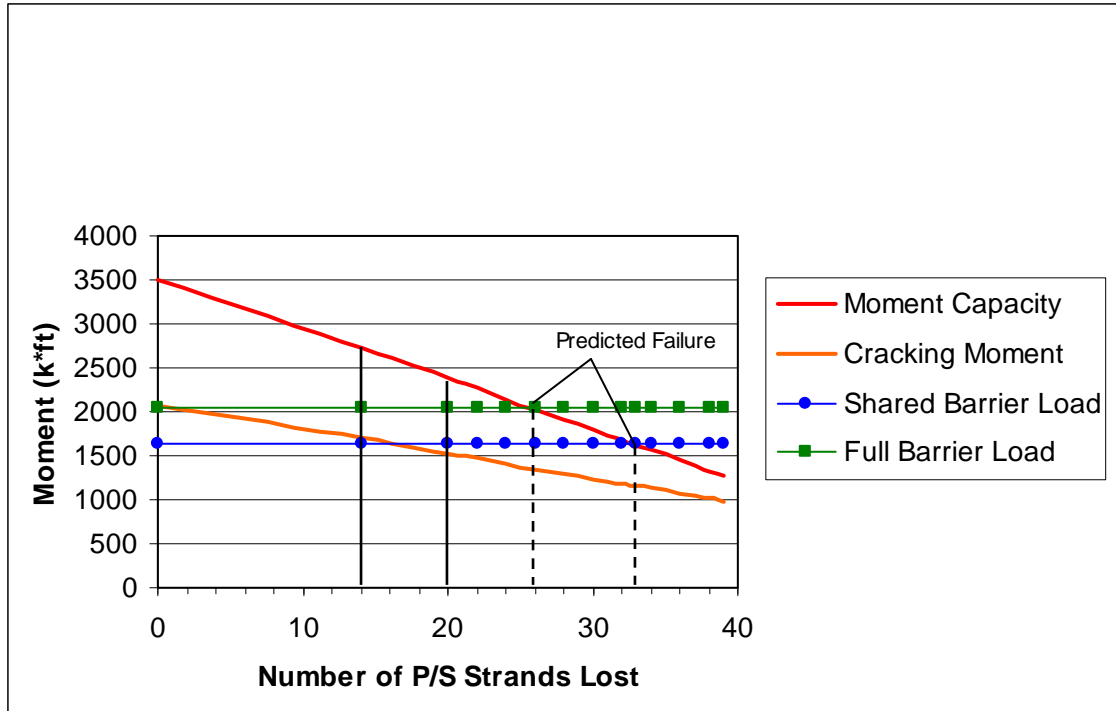
To determine the flexural resistance, the ultimate capacity is a function of the concrete strength, ultimate strength of the prestressing strand and the remaining cross sectional area of prestressing strands. Through bridge safety inspections, the documented strand corrosion must be accounted for in the load rating analysis. As depicted in Figure 10, the reduction in the ultimate moment capacity is directly related to the number of prestressing strands lost. At some point the loss of prestressing strands reduces the beam capacity to a level that the dead loads acting on the beam will cause failure. The analysis should account for un-observable strand corrosion by assuming more strands are corroded than documented by inspections. A sensitivity analysis should be performed similar to the analyses conducted to develop Figure 10 to determine the proximity to a point where the loads exceed the beam capacity based on failed/corroded prestressing strands. A reasonable boundary is to assume 25 percent more strands are corroded than documented, i.e., if the inspection documents 8 strands are exposed, perform the analysis assuming 10 strands are corroded.

Figure 10 - Strand loss vs. Ultimate Moment Capacity Curve

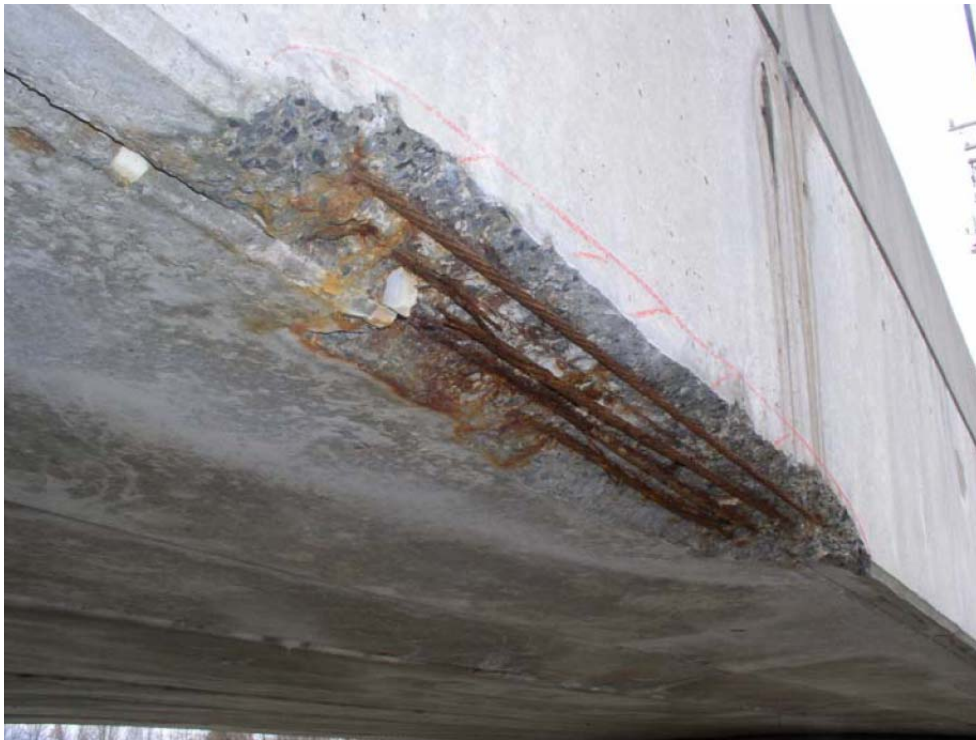
As discussed previously, the shallow structural depth is one advantage of this superstructure. The use as overpass structures, results in a risk of the bridge beams to be struck by overheight vehicles (Figure 11). Typical damage is loss of cover, exposure of prestressing strands leading to corrosion of the prestressing strands. The exposure and corrosion do not instantaneously result in loss of prestressing strand cross section area, but it will eventually occur. The current repair techniques for exposed strands do not provide a long term solution. Thin mortar repairs have been found to be ineffective and it is thought they may actually be detrimental by trapping moisture and thus accelerating the deterioration. Additionally, once the exposed strands are covered, visual inspection cannot detect the ongoing corrosion. However, the precast/prestressed industry is working on development of low cost microdevices that can be installed prior to the repair that will provide inspectors data on unobservable corrosion. Also, sacrificial anodes can be attached and embedded in concrete patching layers.

Figure 11 - Typical Impact Damage
