## **ASSESSMENT OF PREMATURE CONCRETE DETERIORATION IN PRECAST CONCRETE BRIDGE BEAMS**

**Mark E. Williams, PhD, PE, SE** Walter P. Moore and Associates, Inc, Houston, TX  
**Dilip Choudhuri, PE**, Walter P. Moore and Associates, Inc, Houston, TX

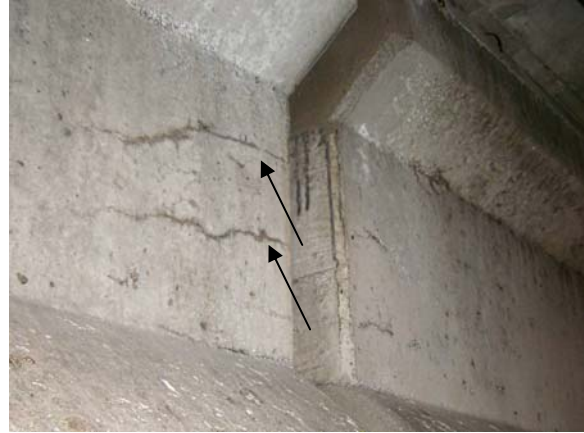
Fig. 2 End Zone Cracking in Interior Beam

Longitudinal cracks, often called *end zone cracks*, at the ends of pretensioned concrete beams are commonly observed after prestressing strand detensioning. The use of relatively high concrete strength and high levels of prestress has made this cracking more prevalent in recent years [1]. Although vertical bursting steel is generally provided in beams, longitudinal cracks in the bottom beam flange and web can still occur if the level of stress from prestress transfer exceeds the tensile capacity of the concrete. Efflorescence (Fig. 1) or other staining (Fig. 2) is often observed along these cracks as water migrates into the cracks over time.

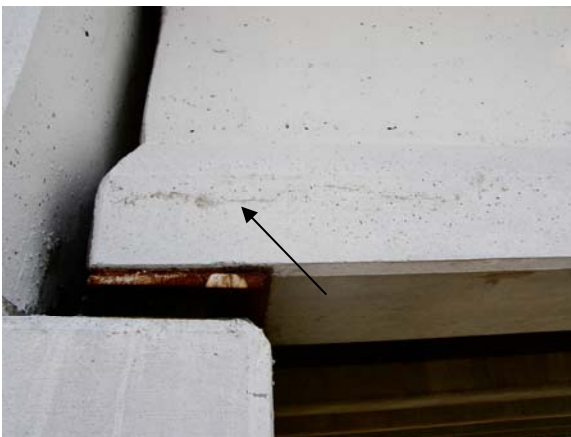
Fig. 3 Longitudinal End Zone Cracking Due to Anchorage Stresses

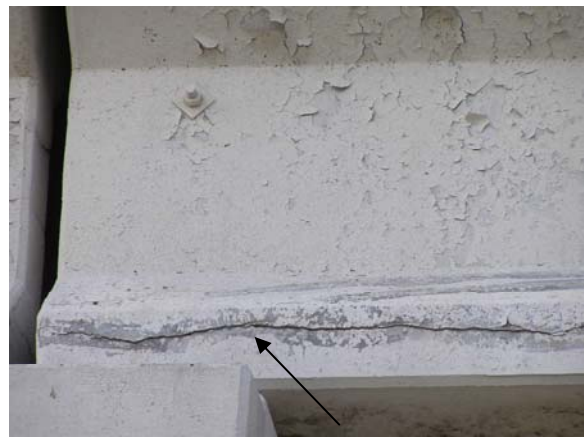
Fig. 4 Longitudinal End Zone Cracking Due to ASR/DEF

Premature concrete deterioration due to ASR or DEF is prevalent in areas of high moisture. This deterioration is commonly characterized by longitudinal cracking in concrete beams and in the case of ASR, the presence of surface discoloration at the crack locations. Depending on the severity of the cracking, it can be difficult to visually discern initial end zone cracking from anchorage stresses (Fig. 3) and long-term cracking due to expansion from ASR or DEF (Fig. 4). It is also likely that ASR or DEF is not the initiator of prestressed beam cracking, but rather the perpetuator of the cracking when there is an abundant source of water to drive the expansive reactions of ASR or DEF within the concrete [2]. Further evaluation is therefore needed to determine whether there is a potential for additional beam cracking.

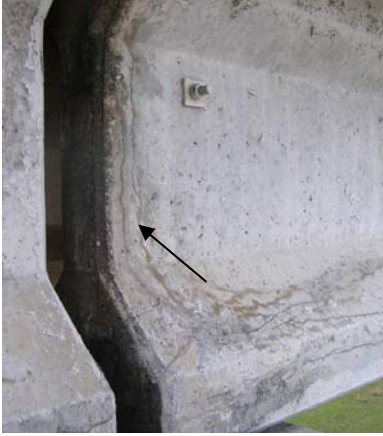
Fig. 5 Cracking in Beam Web Due to ASR/DEF

Vertical cracking at the beam ends noted during a visual assessment also warrants further review. Cracking could be caused by corrosion of the reinforcing steel from an ingress of chlorides at open bridge joints or other damage mechanisms. Cracking at the beam ends could also be due to ASR or DEF, particularly where there is little or no reinforcement (i.e. in the concrete cover) to contain the expansion from deleterious reactions (Fig. 5 and Fig. 6).

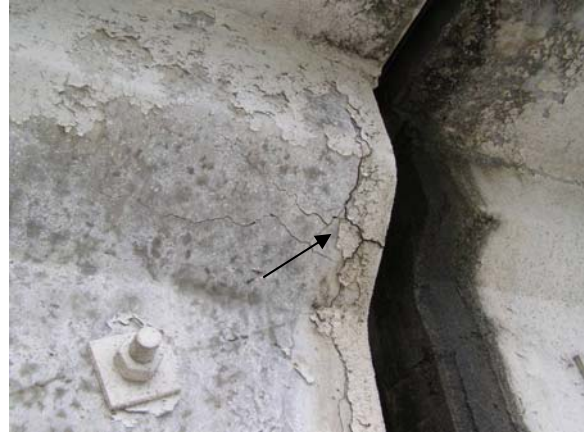
Fig. 6 Cracking in Beam Top Flange Due to ASR/DEF

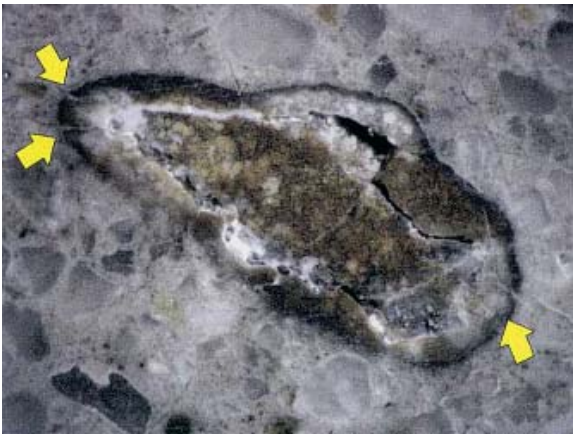
Fig. 10 Petrographic Analysis Showing ASR Gel

Concrete petrography provides an effective means of characterizing concrete deterioration mechanisms. Concrete petrography is generally conducted in accordance with ASTM C856 [3] to visually study the cause of the concrete deterioration on a microscopic level. Petrography can identify an expansive gel in the presence of ASR as well as microcracking and coarse aggregate cracking resulting from the expansive gel formation (Fig. 9 and Fig. 10). Petrography can also be used to identify expansive gaps around the aggregate, a feature consistent with DEF (Fig. 11). Unlike cracking due to ASR or DEF, shrinkage or thermal gradient cracks are generally found passing around the coarse aggregate during petrographic review. Concrete petrography can therefore be used as a valuable method to distinguish between concrete cracking mechanisms. As a cautionary note, concrete petrography may not always identify deleterious reactions in concrete due to ASR or DEF despite the visual evidence of deterioration at the bridge site. Therefore, other laboratory testing methods should be employed in the diagnosis of concrete deterioration.

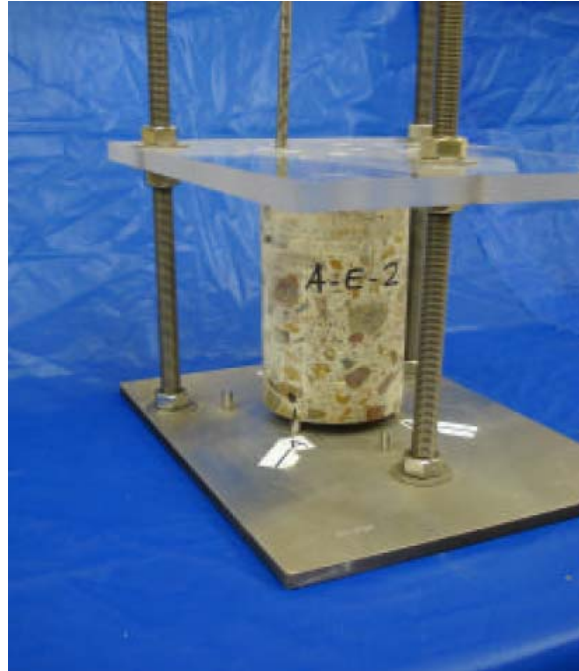
Fig. 13 Accelerated Expansion Testing Measurement

Accelerated expansion tests can also be conducted to study potential expansion of concrete due to ASR in a short time frame of weeks to months rather than years. During the test, periodic volumetric measurements are taken to monitor expansion potential while subjecting the test specimen to elevated temperature and moisture (Fig. 13). In more severe cases of ASR, gel has been observed on the surface of the test specimen as it is exuded through microcracks.

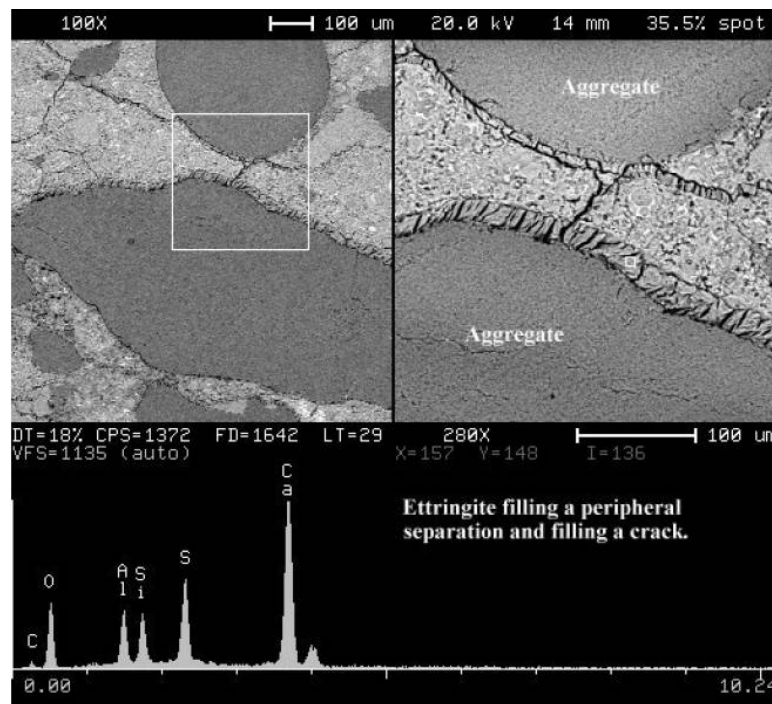
Fig. 14 Scanning Electron Micrograph of Ettringite Filling Gaps Around Aggregate Particles

Scanning Electron Microscopy (SEM) can be utilized to evaluate the mineralogy and microstructure of concrete as well as to identify deleterious reactions. SEM can identify microcracks around aggregate particles and ettringite deposits within these cracks. Furthermore, complete separations around aggregate particles can be identified, which are symptomatic of DEF (Fig. 14). Scanning electron microscopy is typically more costly than concrete petrography and should therefore be used for a confirmatory evaluation if needed.

Energy Dispersive X-ray Spectroscopy (EDX) can be performed in combination with SEM to confirm the chemical composition of the deposits noted in microcracks and separations around aggregates. EDX can identify the chemical composition of the deposits of ettringite ( $3\text{CaO}\cdot\text{Al}_2\text{O}_3\cdot 3\text{CaSO}_4\cdot 32\text{H}_2\text{O}$ ) (Fig. 13) found in concrete undergoing DEF.
