## **Evaluation and Repair Procedures for Precast/Prestressed Concrete Girders with End Zone Reinforcement**

**Christie J. Hasenkamp, M.Sc.**, Larson Engineering, Inc., Omaha, Nebraska, USA  
**Sameh S. Badie, PhD, PE**, George Washington University, Washington DC, USA  
**Kromel E. Hanna, Ph.D.**, University of Nebraska-Lincoln, Nebraska, USA  
**Maher K. Tadros, Ph.D., PE**, University of Nebraska-Lincoln, Nebraska, USA

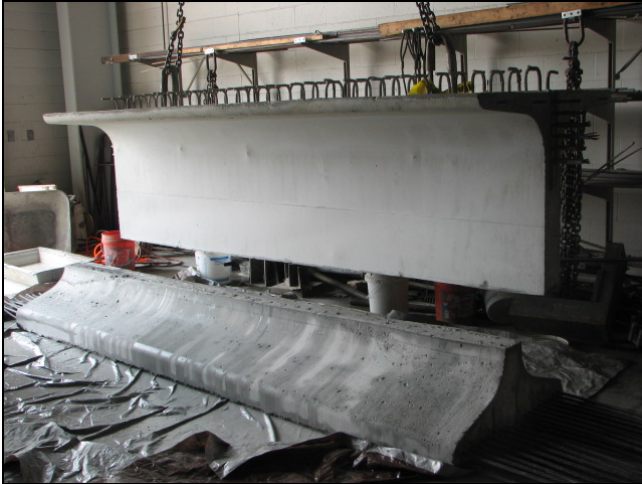
Figure 1. Bottom flange completely cut from the specimen (Girder 1)

The top and bottom flanges were cut away, leaving only the webs of each girder, as shown in [Figure 1](#). The bottom flange contained a large prestressing force in the 32 strands. This force had been resisted by the full section, before the bottom flange was separated from the rest of the section. When the beam was cut, the full extent of the interior cracking became visible, as shown in [Figure 2](#). Upon inspection, it was clear that the epoxy injection did not totally fill the cracks as anticipated. From the cut section, it could only be seen entering approximately 0.2 inches into the crack, as shown in [Figure 3](#). Also, visual inspection revealed a lack of adhesion between the concrete and the epoxy.

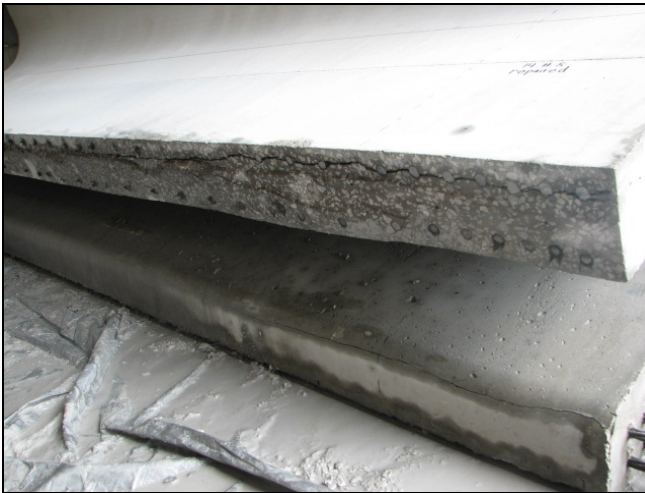
Figure 2. End zone cracking extending the full length of the web (Girder 1)

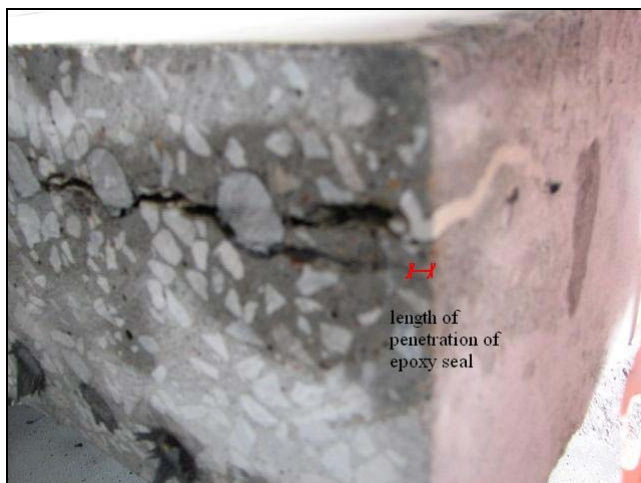
Figure 3. End zone cracking extends vertically and horizontally (Girder 1)

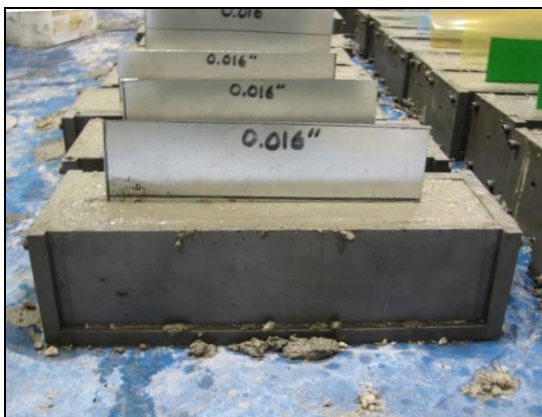
Figure 5. Durability Test Specimens with Metal Shims

The concrete specimens were made in the form of 3 in. × 3 in. × 12 in. (76 mm × 76 mm × 300 mm) rectangular prisms. The design concrete strength was 5000 psi (34,000 kPa). Although this concrete mixture is relatively more porous than the concrete normally used in precast concrete girders, it was used to amplify the amount of water absorbed if the sealers failed. Artificial cracks were formed with metal and plastic shims, penetrating down 2.25 in. (57.2 mm) from the top surface of the specimens and measuring 9 in. (230 mm) in length (Figure 5). These shims were placed in the concrete while it was still wet and removed when it began to set. The artificial cracks were produced in a variety of widths, ranging from 0.007 in. to 0.054 in. (0.2 mm to 1.4 mm). After all specimens were fabricated, they were placed in a draft oven for 24 hours and then the dry weight  $W_A$  was recorded. When cooled, the selected sealants were used to cover the four sides and bottom face of each specimen, leaving only the top surface containing the crack not coated. These sides were covered to prevent moisture from either entering or escaping the surfaces not being tested.

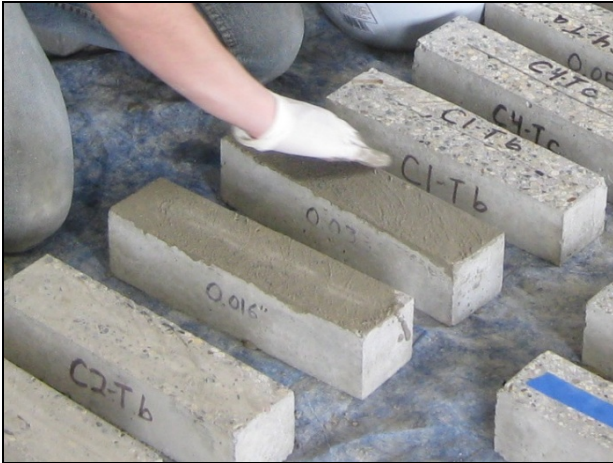
Figure 6. Hand application of the hydraulic cementitious material

There were two sets of specimens for each sealant, with each set containing prisms with cracks of each available size. The top surface of the specimens, which had the crack, of the first set was sealed only with the specified sealant. The top surface of the specimens of the second set had a hydraulic cementitious material rubbed into the cracks by hand, and then sealed with the same sealant as the first set. The hydraulic cementitious material was rubbed into the cracks by hand (Figure 6), while the sealants were applied with a roller. The specimens were placed on their sides and the selected sealants were applied to their specific sets. This orientation mimics the orientation of the cracks on the webs of production girders.
