Post-Tensioning Design and Detailing for Transverse Connections in Adjacent Box Girders

Jenna Hansen, Kromel Hanna and Maher Tadros
University of Nebraska-Lincoln

Keywords: Adjacent box girder, Transverse connection, Post-tensioning

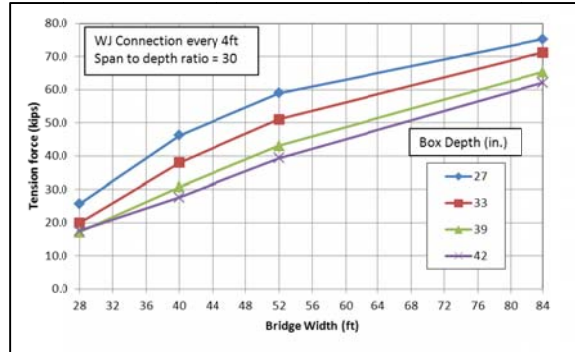
Along with the above research, finite element analysis was used to develop charts to estimate the transverse tension force of the two new systems for various bridge widths and span to depth ratios (Fig. 1 and Fig. 2). These charts were used to establish the post-tensioning force required for the newly proposed system. Post-tensioning was incorporated into the former systems in order to provide joint compression, simplify construction operations, and improve inspection of materials.

Fig. 1 Required transverse tension force for WJ connection

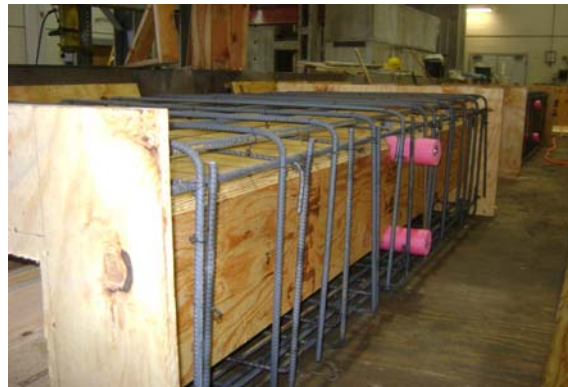
Fig. 7 and Fig. 8 represent the girders that were formed and cast at the UNL lab on the Omaha campus. An unforeseen issue with bearing on the end girders required a second form setup to grout the exterior shear keys. Grout was required to have at least 8 ksi strength and ended up reaching a 28 day strength of 10 ksi. This was important so that the girders did not fail at the bearing locations. It should be noted that with time the grout at the bearing location experienced excessive cracking, however the actual specimen had only a few cracks due to shrinkage. The grout cracked because it was confined to a thickness of less than 1 in. and was unable to be kept moist for curing due to forming constraints.

Fig. 7 Side View of Box Girder

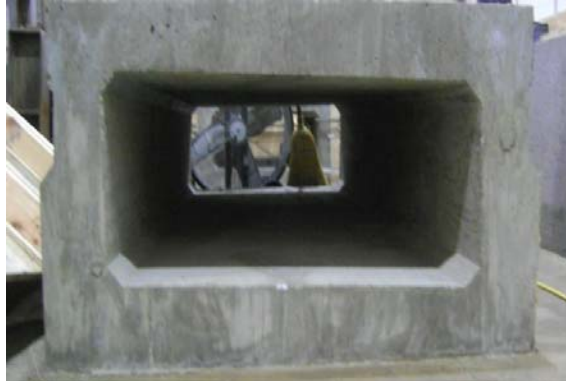
Fig. 8 Fully Cast Box Girder

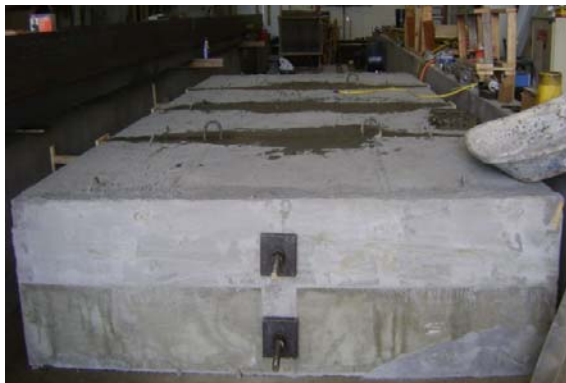
Fig. 9 shows the complete specimen immediately after grouting. Once the grout reached 8 ksi, the post tensioning was jacked to 0.7 f_{pu} or 90 kips according to AASHTO specifications. Jacking started at the top and was done in cycles so that the difference of force between ties was no greater than 30 kips per cycle.

Fig. 9: Specimen after Grouting Shear Keys

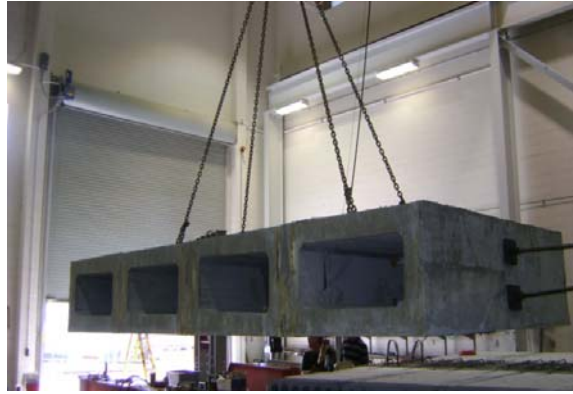
The specimen was able to handle its own weight as it was lifted to the initial top tension test frame. No visible damage took place. After placement, a beam had to be set on top of the specimen in order to prevent it from lifting off its support under loading. This beam was placed as close to the end as lab conditions would allow. Furthermore, no visible damage took place when the specimen finished the top tension test and was lifted again in order to rearrange the supports for the bottom tension setup.

Fig. 12 Initial Specimen Lifting

An actuator was used to apply 5 million cycles of loading to a 15 in x 15 in bearing plate on the specimen. Five strain gages were placed to monitor changes in strain near the load and middle joint. Pictures of the test frame setups can be seen in Fig. 12 through Fig. 14.

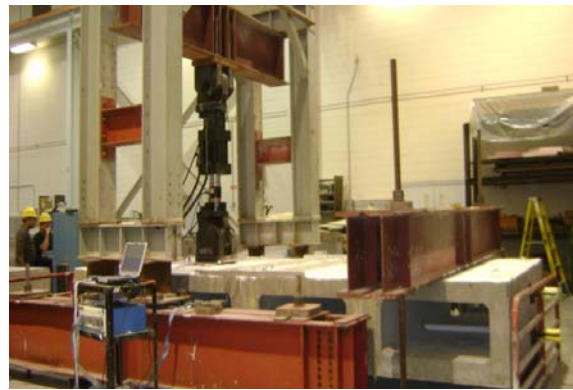
Beam supports for both cases are placed at stiff locations – or in other words – at webs and joints. For top tension, the supports go at the middle joint and edge of the specimen so that a load can be applied at the center of the connection between the two cantilevered box girders. Bottom tension is the result of supports at either end with a load at the center. A neoprene bearing pad was placed between the specimen and the beam to provide additional flexibility to the system.

Fig. 13 Actuator at Exterior Joint for Top Tension Setup

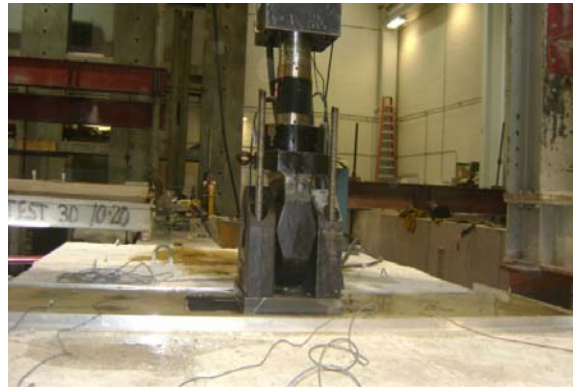
Fig. 14 Actuator at Interior Joint for Bottom Tension Setup

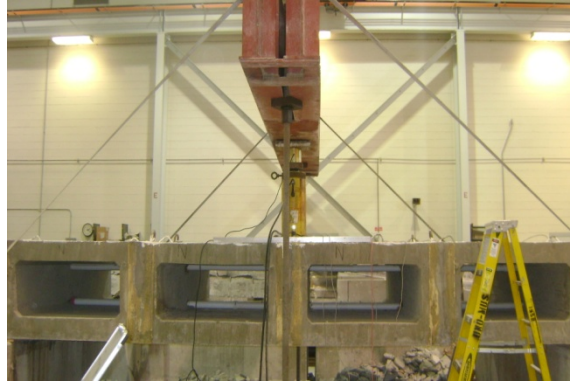
After fatigue testing the specimen was moved onto concrete blocks so that it could be tested for ultimate capacity. Bearing was provided by 4 in by 8 in planks at each end of the specimen. The specimen did not experience any cracking during lifting and placement. A loading cell was placed directly over the center joint to produce tension once more in the bottom flange (Fig. 15). A deflection gage was placed beneath the specimen to take measurements along with the five strain gages on top.

Fig. 15 Actuator at Interior Joint for Ultimate Capacity Setup

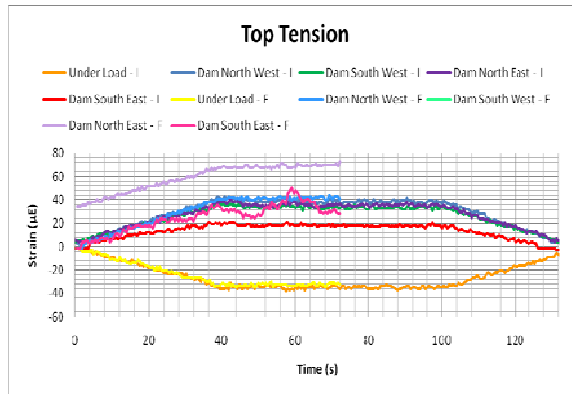
Strain gage data taken from 3 locations on either side of the joint (center and edges) suggests that the stress on the box girder is the same before and after top tension loading. Two of the gages had overlapping initial and final strains. These occur under the load and on the North-West side of the joint. The strain gage on the South-East side of the joint initially read nearly half the average value of the other strain gages ($36 \mu\epsilon$). At the end of the test; however, this strain gage had increased to the $36 \mu\epsilon$ average. The North-East strain gage also doubled, suggesting that the load was being unevenly distributed to the East. The last strain gage broke due to water submersion and accurate data was unable to be obtained from the specimen.

Fig. 16 Initial and Final Strains on Specimen (Top Tension)

As mentioned earlier, leakage was noticed along the flange of the box girder. This leakage occurred mostly at a crack on the North-East side and parallel to the joint. Smaller leaks were due to cracks located North-West and South-West of the joint. These cracks occurred where the top boards for bracing had been placed during the initial casting of the individual girder specimens (perpendicular to the joint). Since the measurement on the west side did not show any strain change, it is reasonable to conclude that parallel cracking is the cause for strain change on the East side. It can also be inferred that the crack caused some strain change in the specimen that otherwise would not have occurred. Strain gage data is shown in Fig. 16. Fig. 17 and Fig. 18 show the North-East crack and leakage.

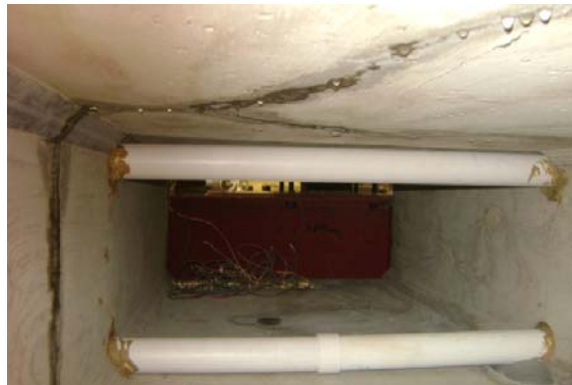
Fig. 17 Interior View of Cracking at Flange along North-East Side of Joint

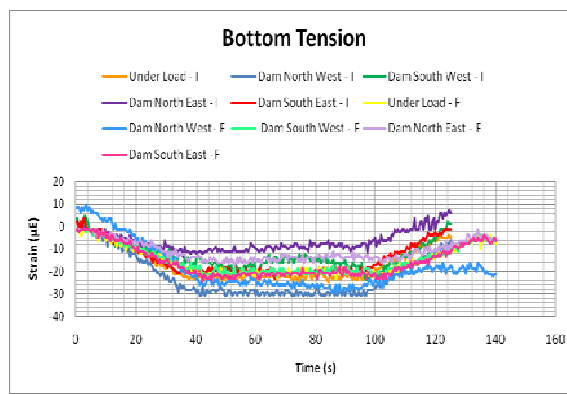
initial and final strains. These occur under the load and on the South-East side of the joint. The strain gage on the North-West side of the joint decreased approximately $5 \mu\epsilon$, while the strain gage on the North-East side increased approximately $5 \mu\epsilon$. The South-West strain gage appears to overlap, however the initial readings show a change of strain when the load is constant. This is probably because the strain gage should have been replaced after the top tension test. The adhesive for the strain gages did not hold up well after being submerged in water a second time. Both North strain gages and the South-West strain gage had to be replaced before obtaining their final readings. Once more, results suggest that the parallel crack caused the changes in strain. It makes sense that the North-East gage would experience an increased compression strain because it is on the compression side of the crack, while the North-West gage would lose compression strain as a result of the increasing tension on the other side of the crack. Strain gage data is shown in Fig. 19.

Fig. 19 Initial and Final Strains on Specimen (Bottom Tension)

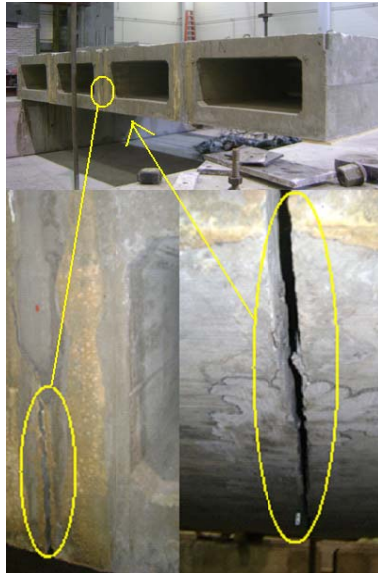
The ultimate load taken by the specimen was 67 kips applied and 90 kips total. This is greater than the expected 61.5 kips applied and 84.5 kips total loading from hand calculations. The joint cracked evenly across the bottom and extended up to where the web indents and forms the shear key that runs the entire length of the specimen (Fig. 20). Deflection stayed evenly below 0.1 inch for approximately 60 kips before increasing exponentially to 3.31 inches between 40 and 67 kips (Fig. 21).

Fig. 20 Side (Bottom Left) and Underside (Bottom Right) Cracking at Interior Joint

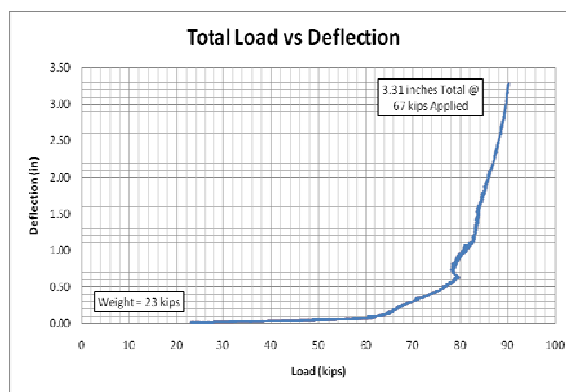
Fig. 21 Total Load versus Deflection of Specimen

Ultimate capacity was calculated as 280 kip-ft using strain compatibility and found to be slightly higher during testing. An applied load of 67 kips in addition to the self-weight of the specimen reached 300 kip-ft before failure. Cracking did not propagate until after reaching a 60 kip total load and then deflection increased exponentially from 0.1 inch to 3.31 inches over the next 30 kips applied.
