EVALUATION OF THE PERFORMANCE OF CAZALY HANGERS IN PRESTRESSED CONCRETE JOISTS

Brandon Mintz, MS, EI Dept. of Civil Engineering, Florida International University
Nakin Suksawang, PhD, EI, Dept. of Civil Engineering, Florida International University
Amir Mirmian, PhD, PE, College of Engineering and Computing, Florida International University

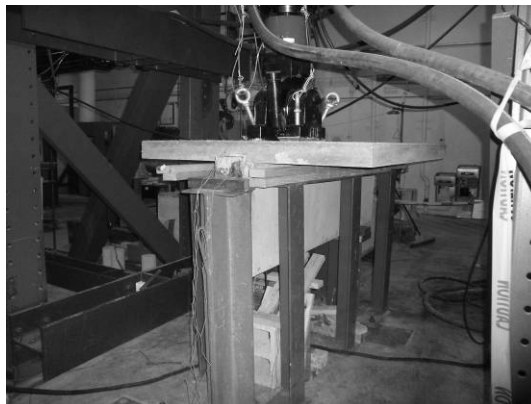
Fig. 3 Test Setup

The specimens, as approximately shown in Fig. 2, were loaded with the setup that can be seen in Fig. 3. The specimen was loaded at a rate of about 75 lbs. per second. The loading

was paused at different loads to mark cracks and take pictures of the specimen. Once the load reached 100 kips (67 kips reaction) the load was sustained for a 24 hours period. The 24 hours sustained load was to test whether the joist can sustain a load at service level. Once the 24 hour sustained loading period was over, the loading continued to be applied until the specimen failed.

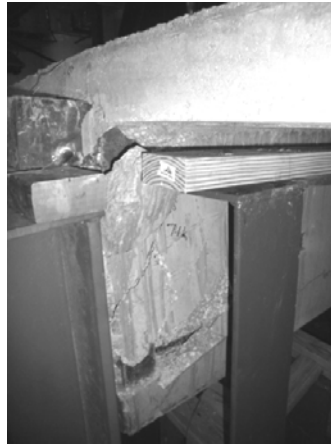
Fig. 7 Shear Failure of the Beam

The final failure in most specimens occurred by sudden shear failure of the hanger. This failure occurred generally in the ranger from 140-160 kips applied load (93.3-106.7 kips reaction load). The load was then removed and the test stopped. The maximum loads are summarized in Table 2 as averages of each specimen type and bearing condition. Fig. 7 shows the shear failure of the joist. This is significant because the strap is not designed for bending. After the joist failure, the hanger would punch would through the slab as is shown in Fig. 8.
