## **Innovative Use of Precast Segmental-Concrete Foundations at a U.S. Government Facility in a Remote Arctic International Location**

Cory R. Brett<sup>1</sup>, Scott J. DiFiore<sup>2</sup>, Dominic J. Kelly<sup>3</sup>, and Paul J. Cheever<sup>4</sup>

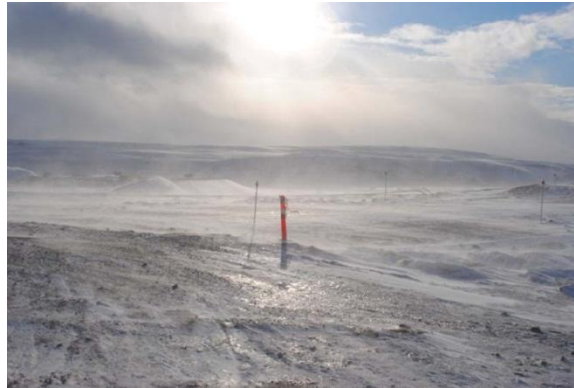
**Figure 1 – Arctic conditions at project site**

The project involved upgrading the airport radar system at Thule Air Base in Pituffik, Greenland. The upgrade included construction of a new, approximately 40-foot-tall, radar tower and a new elevated 2,700 square foot radar facility building. Thule Air Base is located 750 miles inside the Arctic Circle (Figure 1) and 900 miles from the North Pole. The temperature at the base ranges from -40°F to 70°F with a mean annual temperature of approximately 12°F.

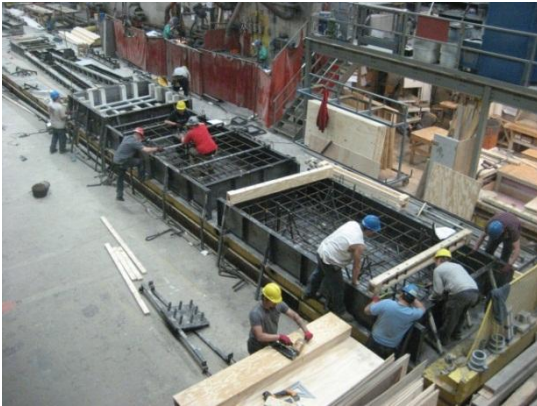
### Figure 3 – Precast fabricator

(a) Preparing footings in forms

(b) Trucking to Virginia

By working with a local precaster, the designers could specify domestic construction materials and practices, work closely with the fabricator to complete design details, and observe the quality of fabrication. The designers, precast fabricator, and material suppliers conferred regularly to determine how best to discretize the foundation pieces into repeatable shapes, how to eliminate the necessity to match-cast adjacent components, and developed details to simplify fabrication and erection. For example, the designer, fabricator, and post-tensioning vendor collaborated to develop details for post-tensioning duct splices in the mat foundation (Figure 4) and grouted splice sleeve details at the pier/footing connections (Figure 5).

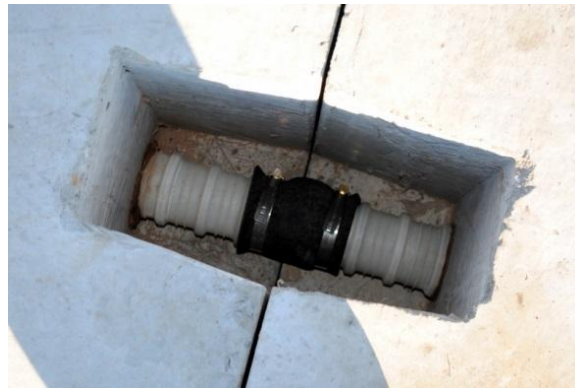
Figure 4 – Post-tensioning duct coupler in handhole between mat foundation segments

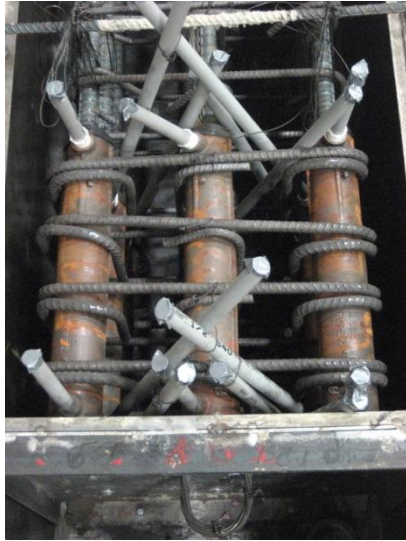
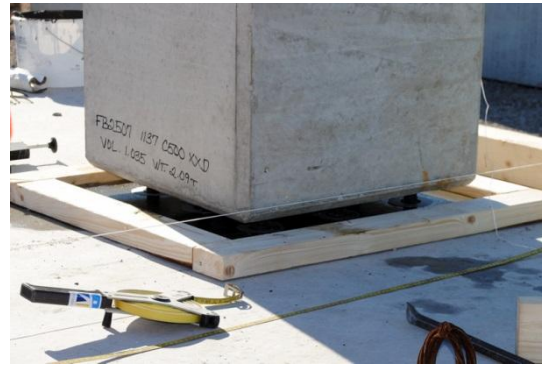
**Figure 5 – Grouted splice sleeves for pier/footing connection**

(a) Splice sleeves in pier form

(b) Placing pier with splice sleeves onto footing dowels

The design engineers detailed the connections at the top and bottom of the piers to increase alignment flexibility and allow the contractor to accurately position the piers and their cast-in anchor rods. The bottom of the piers contained No. 11 splice sleeves to connect to No. 9 dowels in the building footings and No. 10 dowels in the tower foundation, and the elevated steel floor framing had 5/16 in. oversized anchor rod holes. Together these details provided the contractor with nearly 1-3/8 in. of horizontal foundation adjustment prior to steel erection.

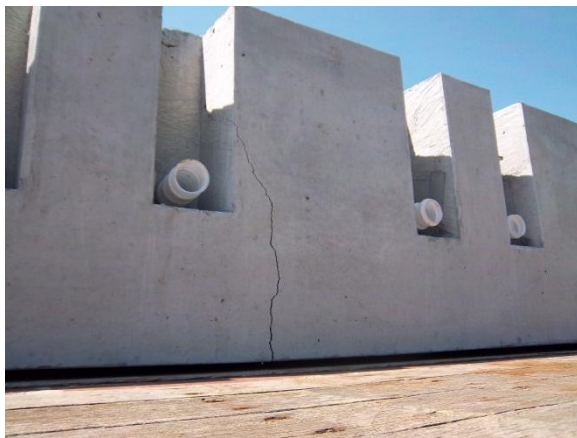
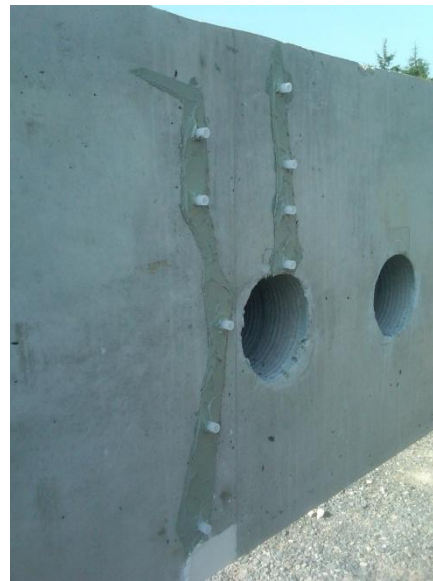
**Figure 6 – Mat foundation border segment cracked and repaired during transportation**

Despite an efficient and timely precast fabrication process, the precast transportation process was not without incident; two of the 2-foot-wide mat foundation border

elements cracked on the drive to Virginia (Figure 6). Designers detailed some long beam-like concrete pieces with minimum mild steel reinforcement since there was relatively little in-service demand on them. Minimum reinforcement was adequate for lifting and handling from the pick points. However, when the precast pieces were loaded onto the truck, blocking supported the pieces at the ends, creating a longer span than that evaluated by the designers. As a result, the pieces cracked en route. Fortunately, the precaster responded quickly and repaired the cracks using an epoxy injection system (Figure 6). Although the damaged pieces sustained some permanent deformation that complicated installation, they were repaired with minimal impact on structural performance and durability.

(a) Cracked mat foundation segment

(b) Repaired crack

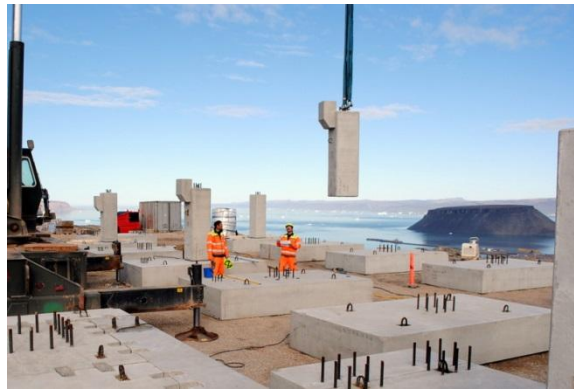
**Figure 7 – Installing a building pier**

With the end of the construction season approaching, the contractor placed all of the building piers (Figure 7), quickly grouted the piers to the footings, and backfilled. As a result, the contractor did not take full advantage of the adjustability provided by the oversized splice sleeves in the piers, and the piers were slightly misaligned from their as-designed positions.

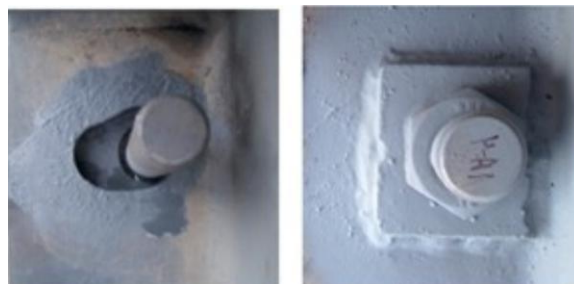
**Figure 8 – Modified Anchor Rod Connection**

This resulted in misalignment of most of the 1-1/8 in. anchor rods, some as much as 1 in. away from the holes in the steel floor beams. The contractor enlarged the anchor rod holes in the beams to fit over the as-built anchor rods (Figure 8). Since the designers detailed the framing and anchor rod projection to accommodate a field-welded plate washer, the contractor applied his solution globally with no impact to the structural performance.

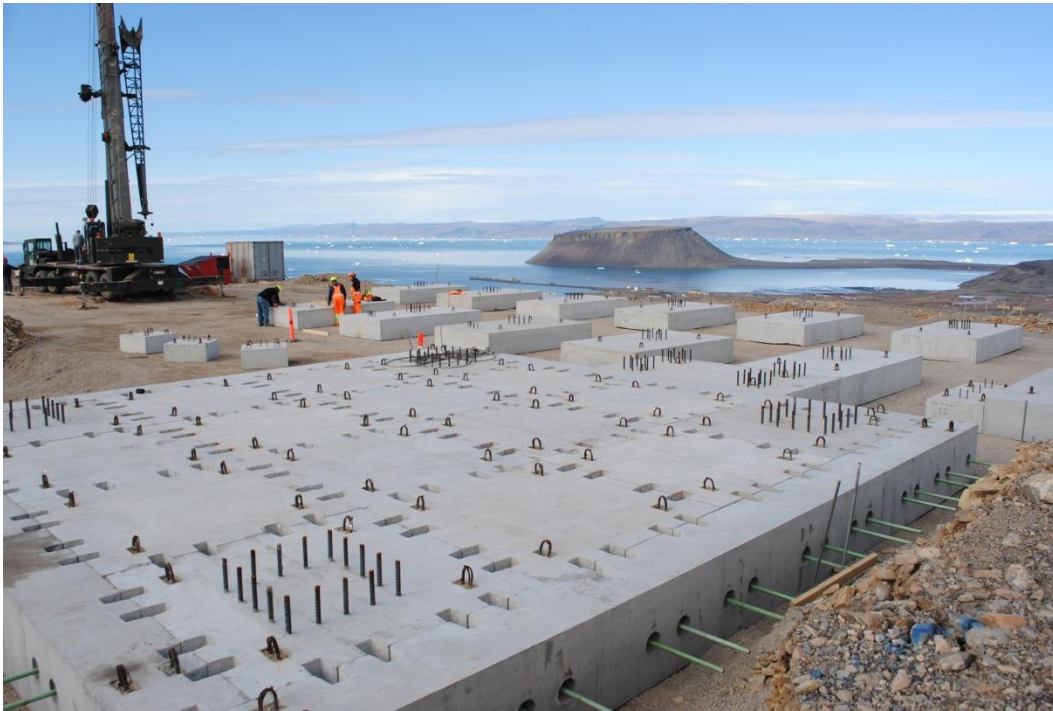
**Figure 10 – Foundation placement**

This mat foundation construction technique has its inherent challenges (Figure 10). Specifically, while tensioning the bars, it was difficult for engineers to differentiate between gap closure and actual post-tensioning bar elongation when measuring the apparent bar elongations. When the contractor tensioned a bar, the precast segments shifted slightly as the gaps between segments closed; this relieved tension in other bars. To work around this, engineers required the contractor to stage stress and tension the bars in the sequence indicated by Figure 11. The contractor sequentially applied load to the post-tensioning bars in increments of 5% of final stress and closed the gaps between adjacent precast pieces. By incrementally applying load to the post-tensioning bars and tensioning in the sequence illustrated by Figure 11, the designers could observe gap closure, control bar tensioning and tension relief due to gap closure, and confirm permanent tensioning. This systematic method of post-tensioning proved to be very effective; the radar tower fit perfectly onto the foundation anchor bolts with no modification.

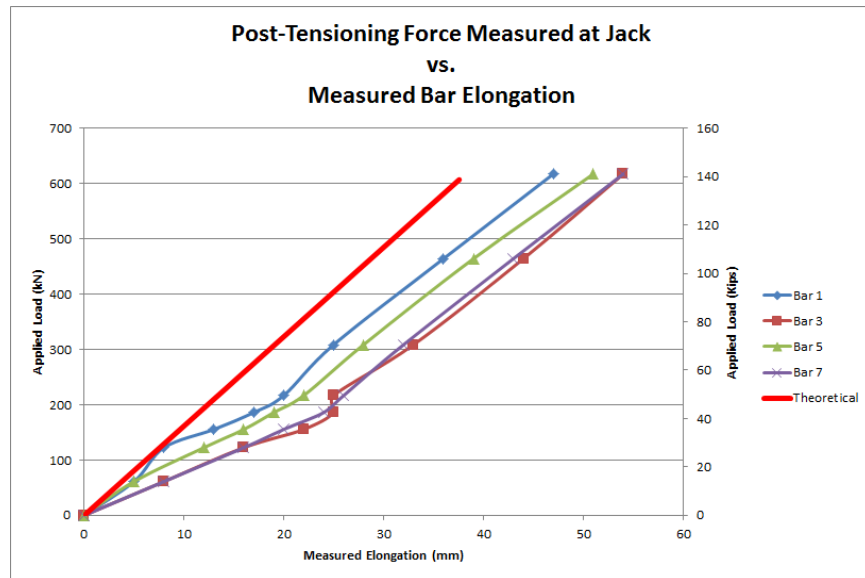
**Figure 12 – Measured bar elongation vs. theoretical bar elongation**

Figure 12 shows the measured, apparent bar elongation as a function of jacking force for Bars 1, 3, 5, and 7. The theoretical line in this chart represents the elongation an isolated 36-ft-long piece of post-tensioning bar when subjected to the jacking forces. The plots for Bars 1, 3, 5, and 7 are not linear for the first 30-percent of the jacking force. This occurred because the jacking force applied to the ends of the bars initially serves to close the gaps between the adjacent concrete pieces rather than to actually tension the bars. Once the concrete pieces are drawn together, the load elongation plots for the four bars becomes linear and parallel with the theoretical line, indicating that the bars are actually undergoing elastic deformation and taking load.

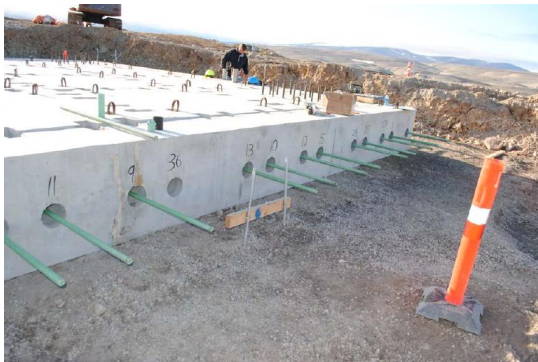
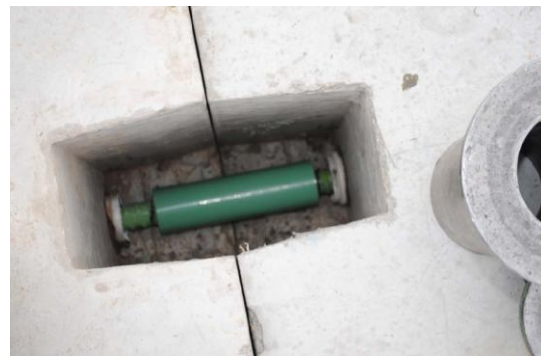
**Figure 13 – Post-tensioning bar splice for short bar**

Of the thirty-six post-tensioning bars shipped to the site, one bar in the shipment was nearly 3 feet shorter than the rest. As a result, it was too short to lock off and tension. The post-tensioning supplier, through expedited air shipment, sent a short length of post-tensioning bar and a bar coupler to the job site. Fortunately, the oversized post-tensioning ducts and rubber duct splice sleeves were large enough to accommodate the bar splicer, and the hand holes in the mat provided enough room to allow the splicer to move during bar tensioning (Figure 13).

(a) Post-tensioning bar stub

(b) Post-tensioning bar splicer

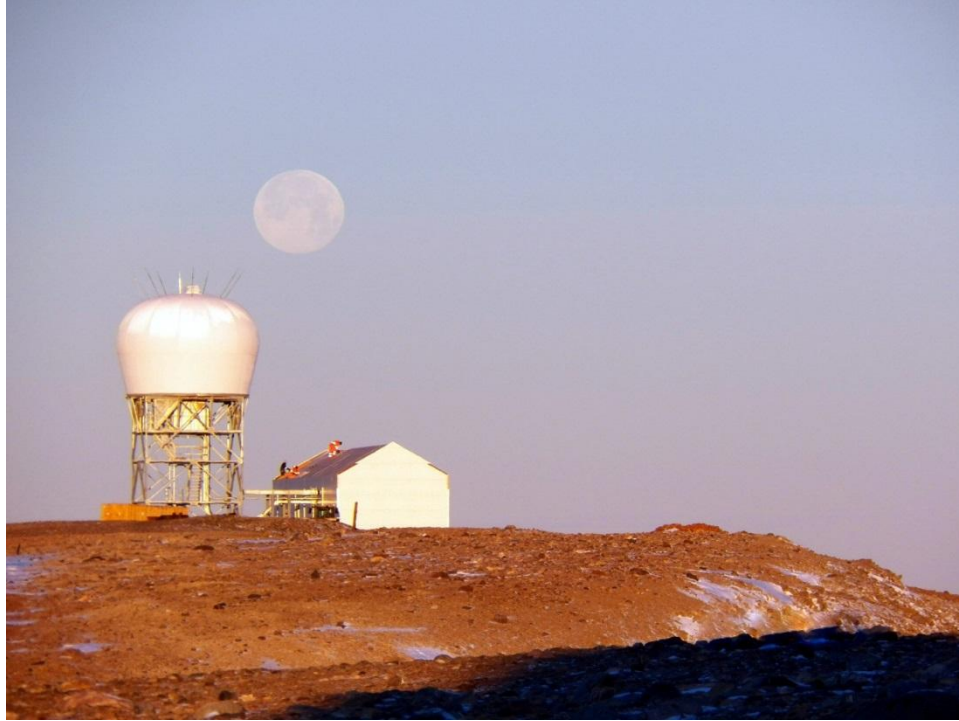
**Figure 14 – Contractor installing roofing material at the end of the construction season**

With the designers' assistance, the contractor was able to erect and enclose the building with European construction materials during the second construction season, and allow work to continue inside the building until the next winter (Figure 14).
