SHEAR PERFORMANCE OF POST-TENSIONED BULB-TEE GIRDERS

Andrew M. Moore, The University of Texas at Austin, Austin, TX
Chris Williams, The University of Texas at Austin, Austin, TX
Dhiaa Al-Tarafany, The University of Texas at Austin, Austin, TX
Josh Massey, The University of Texas at Austin, Austin, TX
Oguzhan Bayrak, The University of Texas at Austin, Austin, TX
James Jirsa, The University of Texas at Austin, Austin, TX
Wassim Ghannoum, The University of Texas at Austin, Austin, TX

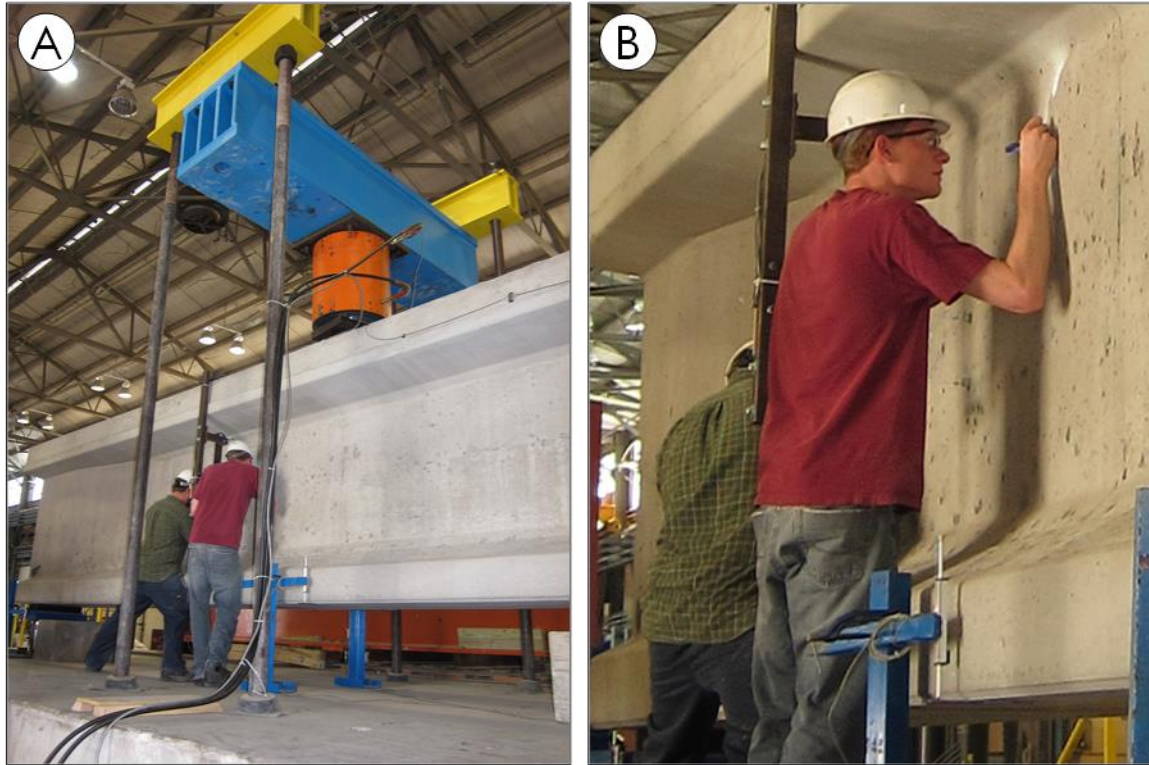
Figure 9: (A) 2,000 kip Load Frame & (B) Crack Mapping between Load Steps

All test girders were loaded in increments of approximately 75 kips shear until shear failure. This load was applied using the 2,000 kip load frame shown in Figure 9(A). Until the applied load level created safety concerns, all cracks were marked with felt-tipped permanent markers as shown in Figure 9(B).

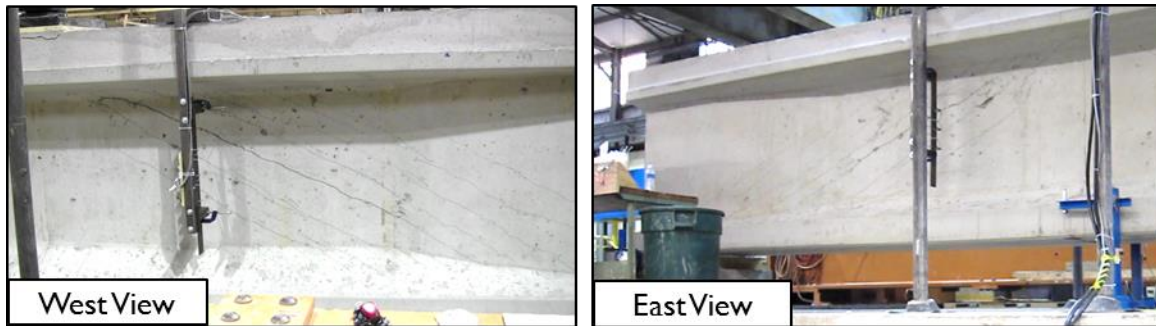
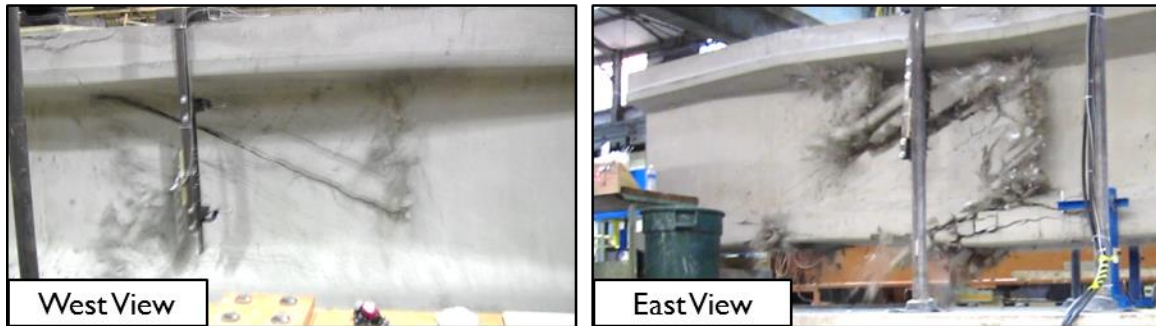
Tx62-3 (South): immediately prior to shear failure

Tx62-3 (South): immediately after shear failure

***Figure 11: Crushing of Diagonal Strut in Control Specimen (Tx62-3 South)
At the moment of failure & immediately after failure***

Tx62-3 (referred to as the "control") did not contain a post-tensioning duct but only pretensioning strands in the bottom and top flanges. This girder was designed to provide a comparison between the shear behavior of a post-tensioned girder (with a duct in the web region) and a prestressed girder without a duct. Although this girder did not contain a duct within the web it still failed due to crushing of the primary diagonal compressive strut. The primary difference between the failure mechanism observed in the

control test and the post-tensioned shear tests was the location of this crushing failure. Figure 11 (A) shows the initial crushing of the web concrete at the base of the diagonal strut near the beginning of the end-block transition. Figure 11 (B) shows the moment after failure as the entire web of the girder crushes. It is important to understand that Figure 11 was captured with a pair of high speed cameras and the time between photos was approximately one second.

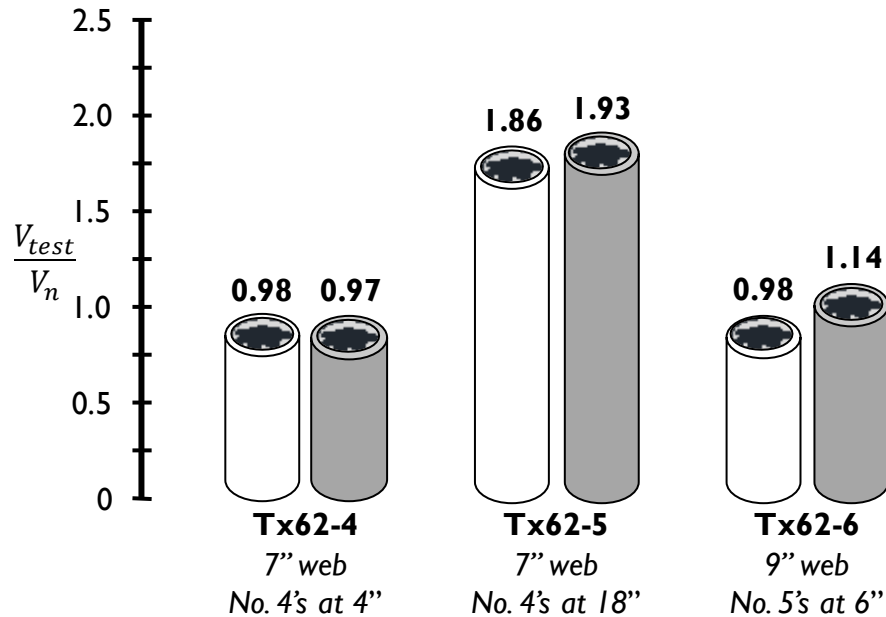
Figure 14: Effect of Duct Material on Girder Strength

(gray indicates steel post-tensioning duct; white indicates plastic post-tensioning duct)

Unlike the results of small-scale panel testing programs,^{2,8} the post-tensioning duct material had no discernable effect on the shear strength of the full scale girders. Three beams were cast which contained both plastic and steel post-tensioning ducts, which were coupled into a single tendon outside of the test region. These three beams allowed for a direct comparison of the effect of duct material on the shear strength of a post-tensioned girder because they isolated a number of other variables which could have influenced the shear behavior. The accuracy of the six tests on these three girders is illustrated in Figure 14. Although there is a slight variation between the tested and calculated capacities of each of these girders they are within the scatter of the data seen during this testing program as a whole. Moreover, these tests indicate that the severe reduction in strength seen in panel testing of plastic ducts does not hold true in full scale girder testing, and that the equations used for design should not follow calibrations from the small scale panel tests found in the literature^{2,8}.
