1 **EVALUATION OF A SPLICE CONNECTION FOR PRECAST CONCRETE PILES**

10
11 *Two flexural tests were performed for a connection for splicing precast concrete piles. The*
12 *splice consisted of steel male studs and female sockets attached with steel locking pins.*
13 *Internal forces in the splice were transmitted to the piles through #10 bars welded to the*
14 *back side of the splice assemblies. The splice connection exhibited experimental flexural*
15 *capacities of 273 kip-foot and 287 kip-feet. Peak capacities corresponded to crushing of the*
16 *concrete compression zone adjacent to the splice location. This report presents details of the*
17 *test program and theoretical calculations of flexural capacity. Comparison between*
18 *experimental and theoretical results suggest that the #10 bars were near ultimate capacity at*
19 *peak load.*

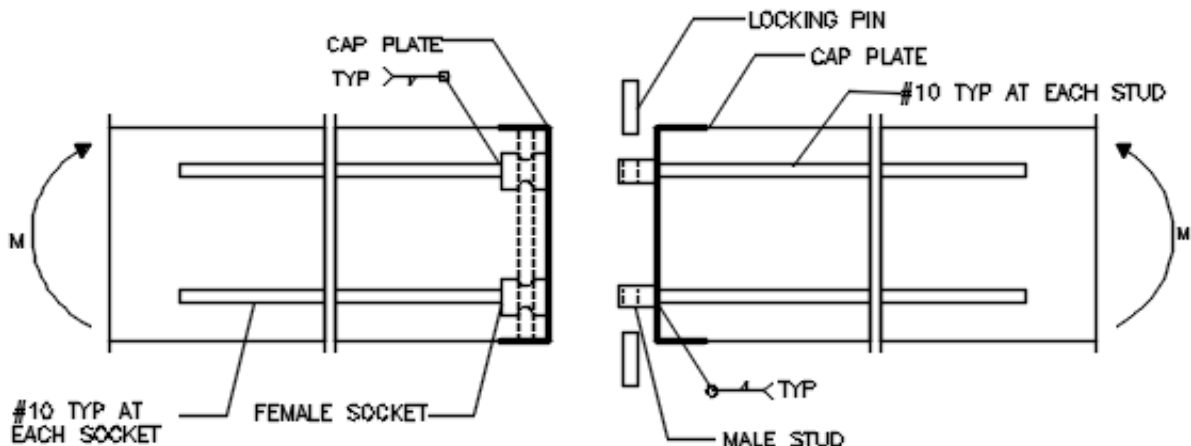
85 Working left-to-right in Fig. 2, the load path through the splice connection is as follows:
86 Flexural-tension force from the pile is transferred to #10 bars, which are welded to the back
87 of the socket. Forces are transferred between the socket and stud through a locking pin which
88 is inserted from the side after the two splice assemblies are joined. A #10 bar is welded to the
89 back side of the stud to receive forces from the stud and deliver them to the pile. The #10
90 bars extend four feet into each pile.

114
 115 Fig. 2 – Components in Pile Splice Connection
 116
 117
 118

- NOTES:**
- PRESTRESSING STRANDS NOT SHOWN FOR CLARITY
 - #10 BARS EXTEND 5'-0" FROM BACK OF STUD/SOCKET

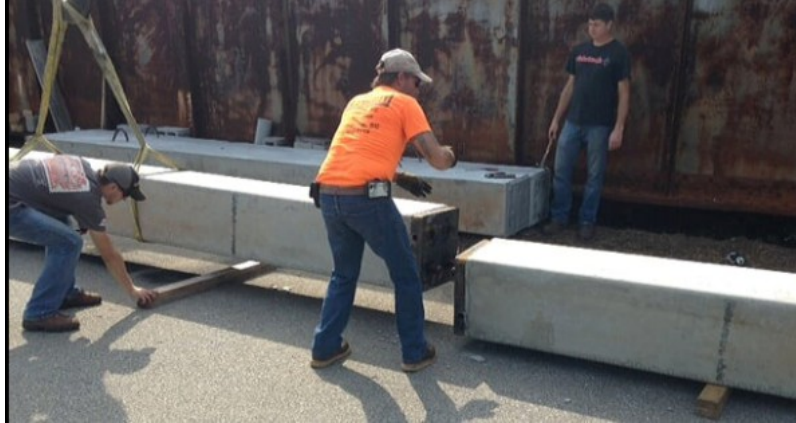
119
120 Fig. 3 - Pile supported by crane and wood dunnage
121

98 The piles were oriented horizontally end-to-end on the ground during the splicing process.
99 One of the segments was supported on wood dunnage and the other was supported by a crane
100 (Fig. 3). In order to get the locking pins to fit into the holes, the cap plates needed to be flush
101 against each other. This required some adjustments to the crane-supported pile segment.
102 Once aligned, the pins required 10-12 hits with a 2 lb hammer to be secured in place (Fig. 4).
103 The time from when that the segments were oriented end-to-end (Fig. 3) until the locking
104 pins were secured in place was approximately 10 minutes. After the segments were spliced,
105 they were lifted by crane to the testing bed (Fig. 5).

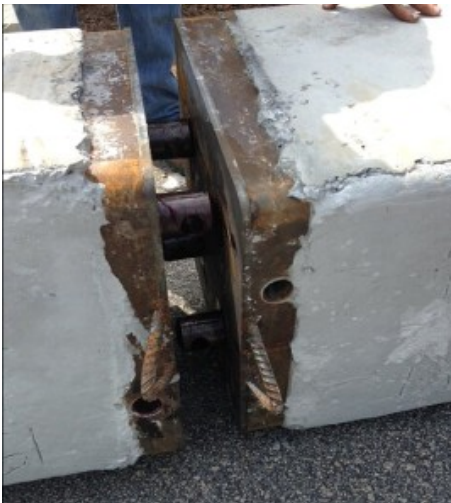
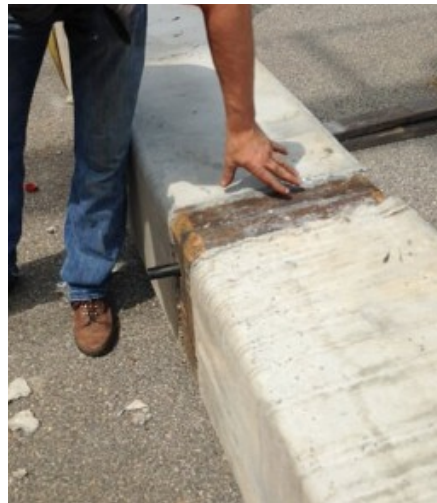
122
123 Fig. 4 – Splice connection during alignment (left) and installation of locking pins (right)
124

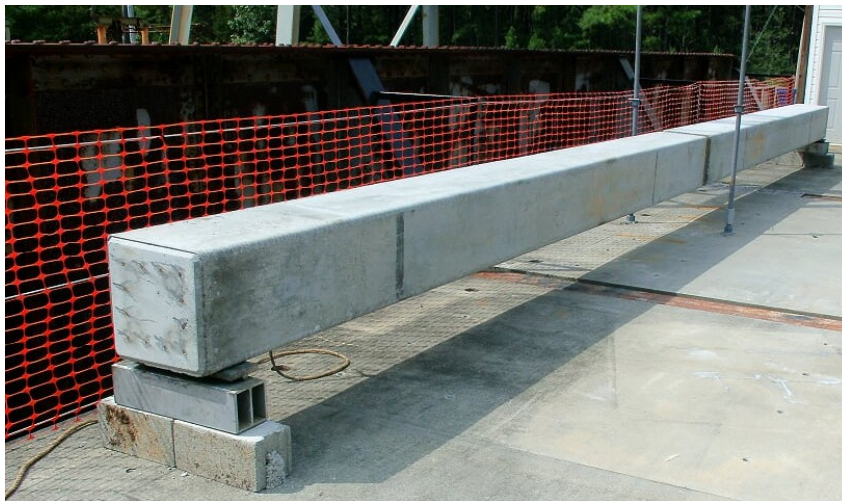
126 Fig. 5 – Segments spliced together and positioned on test bed
127

141 As shown in Fig. 5 and Fig. 7, the specimens spanned horizontally and were supported at
142 each end. The splice was located at mid-span. Load was applied through a steel spreader
143 beam that was centered over the splice. A hydraulic actuator applied load to the center of the
144 spreader beam (Fig. 8). Pressure in the hydraulic system was monitored and recorded during
145 testing using an electronic pressure gauge. The applied force was calculated by multiplying
146 the gauge pressure by the internal cross-sectional area of the jack. The pressure gauge was
147 calibrated prior to testing and found to be accurate to within +/- 0.5%.

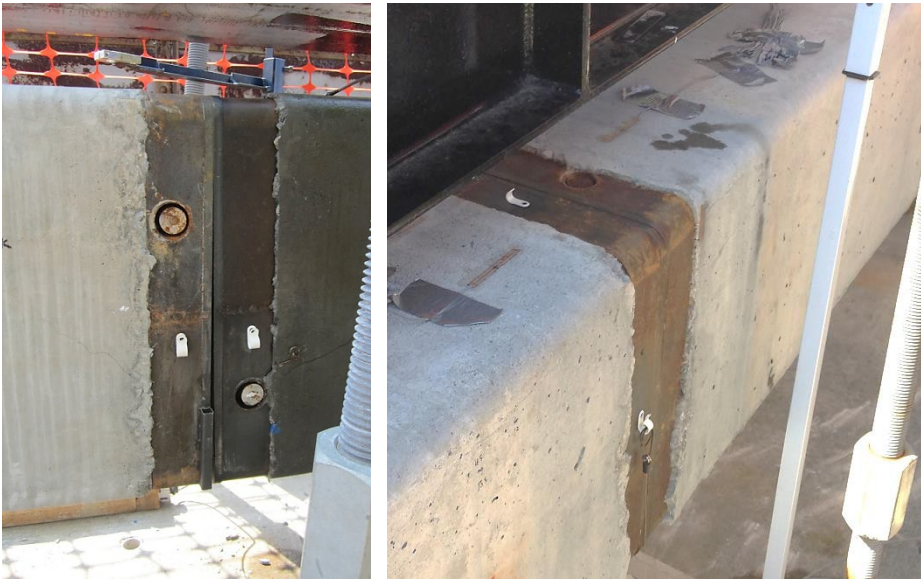
128 Two test specimens were built from four pile segments. The specimens were effectively
129 identical. The only difference between the specimens was orientation of the pins during
130 testing. Pins were located on the sides for Test 1 (Fig. 6 left) and on the top/bottom for Test
131 2 (Fig. 6 right). For piles supporting a bridge or other structure, flexural moments in the piles
132 can be applied to the splice along either or both axes. For this reason, both orientations were
133 tested in the experiments.
134

135
136 Fig. 6- Pin orientations for Test 1 (left) and Test 2 (right)

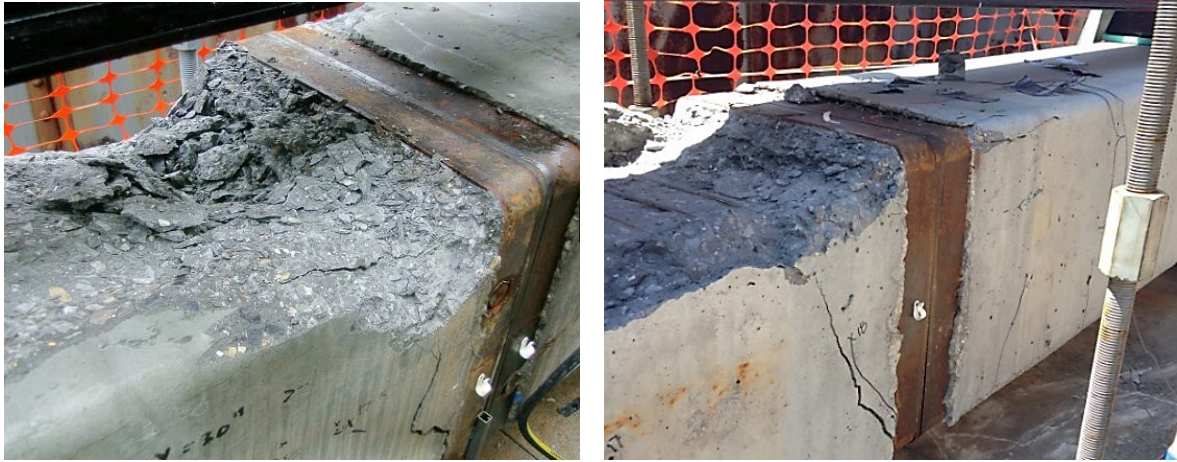
182 For both tests, peak load corresponded to crushing of the compression zone adjacent to the
183 splice. The portion of the concrete that spalled away at peak load was outside of the
184 transverse reinforcement that supported the core of the piles. Displacement at peak moments
185 for Test 1 and Test 2 were 4.5 inches and 7.3 inches, respectively. Crushing occurred on the
186 same side of the splice as the largest of the flexural cracks (Fig. 10). The additional
187 displacement observed in Test 2 is attributed to the separation between the concrete and the
188 splice assembly (Fig. 11).

Fig. 10 – Failure of compression zone of Test 1 (left) and Test 2 (right)

197 The post-test width of the cracks adjacent to the splice in Test 1 and Test 2 (Fig. 10) were
198 approximately 0.5”. The cracks were wider while the piles were under load; however, no
199 measurements of crack width were taken during loading. The width and location of the crack
200 indicate that the #10 bars and splice assembly did not maintain strain compatibility with the
201 concrete at peak loads. Separation of the concrete and splice observed in Test 2 also supports
202 this notion. Loss of strain compatibility is considered in the theoretical calculations presented
203 in the next section.

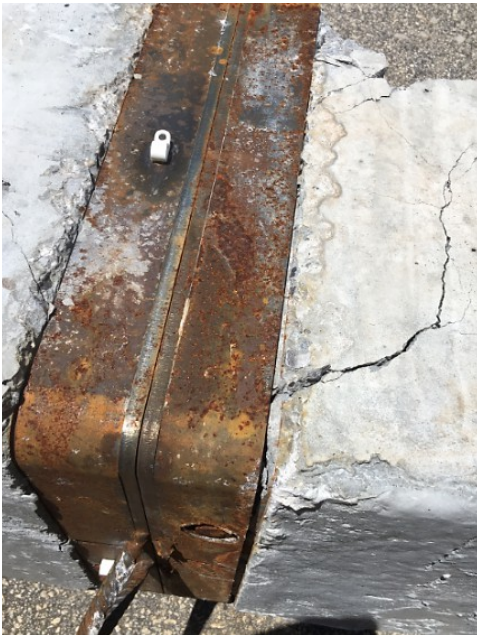
Fig. 11- Gap between splice assembly and the concrete in Test 2

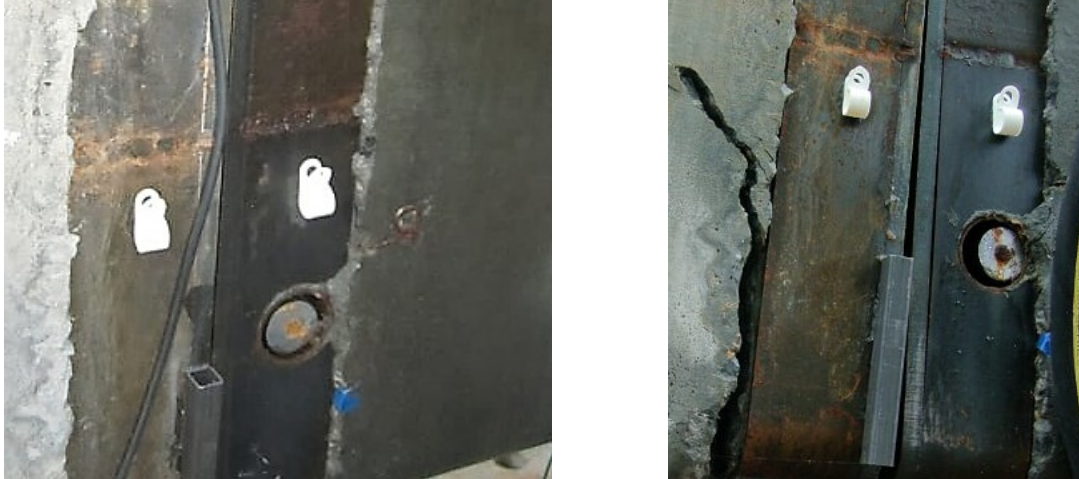
190 For Test 1, popping noises were heard as the test approached the peak moment. The noises
191 seemed to come from the splice location, and are attributed to bending of the locking pins
192 and separation of the splice assembly and #10 bars from the concrete. For both tests, the
193 locking pins were initially centered in the holes, but testing caused permanent deformation of
194 the pins towards the side of the holes (Fig. 12). Deformation was more obvious in the pins on
195 the flexural-tension side.

216
217 Fig. 12 – Test 1 location of locking pin prior to (left) and after (right) load tests
218
219
