ADJACENT BOX BEAM BRIDGE REHABILITATION USING VERY HIGH PERFORMANCE CONCRETE

Carrie Field, Via Dept. of Civil Engineering, Virginia Tech, Blacksburg, VA
Carin Roberts-Wollmann, PhD, PE, Via Dept. of Civil Engineering, Virginia Tech,
Blacksburg, VA
Thomas Cousins, PhD, PE, Glenn Dept. of Civil Engineering, Clemson University,
Clemson, SC

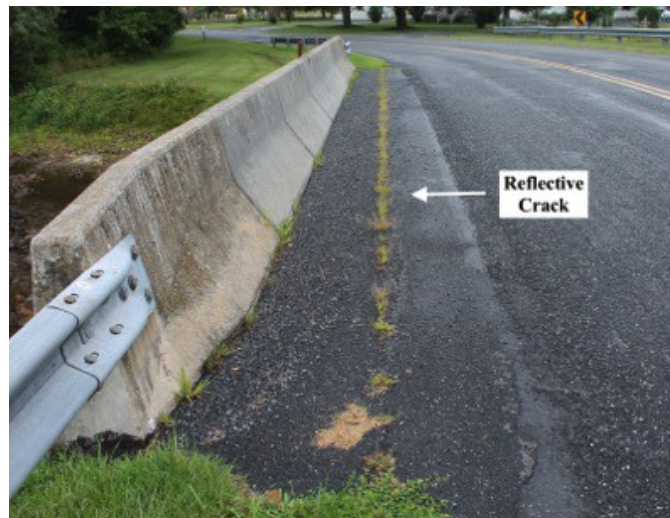
Figure 1. Reflective cracking

Adjacent prestressed beam bridges are comprised of either precast box beams or voided slab sections as the superstructure with a deck or topping placed directly on top. The precast members are traditionally connected with a longitudinal shear key filled with grout and transversely tied at intermittent diaphragm locations. This enhances transverse load transfer between neighboring adjacent members. By using precast members, these bridges are fairly simple and can be rapidly constructed. Adjacent box beam bridges are an efficient design for short spans and bridge locations with low vertical clearance requirements. However, over time the traditional grout shear key tends to deteriorate causing reflective cracking to propagate through the wearing surface as shown in Figure 1.

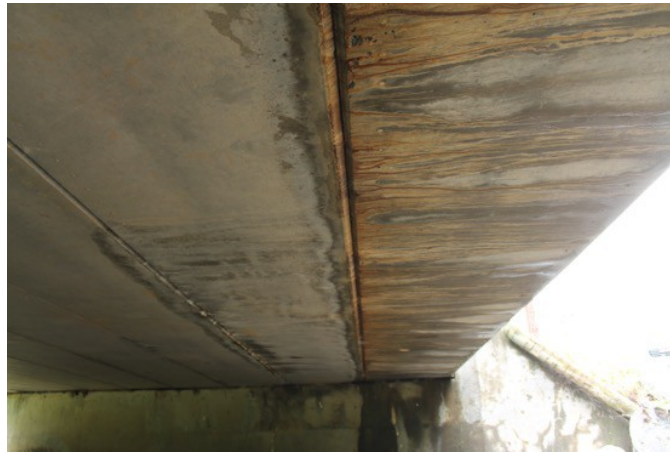
Figure 2. Leaking joint

These reflective cracks allow water and corrosive agents, such as deicer salts, to penetrate down into the joints, which, if left uncorrected, can eventually cause the reinforcing and prestressing steel in the precast members to corrode. This leads to the need for bridge repair or replacement well before the end of its anticipated design life, negating the assessed economic value of the adjacent member system. Reflective cracking allowing water to leak through the joint can be seen in Figure 2, which is the underside of the joint in Figure 1.

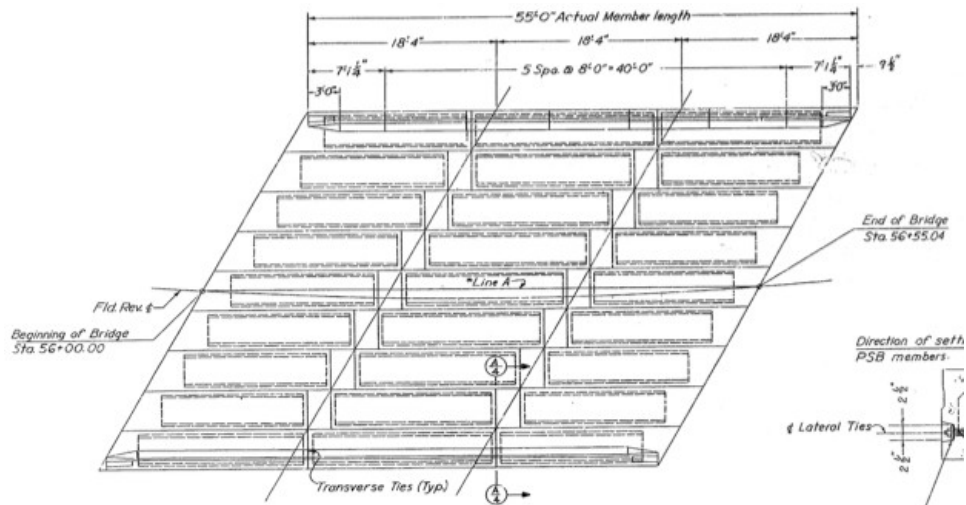
Figure 3. Plan view of Buffalo Branch Bridge

The most recent VDOT visual inspection of the Buffalo Branch Bridge performed in January 2014 stated that water and efflorescence were seeping through the furthest downstream joint for the full length. Evidence of leakage was also seen on the second downstream joint and the furthest upstream joint within 6 ft of the abutments. A picture of the leaking downstream joint is shown in Figure 2. The plan and cross-section views of the bridge are shown in Figure 3 and Figure 4. The 55 ft span bridge consists of nine adjacent box beams with transverse ties at the third points.

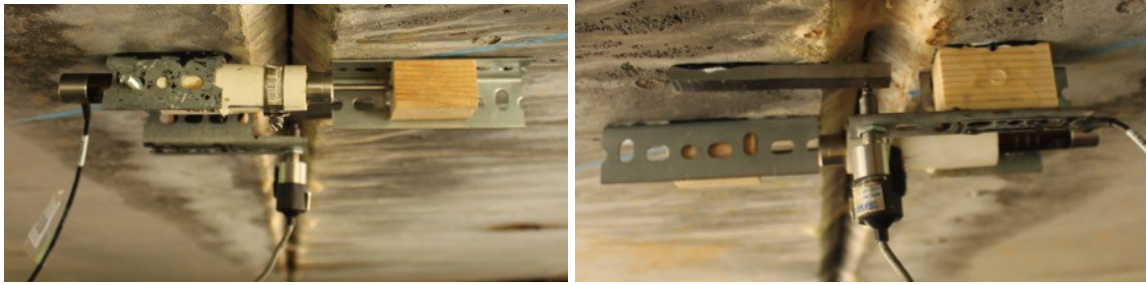
Figure 8. Horizontal and Vertical LVDTs

LVDTs were used to measure the horizontal and vertical relative displacements of adjacent box beam members. The LVDTs were strategically placed at the location of the highest expected relative girder displacements. Horizontally and vertically oriented LVDTs are shown in Figure 8.

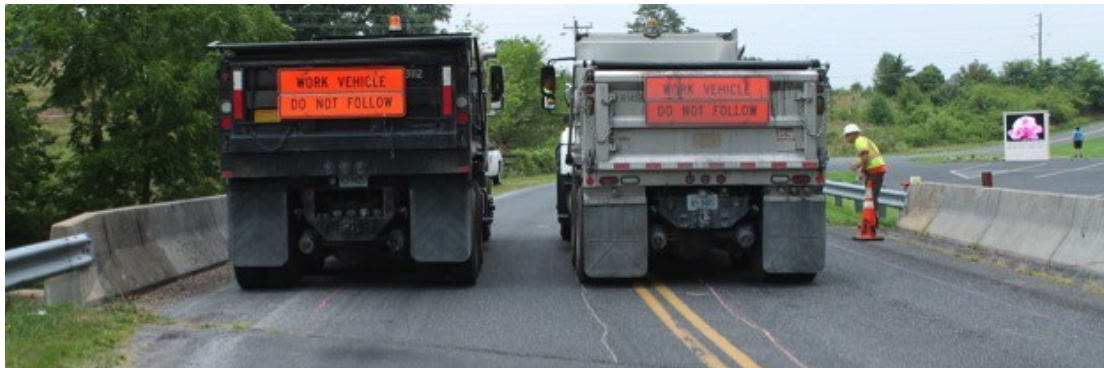
Figure 11. Test trucks crossing for Load Case 3

A total of six quasi-static load cases were run by driving the same loading trucks over the bridge. Each load case was repeated three times. The drivers maintained the slowest possible speed of two to three mph when crossing the bridge. A two truck crossing is shown in Figure 11.

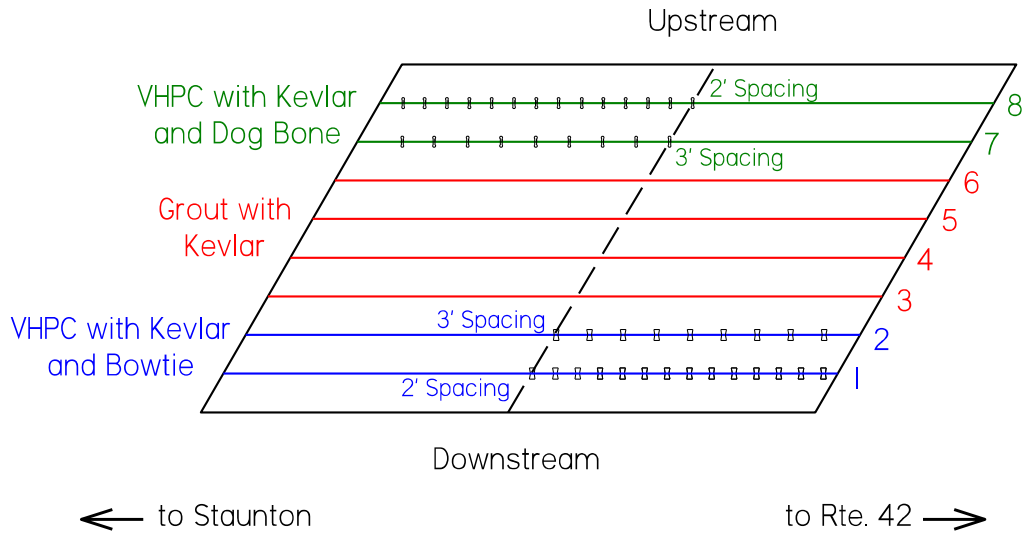
Figure 15. Buffalo Branch Bridge rehabilitation plan

The proposed rehabilitation plan for the Buffalo Branch Bridge is shown in Figure 15. The plan was for all of the joints to be completely cleaned out. The four interior joints were to be replaced with fresh grout and a Kevlar and epoxy topping. The four exterior joints were to be replaced with VHPC and geometric cutouts at the obtuse skew corners were to be added. Figure 16(a) shows the dimensions for the dog bone cutouts to be used in the upstream joints. Figure 16(b) shows the dimensions for the bowtie cutouts to be used in the downstream joints. Laboratory testing was performed on a variety of cutout shapes and the dogbone and bowtie were determined to be the two best alternatives. The depth of the cutouts was to be 4 in.

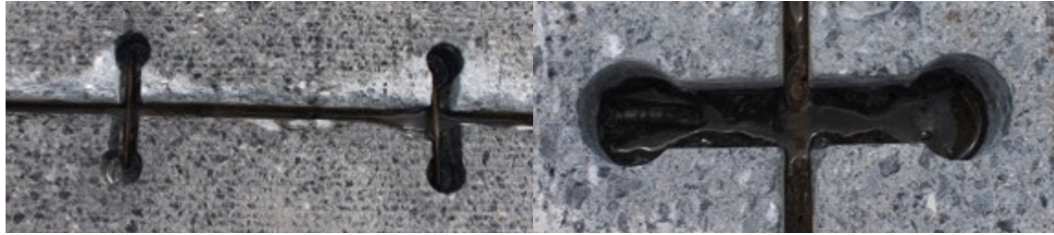
Figure 17. Dog bones

in core drill. Next, the inside was cut with a saw blade and the whole dog bone was chiseled out. Completed dog bone blockouts are shown in Figure 17.

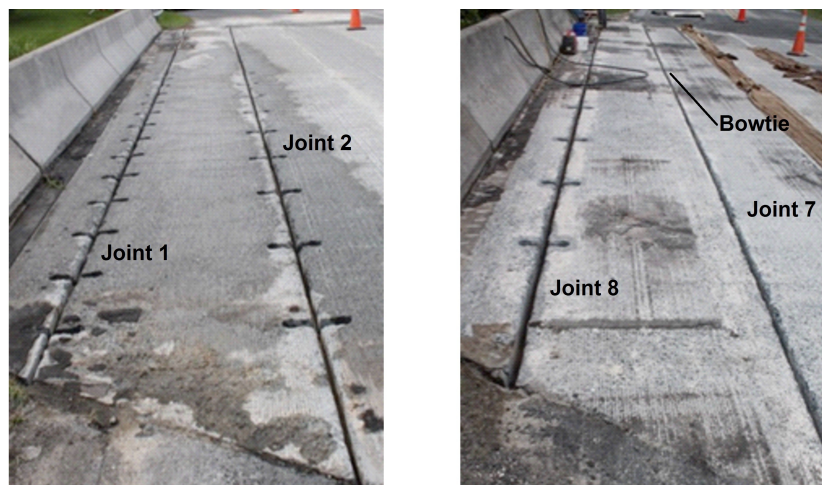
a) Joints 1 and 2

b) Joints 7 and 8

Figure 18. Final configuration of blockouts

Figure 18(a) shows joint 1 with dog bones spaced at 2 ft and joint 2 with dog bones spaced at 3 ft as specified in the proposed rehabilitation plan except using dog bones instead of bowties. Figure 18(b) shows Joint 7 with only a bowtie at midspan and Joint 8 with dog bones spaced at 4 ft. The joints were sand blasted and sprayed with a hose to create a clean, SSD condition immediately before placing the VHPC.

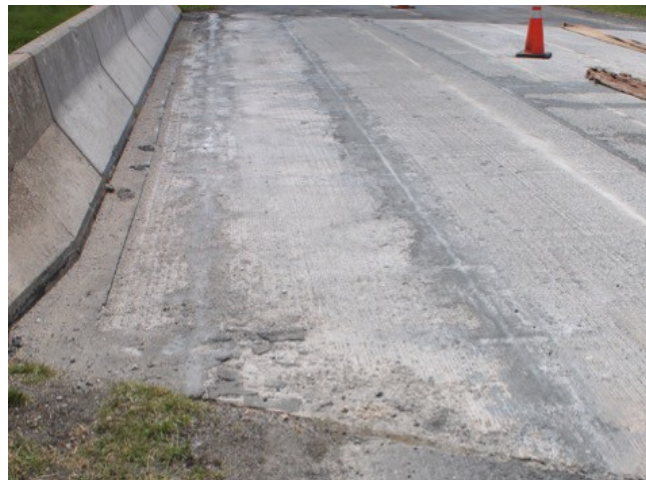
Figure 19. Completed joints

The VHPC began to set very quickly, as evident by a skin forming on the surface of the joint. Once the VHPC was placed in the entire length of the joint, the joint was covered with wet burlap to provide a moist cure. On day one, the downstream joints were completely placed by 12:00 pm and on day two the upstream joints were completely placed by 1:00 pm. At 5:00 pm each day, the traffic lane traveling over the newly placed joints was opened back up. Therefore, the VHPC was allowed to moist cure for five hours on day one and four hours on day two before traffic was directed back on it. Figure 19 shows the downstream joints that were placed on day one after being driven on from 5:00 pm to the following morning. The joints did not show visual signs of damage due to exposure to traffic this soon after placing the VHPC.

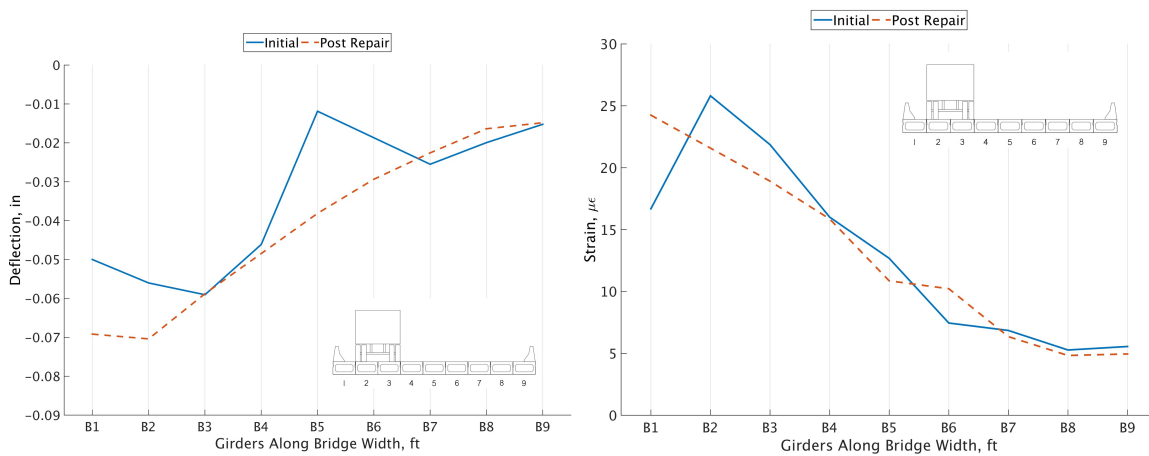
Figure 20. Load case 1 deflection and strain comparisons

Live load tests of the Buffalo Branch Bridge were conducted before and after the repair of the longitudinal joints. Figure 20 through Figure 25 present comparisons of the pre-repair (initial) and post-repair response of the bridge. The plotted lines are the averages of the three truck crossings for each load case. As can be seen in the plots, the pre- and post-repair behaviors are not significantly different, except for the behavior of Beam 1. The worst joint was between Beam 1 and Beam 2, and in pre-repair load cases 1, 2, and 3, which heavily loaded that side of the bridge, the deflections and strains in Beam 1 are smaller in the pre-repair condition than the post-repair condition. This would indicate that post-repair the beam is better tied to the system and carries a larger percentage of the total load. For load cases 4, 5 and 6, there is not a significant difference in behavior because the joints on the heavily loaded side of the bridge were in much better condition pre-repair.

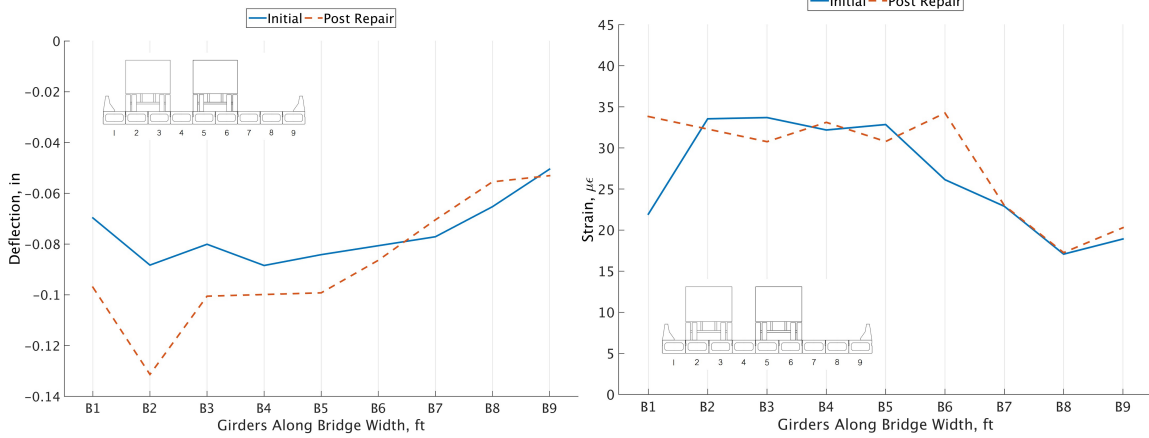
Figure 22. Load case 3 deflection and strain comparisons

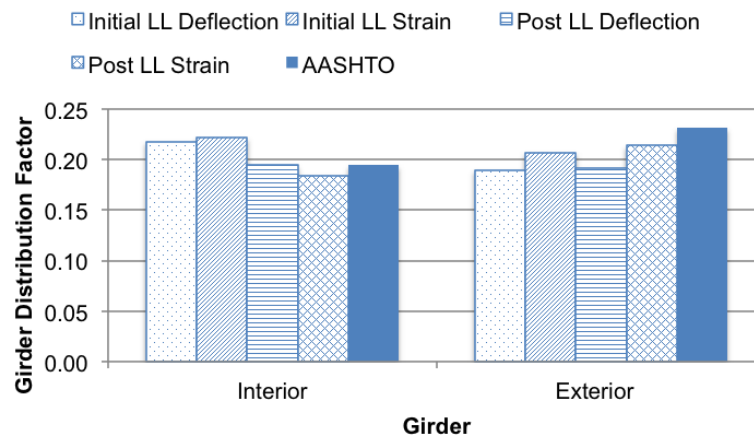
Figure 28. GDF comparison for one design lane loaded

A comparison of the GDFs obtained using the AASHTO method and the test results is shown in Figure 28 for one design lane loaded and in Figure 29 for two or more design lanes loaded. The maximum GDFs calculated from the live load test data are presented in two groups, the maximum of the seven interior girders and the maximum of the two exterior girders.

The GDFs obtained from the AASHTO method and both live load tests are all similar. The AASHTO method over predicts the GDFs leading to a conservative design for all cases except the interior girders with one truck load pre-repair. The GDFs measured for interior beams with one lane loaded after repair were smaller and the GDFs for the exterior beams were larger. This is another indication that the repair results in better transfer of load to the exterior beams.
