FLEXURAL STRENGTHENING OF PRECAST CONCRETE BEAMS USING A HIGH STRENGTH FIBER-REINFORCED CONCRETE LAMINATE

Matthew K. Swenty, PhD, PE, Virginia Military Institute, Lexington, VA
Kacie D'Alessandro, PhD, Washington and Lee University, Lexington, VA
Andrei Ramniceanu, PhD, Virginia Military Institute, Lexington, VA
Zach Thoele, Virginia Military Institute, Lexington, VA
Charles Pitchford, Virginia Military Institute, Lexington, VA

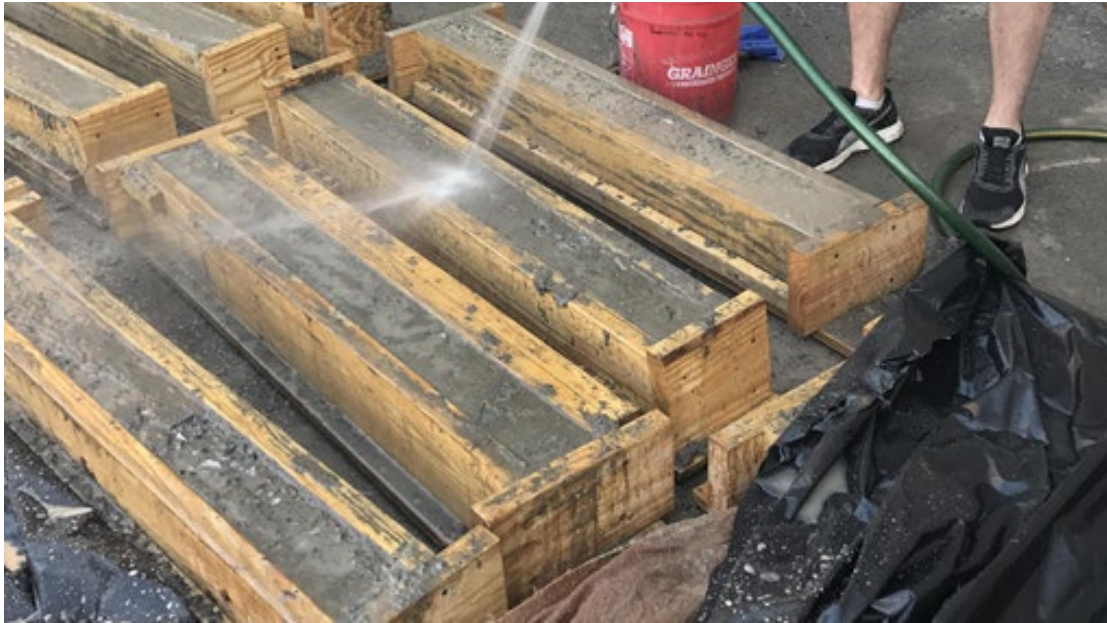
Fig. 4 Preparing the exposed aggregate surface on the HSFRC laminate face.

The HSFRC laminates and the embedded #3 reinforcing bars were added together. HSFRC was treated as a self-consolidating concrete, similar to UHPC, during casting. To facilitate optimal fiber alignment, the HSFRC was placed in one end of the beam mold and allowed to flow across in the longitudinal direction to fill the mold. HSFRC was not tamped or vibrated; rather, beam molds were tapped on the outer edges to aid HSFRC flow and consolidation. The beams were cured in a controlled environment of approximately 70°F and 100 percent humidity until the day of testing. The beams were removed from the curing chamber and tested in bending 21 days after casting the laminates. The beams with HSFRC1 are referred to as Laminate1 beams and those with HSFRC2 are referred to as Laminate2 beams.

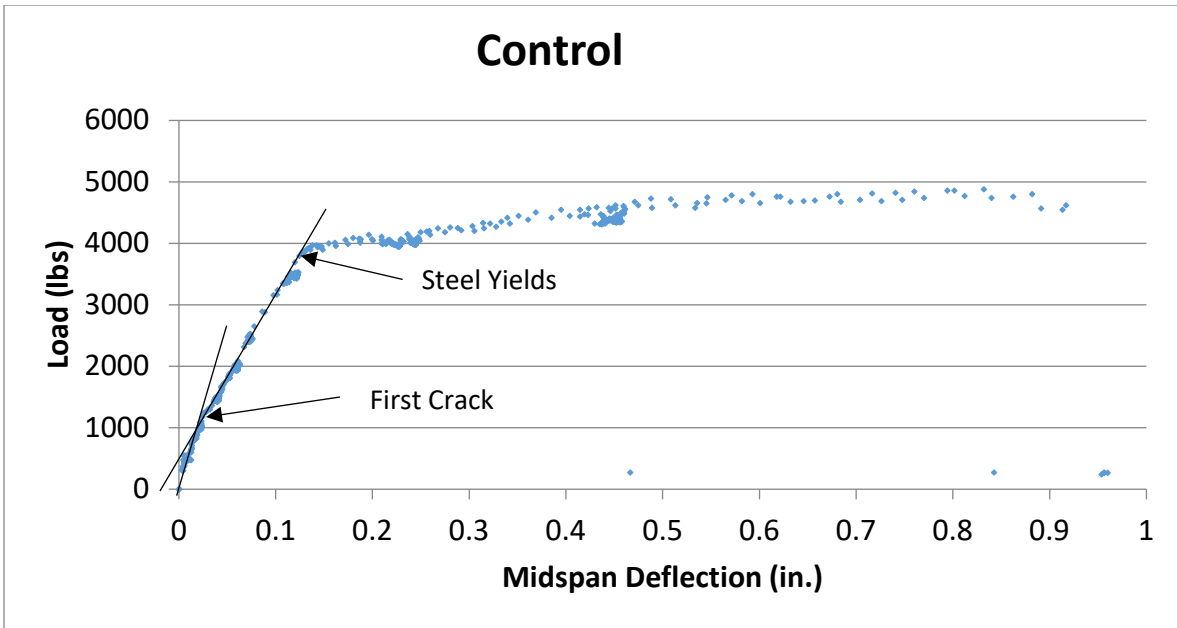
Fig. 5 Load versus midspan deflection of a typical control beam.

The first crack was measured using the plot of load versus deflection and the DEMEC strain data. As shown in Figure 5, the control specimens had very distinct first crack and yielding points on the plots. The visual cracking patterns and DEMEC data confirmed these results. On average, the control beams cracked within 15 percent of the computed cracking moment (Table 5).

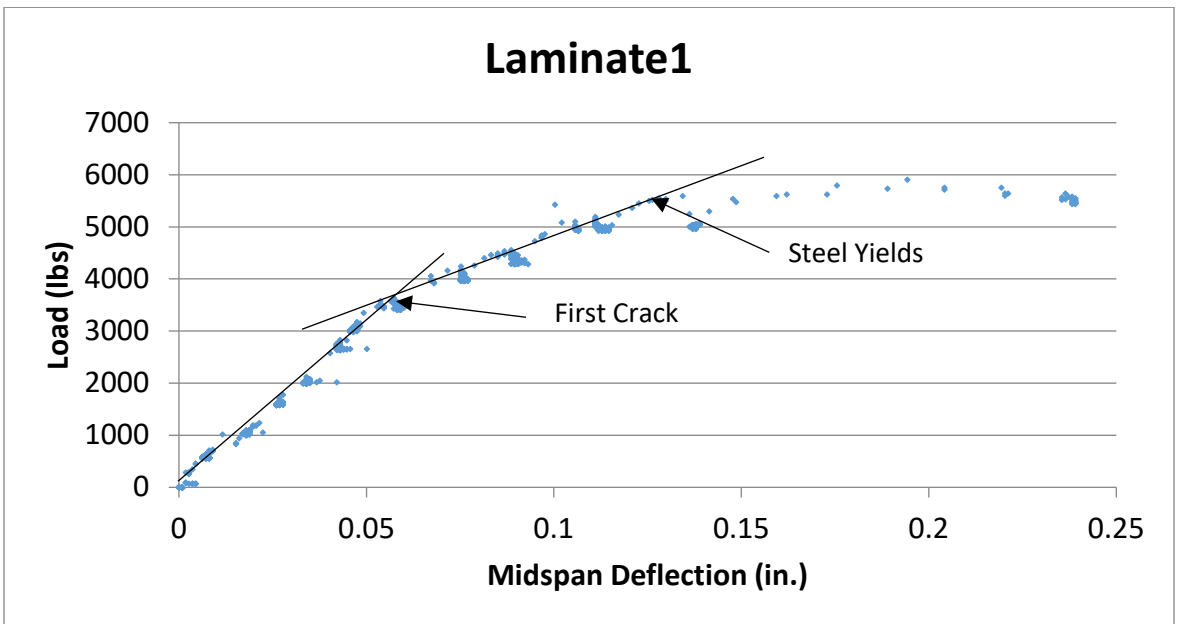
Fig. 6 Load versus midspan deflection of a typical Laminate1 beam.

The laminate beams exhibited very different behavior based on the unique material properties of the HSFRC laminate. The Laminate1 beams had 0.5 in. long, straight steel fibers, while the Laminate2 beams had 1.5 in. long, bent steel fibers. In both cases the laminate beams did not show a distinct crack at a load near the computed cracking load. Instead, as the beam started to crack, the fibers arrested the crack. As shown in Figure 6, the first crack for Laminate1 beams was closer to the yielding of the steel. The Laminate2 beams never had a distinct first crack as shown in Figure 7. The Laminate2 behavior can be contributed to the longer steel fibers which continued to arrest the cracks up until the yielding of the steel. Prolonged crack arrest was possible in the HSFRC laminates because fibers bridged cracks, indicating the placement procedures for HSFRC were successful in orienting fibers in the longitudinal direction of the beam. After the steel yielded, the deflections increased and cracking became more pronounced in all laminate beams.

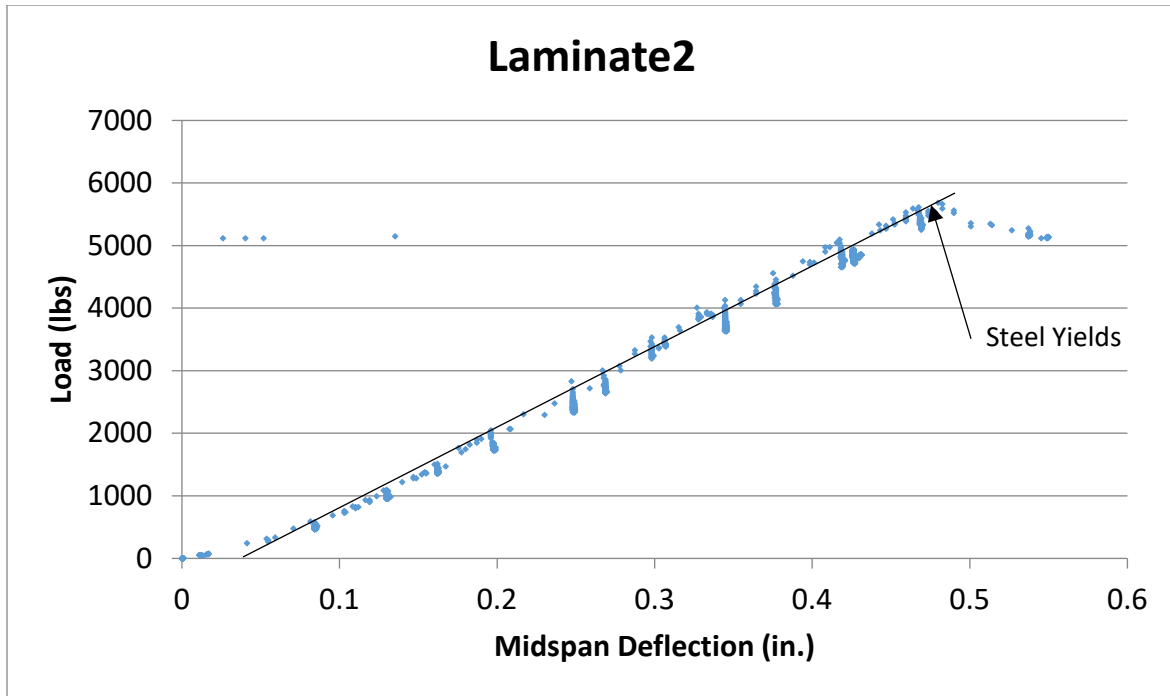
Fig. 7 Load versus midspan deflection of a typical Laminate2 beam.

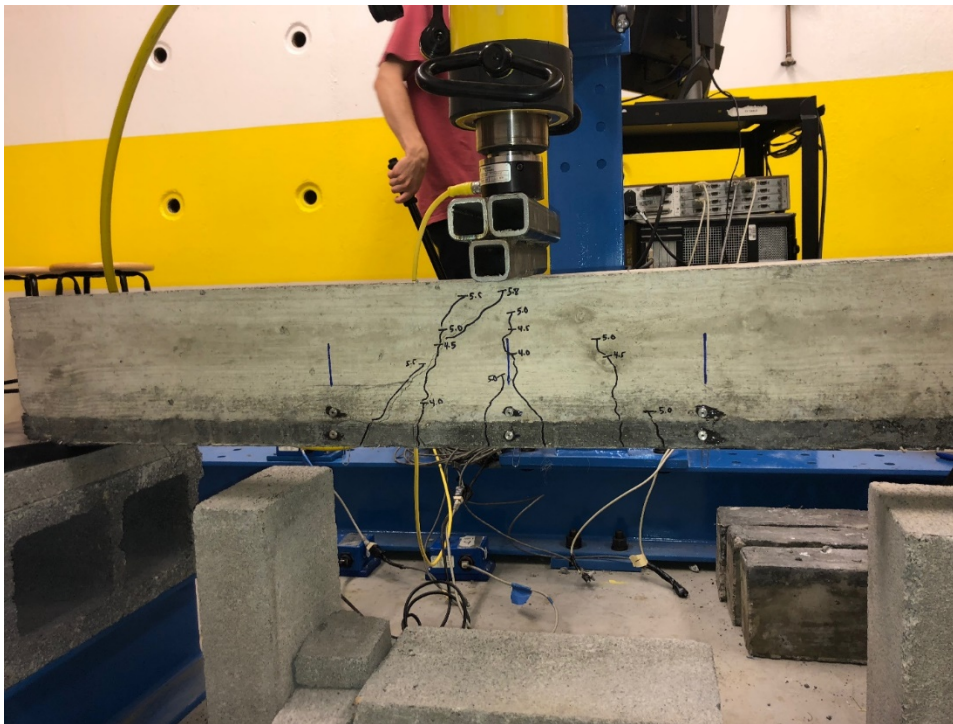
Fig. 9 Laminated beam cracking pattern at ultimate load without any delamination.

The Laminate1 beams had two different failure modes. The first mode was a post steel yielding, concrete crushing failure referred to as an under-reinforced failure. However, what made this failure unique was the laminate started to delaminate at the ultimate load. The failure of the compression concrete and laminate occurred simultaneously in these beams. The other failure mode was a steel rupture failure (Figure 9). In this case the laminate remained intact and the concrete did not crush until after the steel ruptured. As noted previously, all failure loads were at least 35 percent beyond the nominal moment capacity (Table 4).

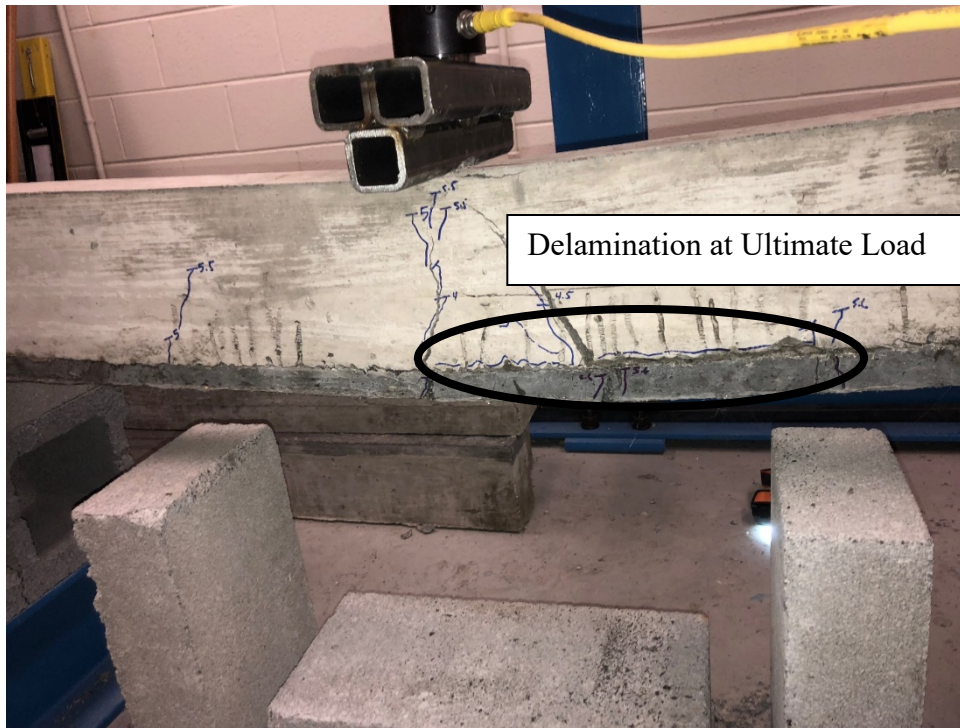
Fig 10 Laminate2 beam cracking pattern at ultimate load with delamination.

The Laminate2 beams had two different failure modes. The first mode was a post steel yielding, concrete crushing failure referred to as an under-reinforced failure. However, what made this failure similar to Laminate1 beams was the laminate started to delaminate at ultimate load (Figure 10). The failure of the compression concrete and laminate occurred simultaneously in these beams. The other failure mode was a traditional post steel yielding, concrete crushing, under-reinforced failure. In this case the laminate remained intact and the failure looked identical to the control beams. As noted previously, in all failure modes the failure loads were at least 39 percent beyond the nominal moment capacity (Table 4).
