# Joint Heating Allows Winter Construction on Linn Cove Viaduct

## Synopsis

Winter erection of precast concrete segments is always difficult when epoxy is used in the joints, because this material will not harden when temperatures fall below a certain level.

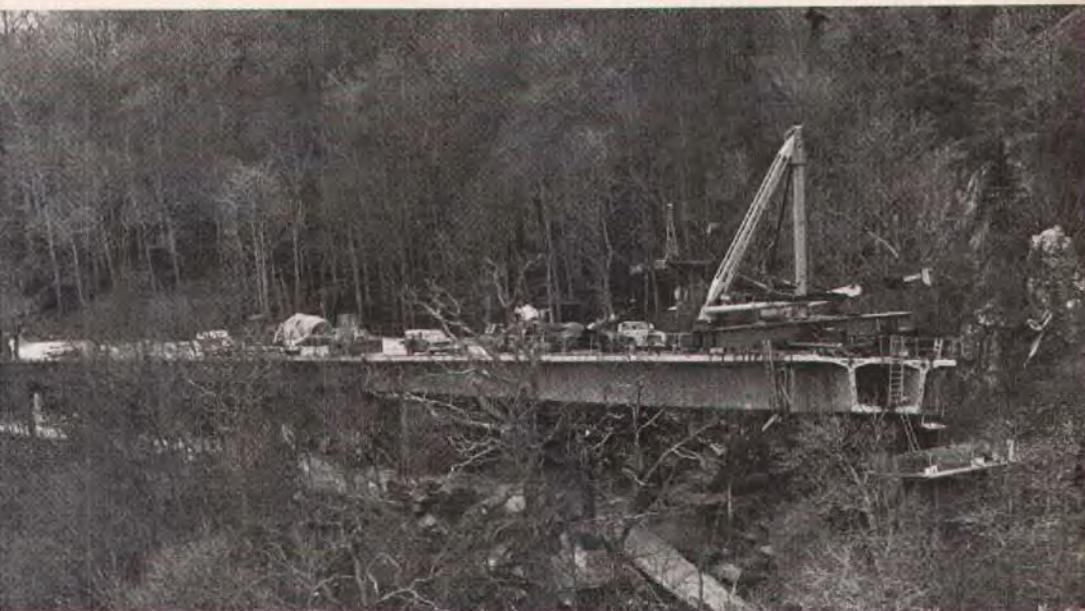
Fig. 1. Linn Cove Viaduct constructed with precast segments erected by progressive placing. This photo shows progress through February 1982.

**T**he Linn Cove Viaduct, located near Grandfather Mountain in North Carolina, is a 1243-ft (379 m) multispan precast segmental bridge being erected by the progressive placing method. Fig. 1 shows the construction progress through February 1982.

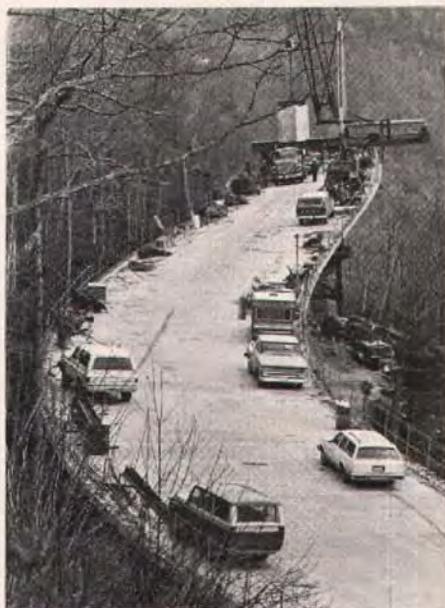
Fig. 2. All substructure and superstructure erection is being done from the top. Here, a precast pier segment is being lifted by the stiffleg crane.

The design of this project was complicated by the fact that the surrounding terrain is among the most rugged and environmentally sensitive in the eastern part of the United States. The use of precast segmental construction for both sub- and superstructure construction, with all erection being done from the top (Fig. 2), was the solution chosen to the challenge of building the

All materials, including microshaft reinforcement, subfooting, footing concrete, and pier segments, are placed with the stiffleg crane mounted on the end of the completed superstructure. The stiffleg is also used to erect the superstructure segments. A general description of progressive placing erection is included in References 1 and 2.

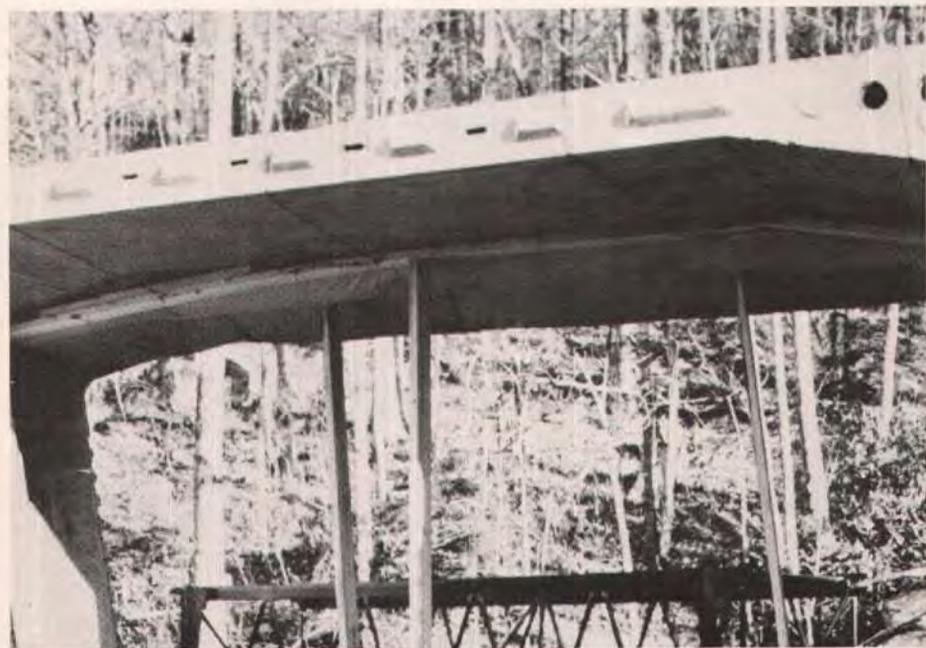
Fig. 4. The test segment being heated with an electric blanket. The blanket was wrapped around the edge of the segment and fastened.

the top slab thermocouples was heated from both directions. No insulation was provided, and the thermocouples in the bottom slab received no artificial heat. Fig. 4 shows the test segment with the blanket as placed for Tests II and III. Table 2 shows the data for Test II.

Test III was run with the same blanket arrangement as Test II (see Fig. 4). As mentioned before, this test was run at night and somewhat later in the year to test the blankets in the absence of sun and with colder weather. Table 3 presents the data taken for Test III.

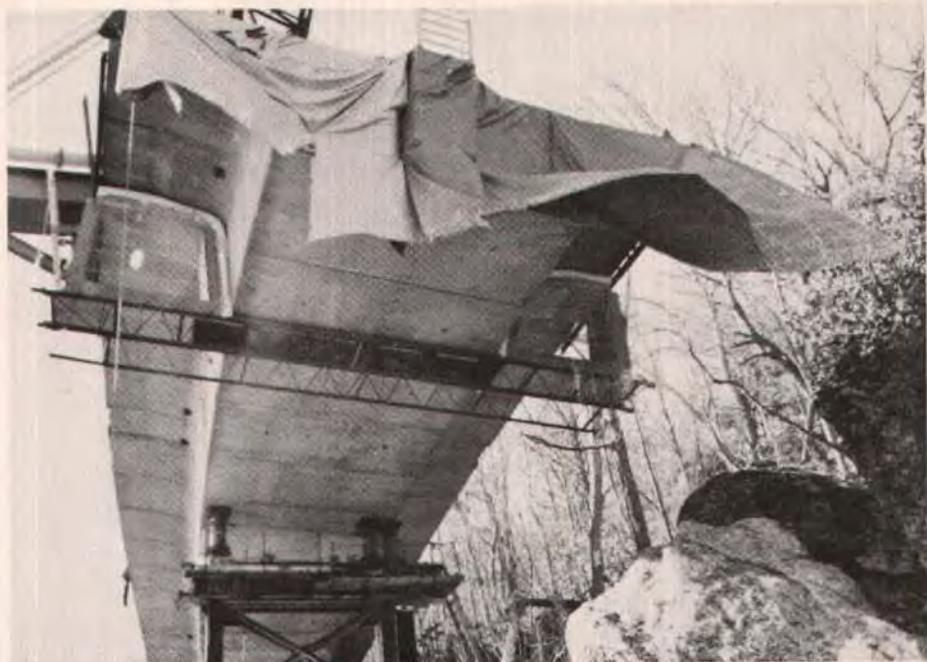
Fig. 6. The foam on the edges of the heating frame provided a good seal as the frame was moved from joint to joint around the curve.

Fig. 6 shows the insulating frame in place under the cantilever. This bridge has a very complicated geometry, with S curves, transitions, and super-elevations, but the foam gasket on the inside provided sufficient adjustment to seal around the joints as the curve shown in the photo was negotiated. The frame was suspended by and traveled along steel rails which were temporarily attached to the underside of the curb areas.

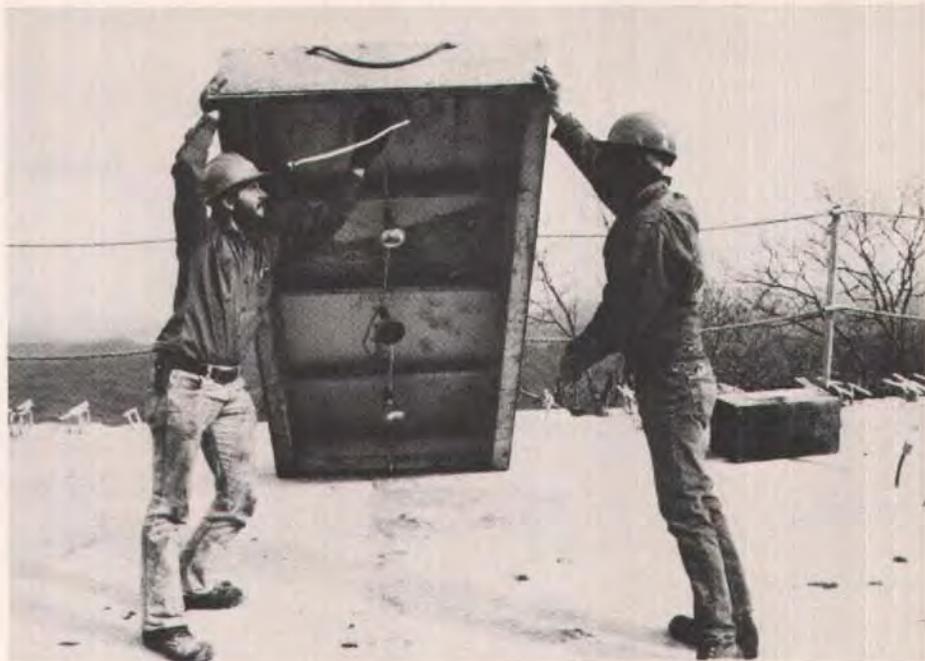
Fig. 7. Heating box, built with plywood and insulated with styrofoam, for heating the top of the joint.

As an alternative, the contractor then built four wooden boxes, 4 ft (1.2 m) wide, which when placed end-to-end would extend across the entire width of the deck. The boxes were insulated with styrofoam on the inside and each was wired for four electric heating lamps (Fig. 7). This system was very effective for heating the top slab joint. Also, as long as enough replacement heat lamps were kept on hand, this system was much more durable.

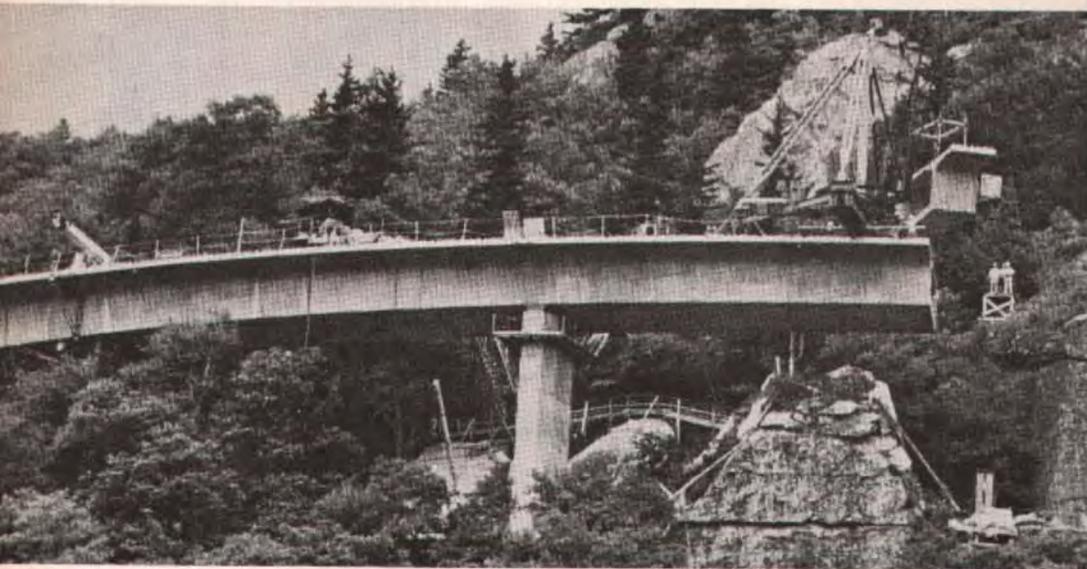
After being delivered over completed portion of bridge, segment is lowered into place, making superstructure 77 ft (23.5 m) in one directional cantilever.
