# Evaluation of Degree of Rusting on Prestressed Concrete Strand

*Presents a procedure for classifying the degree of rust on a piece of prestressing strand and discusses the reasons for acceptance or rejection of each classification. Visual standards are developed by which inspectors can identify the degree of corrosion at which pitting occurs.*

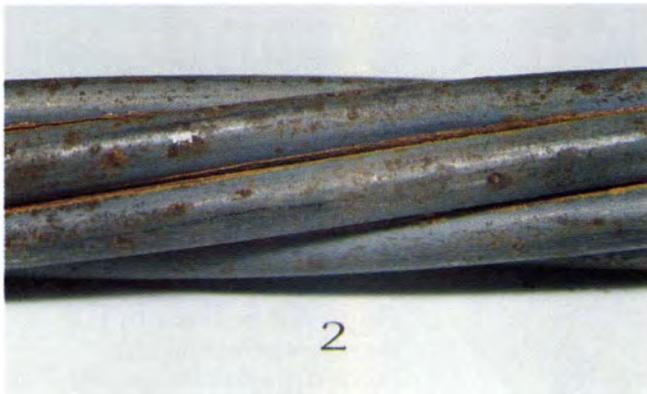
Photo 2. Strand surface before cleaning.

Photo 2A. Strand surface after cleaning.

Photo 1 represents a new strand with no rust and has a bright surface. Photos 2 through 6 illustrate various amounts of corrosion on strand samples that were exposed to a corrosive environment for different lengths of time and include some pits that are to be considered cause for rejection.

It is the opinion of the writer that Picture Sets 1 through 3 are acceptable. Picture Set 4 is borderline and is subject to discussion, agreement or compromise. Some engineers may find this level of rusting objectionable for critical applications. Picture Sets 5 and 6 are pitted and unacceptable.

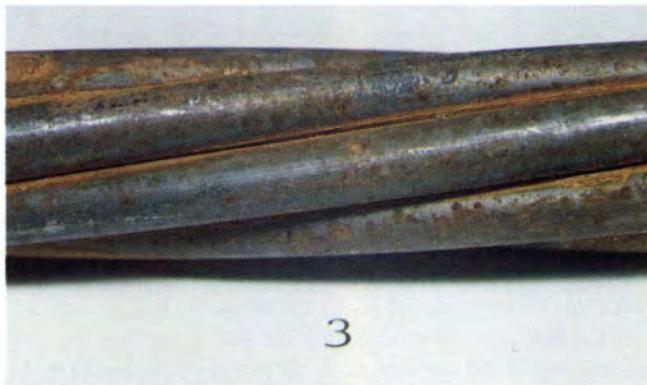
Photo 3. Strand surface before cleaning.

Photo 3A. Strand surface after cleaning.

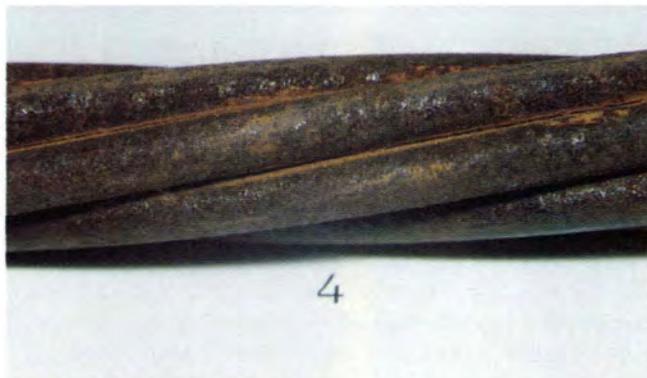
Photo 4. Strand surface before cleaning.

Photo 4A. Strand surface after cleaning.

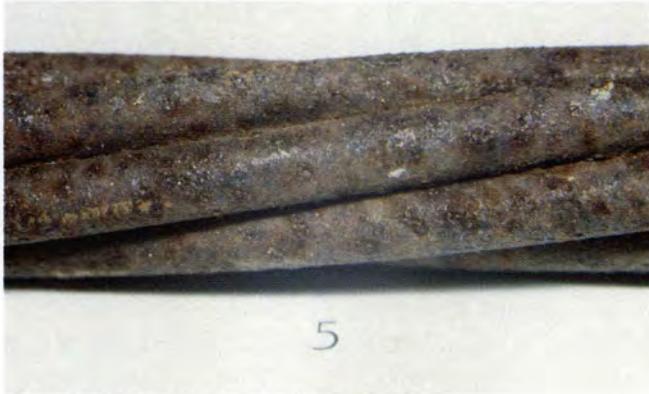
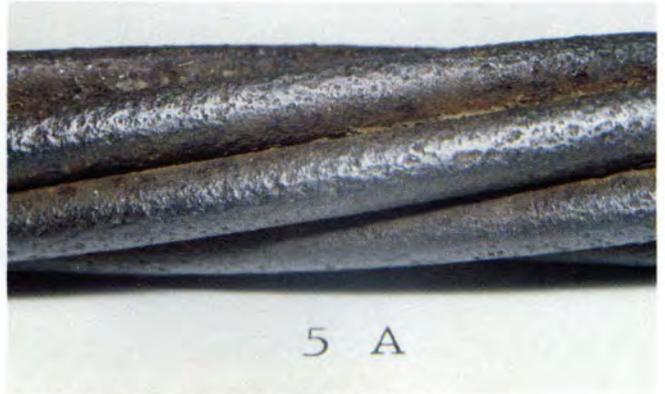
Photo 5. Strand surface before cleaning.

Photo 5A. Strand surface after cleaning.

The differences in values between Samples 1 through 4 are within the normal variation in the testing procedure and equipment. Samples 5 and 6 showed a significant drop in breaking strength compared to Sample 1 because of excessive pitting, as shown in Photos 5 and 6 and also in Photomicrographs 5 and 6. However, the breaking strengths are high enough to meet the minimum requirement of ASTM A 416 because the loading was axial and the decrease in cross-sectional area was very small.

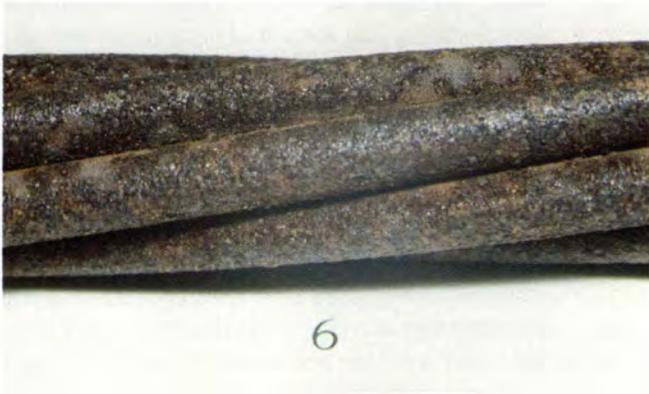
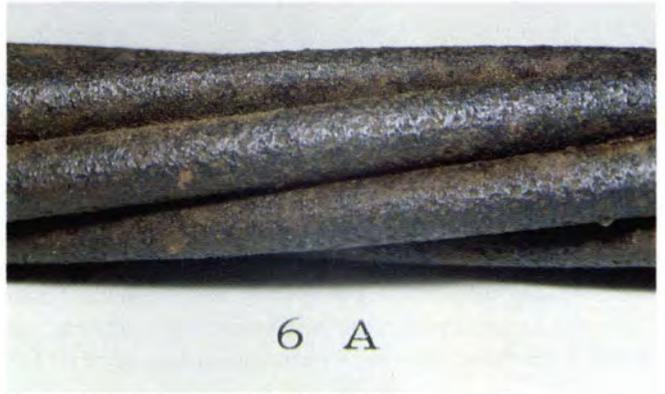
Photo 6. Strand surface before cleaning.

Photo 6A. Strand surface after cleaning.

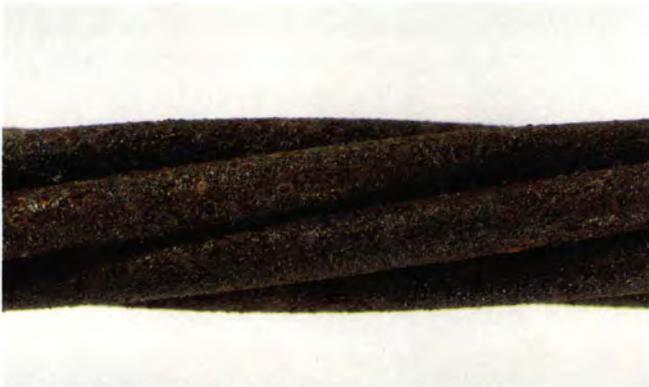
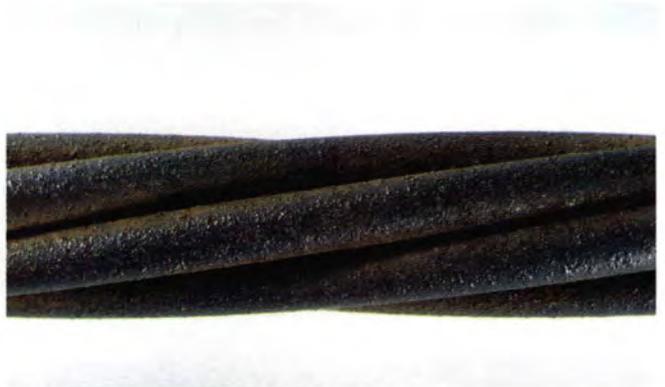
Photo 7. Strand surface before cleaning.

Photo 7A. Strand surface after cleaning.

The corrosion and pitting in the center wire were examined. A rusty strand sample shown in Photo 7 has corroded the outer wires with the same degree of pitting as in Picture Set 5. After cleaning with a Scotch Brite pad, the pitted surface is revealed as shown in Photo 7A.

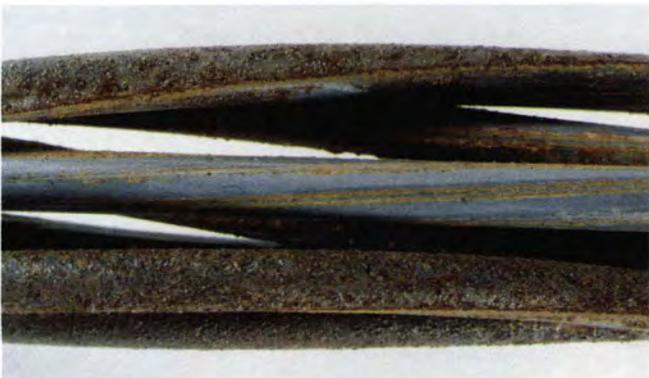
Photo 8. Strand surface before cleaning.

Photo 8A. Strand surface after cleaning.

When the strand was opened by unstranding the outer wires, the center wire showed that it was not pitted. A closeup picture of the center wire after unstranding is shown in Photo 8. The center wire did not show any pitting, as shown in Photo 8A, after cleaning with the Scotch Brite pad.

These two pictures indicate that pitting due to corrosion takes place at the outer wires, which are exposed to a humid atmosphere, while the center wire is protected. A similar condition exists on portions of strand located inside the reel, which are protected by the outer layers. The outer layers get full exposure to the atmosphere and have a heavier degree of rusting compared to the inner layers.

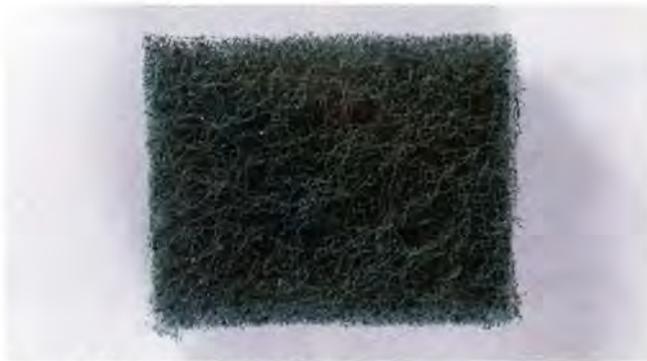
Photo 9. Scotch Brite Cleaning Pad.

In order to evaluate the extent of pitting, the superficial rust has to be removed. In the samples described herein, care was taken to not abrade the strand surface below the iron oxide or rust layer. This was accomplished by cleaning the surface with Scotch Brite™ cleaning pads in order to expose the pits. Scotch Brite Cleaning Pad No. 96, made by 3M, or its equivalent, is a synthetic material which is non-metallic. This material is available from cleaning supply retailers or supermarkets for general purpose cleaning. A sample of this material is shown in Photo 9.

Cleaning is accomplished by holding a new pad by hand and rubbing it against the strand surface longitudinally along the strand axis. The amount of pressure exerted on the pad against the strand is equivalent to that when cleaning pots and pans.
