Monitoring of a Prestressed Segmental Box Girder Bridge During Strengthening

The Grand-Mère Bridge, a 285 m (935 ft) long cast-in-place segmental box girder bridge, experienced some distress which required strengthening by adding external prestressing equivalent to 30 percent of the remaining internal prestressing. Considering the importance of this undertaking, the Québec Ministry of Transportation supported an extensive research program with the objectives of measuring the external prestressing effects on the existing bridge and validating several design assumptions. The testing program comprised various measurements. Instrumentation included electrical strain gauges, mechanical strain gauges, thermocouples, and surface and embedded vibrating wire gauges. One mobile and two permanent data acquisition systems were used, together with manual reading devices. This paper presents details of the instrumentation program. Some field measurements are presented and comparisons with several design assumptions are discussed. The technology gained from this project is also applicable to precast, prestressed concrete bridges.

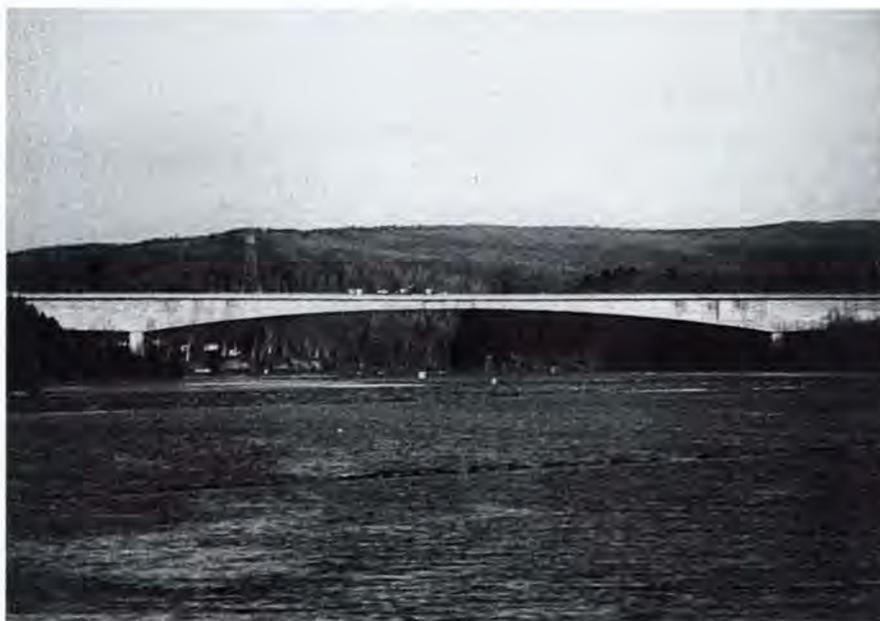
Fig. 1. The Grand-Mère Bridge.

The Grand-Mère Bridge, located on Highway 55 over the St. Maurice River, is 285 m (935 ft) long. The bridge has three continuous spans of 39.6, 181.4 and 39.6 m (130, 595 and 130 ft) with a wedge-shaped solid cantilever span of 12.2 m (40 ft) at each end acting as counterweights (see Figs. 1 and 2).

The Grand-Mère Bridge is a 285 m (935 ft) long cast-in-place post-tensioned box girder bridge built in 1977 and located 200 km (125 miles) northeast of Montréal, Québec, Canada (see Fig. 1). This bridge experienced various problems and distress that resulted in significant deflection in the 181.4 m (595 ft) central span. After numerous independent studies, and considering the
