**END-REGION CRACKING IN PRETENSIONED CONCRETE GIRDERS
EMPLOYING 0.7-IN. STRANDS: TIME-DEPENDENT AND SERVICE-LOAD
EFFECTS**

Hyun su Kim, The University of Texas at Austin, Austin, TX

ABSTRACT

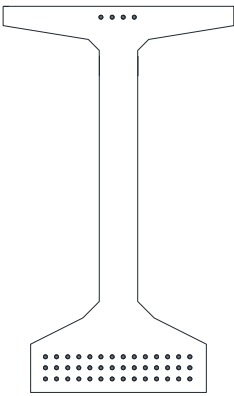
Table 3 Summary of specimen design properties

Design properties	Tx70-II	Tx46-IV	Tx46-V
Cross section

Design f'_{ci} [ksi]	7.8	8.0	8.0
Effective depth from top* [in.]	65.5	41.8	41.8
Number of top strands	4	4	4
Number of bottom strands	42	36	36
Jacking stress for bottom strands [ksi]	202.5	202.5	202.5
Jacking stress for top strands [ksi]	202.5	165.0	165.0
End-region modification	None	Use Larger Transverse Reinforcement	Add Horizontal Bars

All specimens employed straight 0.7-in. diameter prestressing strands that were placed on a standard 2- by 2-in. grid. To maximize the flexural capacity of the specimens and create critical conditions for spalling stresses, the strands in the bottom flange were placed at the greatest possible eccentricity in each specimen. Each specimen also contained four 0.7-in. diameter strands within the top flange to control the stresses at the time of prestress transfer. Parametric studies by Salazar et al.¹² showed that increasing the release strength of concrete, to a minimum of 7.5 ksi, can provide noticeable benefits in terms of additional flexural capacity when using 0.7-in. diameter strands. Therefore, the specimens were designed assuming a concrete release strength on the order of 8 ksi, which is greater than what is typically used in the industry. The specimens were designed according to the 2016 interim revisions to AASHTO LRFD Bridge Design Specifications¹³.

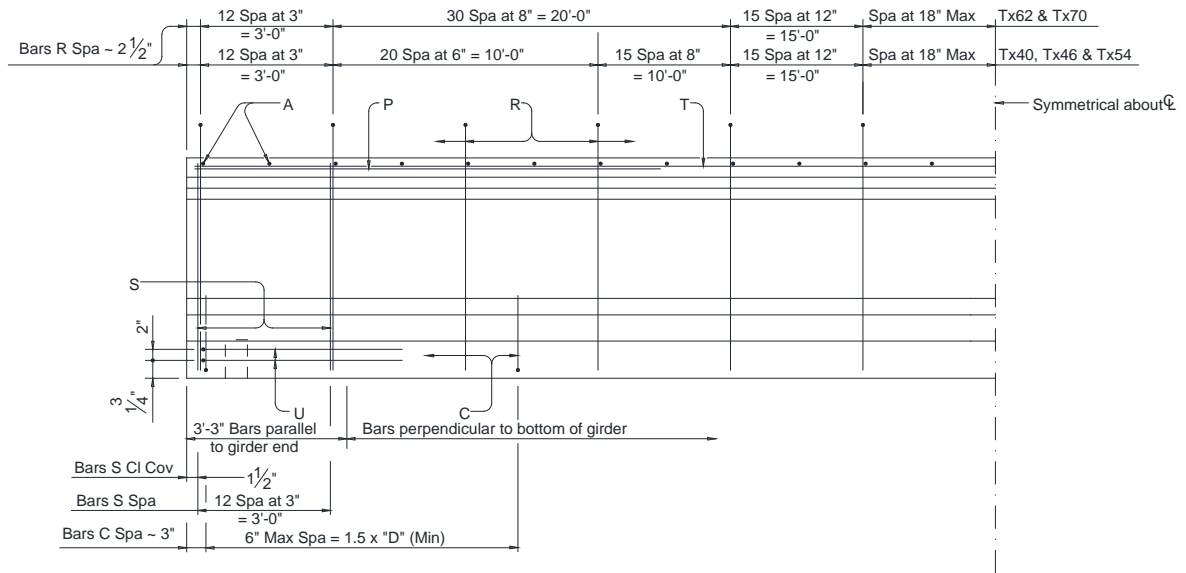
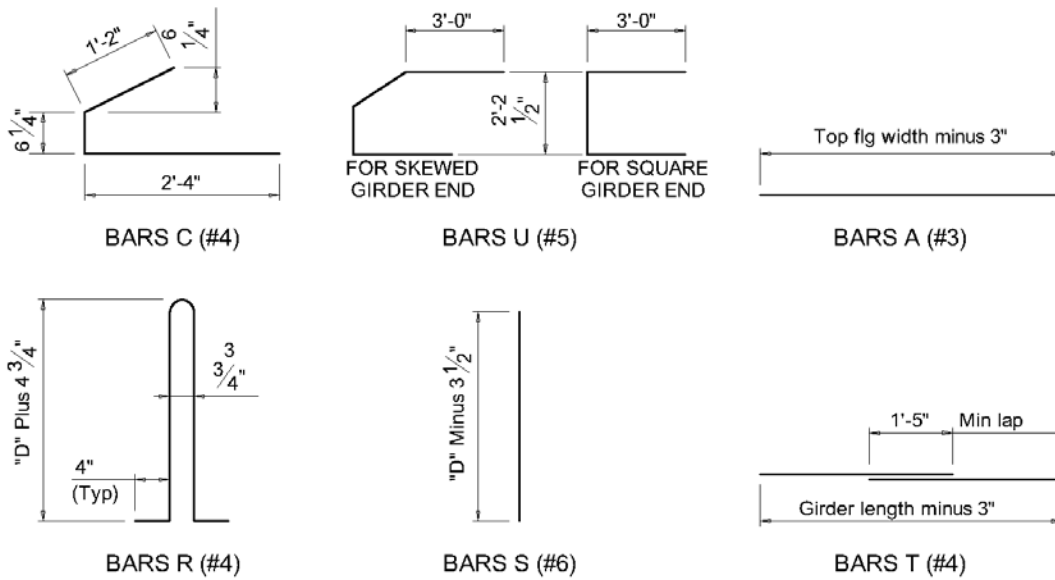
Fig. 1 Standard TxDOT detailing for end-region reinforcement in Tx-girders¹⁴

(a) Elevation view

(b) Reinforcing bars details

The first specimen, Tx70-II, was designed and detailed according to the standard drawings currently used by the Texas Department of Transportation (TxDOT) for Tx-girders with smaller-diameter strands¹⁴, which is shown in Fig. 1. Tx46-IV and Tx46-V had similar designs in terms of prestressing layout and concrete release strength. However, the end-region detailing was modified in these two specimens in an effort to reduce the width and number of end-region cracks and control the strand slip under applied loads. In Tx46-IV, the diameter of S-bars (shown in Fig. 1) at the dead end was increased from No. 6 to No. 8. Tx46-V contained No. 6 S-bars, but as shown in Fig. 2, a series of horizontal No. 4 bars were added within the web of this specimen at the dead end to help restrain the growth of inclined spalling cracks. Moreover, Tx46-V contained “cap bars” at both ends to more effectively confine the bottom flanges and assess the impacts of strand confinement on the shear capacity and the ductility of the girders.

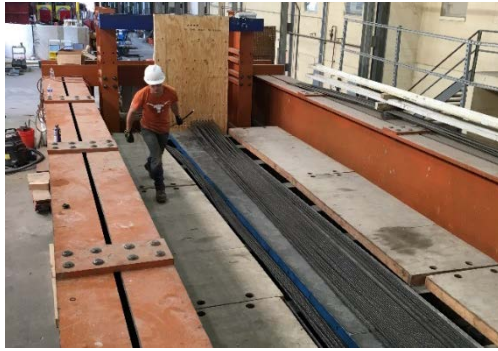
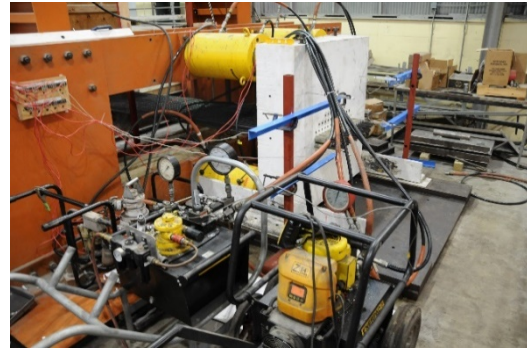
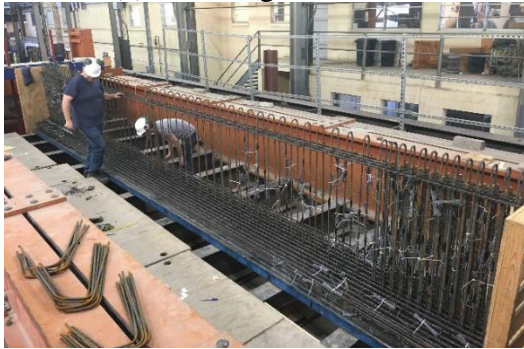
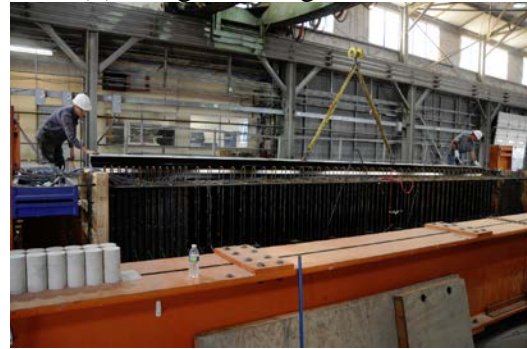
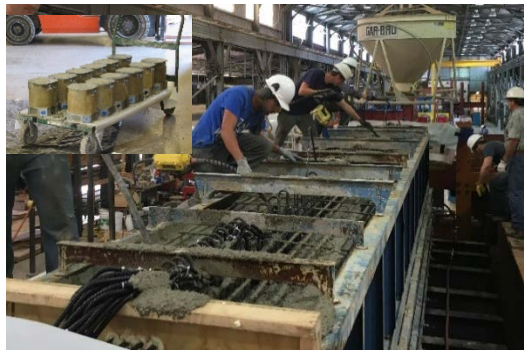
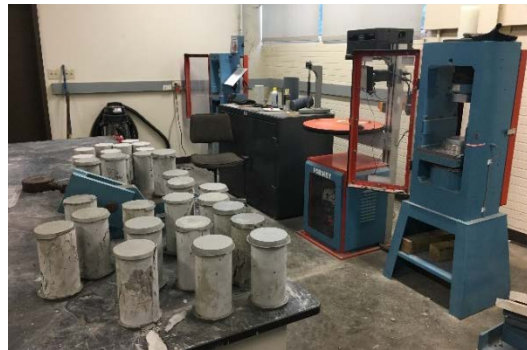
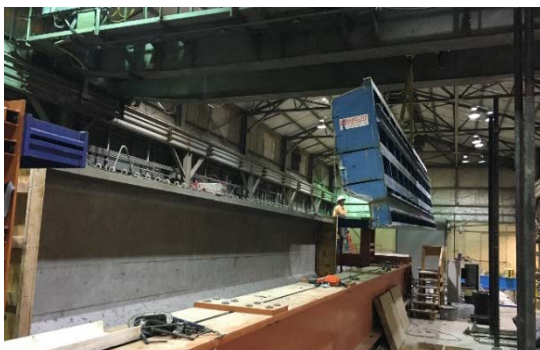
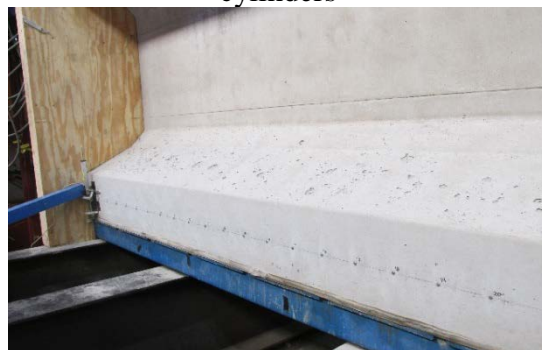
Fig. 3 Specimen fabrication process

(a) Installing the strands

(b) Gang-stressing the strands

(c) Installing the reinforcement and instrumentation

(d) Closing side forms

(e) Casting the specimen

(f) Periodic testing of match-cured cylinders

(g) Removing the side forms

(h) Prestress transfer and inspection

Fig. 3 shows an overview of the fabrication process for the specimens. Reusable strand chucks were used for anchoring the 0.7-in. diameter strands at each end on a 2- by 2-in. grid. Initially, each strand was individually stressed to remove the slack and ensure uniform stressing of the strands. After the slack was removed, all strands were gang-stressed, i.e. stressed together, in 10 increments using hydraulic rams, during which the hydraulic pressure in the rams was carefully monitored. The elongation of the strands was also monitored using a series of linear potentiometers at each end of the prestressing facility and verified to be within 5 percent of the calculated value at the completion of each stressing increment.

Once the strands were stressed to the desired level, installation of the transverse reinforcement and instrumentation was carried out. Strain gauges were installed on transverse reinforcement to measure strains in the stirrups and on strands to estimate transfer length. Vibrating wire strain gauges (VWGs) were also placed at the midspan locations of the girders to measure the strains due to time-dependent effects and prestress losses.

The strands were released through gradual retraction of the hydraulic rams over 20 steps, which typically took approximately one hour. While the strands were being released, the compressive strength and modulus of elasticity were measured to obtain the mechanical properties at prestress transfer, which are presented in Table 4.

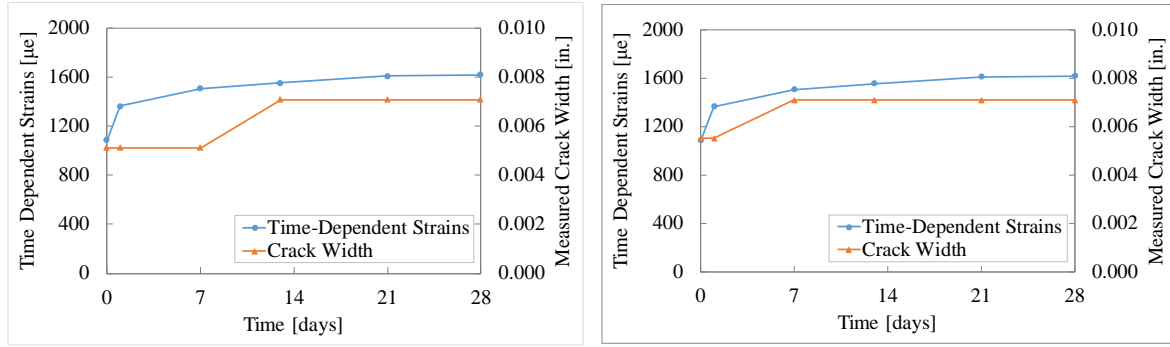
Fig. 16 Time-dependent changes in strains and widths of spalling cracks in Tx70-II

(a) Live End (Crack: NE-1.1)

(b) Dead End (Crack: SE-1.3)

Fig. 16 through Fig. 18 present the observed growth in the widths of widest spalling cracks within the end-regions of each specimen in comparison with the measured time-dependent strain at the centroid of prestressing strands at the midspan of that specimen. The cracks in these figures are identified with the notation that was introduced in Fig. 13 through Fig. 15.

Fig. 16 through Fig. 18 show a clear correlation between the widths of inclined spalling cracks and time-dependent strains. Over the 28-day period of measurements, the growth in the width of the widest spalling crack was 34 percent for Tx70-II, 65 percent for Tx46-IV, and 53 percent for Tx46-V. During this period, the increases in strains at the centroid of strands at midspan were 49, 60, and 55 percent for Tx70-II, Tx46-IV, and Tx46-V, respectively.

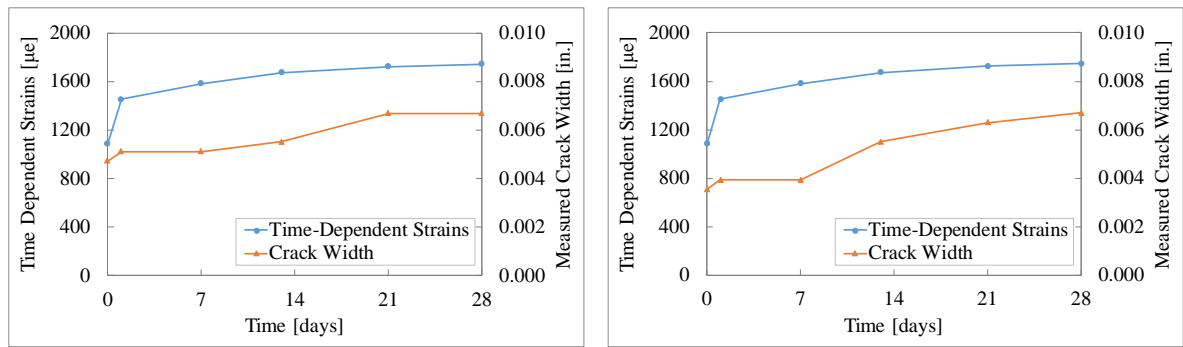
Fig. 17 Time-dependent changes in strains and widths of spalling cracks in Tx46-IV

(a) Live End (Crack: NE-1.3)

(b) Dead End (Crack: SW-2.6)
