# Prestressing the CN Tower

A major feature of this, the world's tallest structure, is that prestressing was used extensively in both the foundation and superstructure of the Tower.

This article describes the design and construction highlights in planning and building the structure especially as related to the post-tensioning operations.

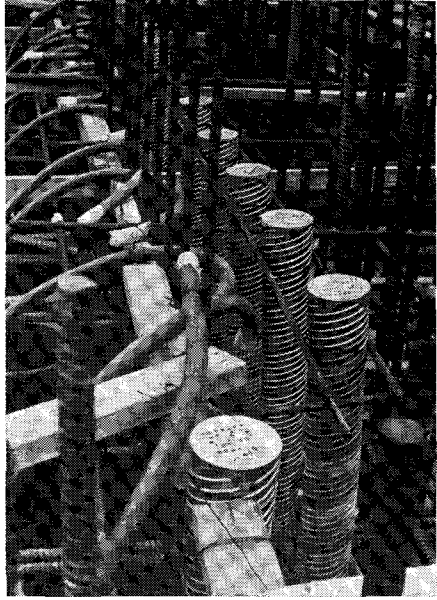
**Fig. 12. Series of capped sheaths at base of Tower shaft.**

Each cable duct was provided with a cap after every new unit was installed to prevent foreign material from entering and blocking the ducts. In retrospect, this measure proved quite successful except for four ducts which became clogged during construction. Three of these ducts were subsequently cleared by using a flexible shaft diamond drill. This instrument was very effective in removing concrete chunks (some 400 ft deep) from the ducts. Nevertheless, this drilling operation was very expensive and caused many delays. Therefore, not all the ducts were cleaned out in this manner.
