Evaluation of Degree of Rusting on Prestressed Concrete Strand

Presents a procedure for classifying the degree of rust on a piece of prestressing strand and discusses the reasons for acceptance or rejection of each classification. Visual standards are developed by which inspectors can identify the degree of corrosion at which pitting occurs.

Augusto S. Sason, P.E.

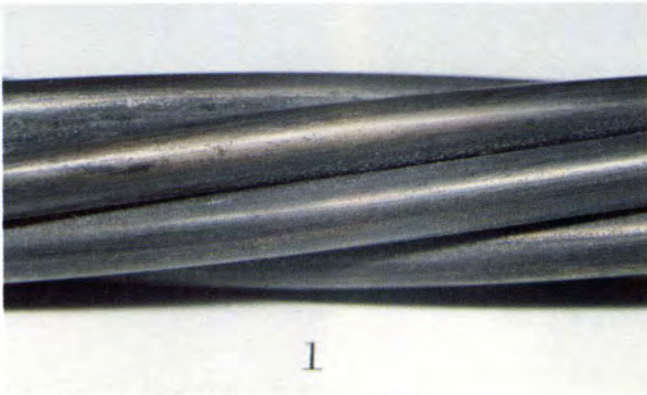
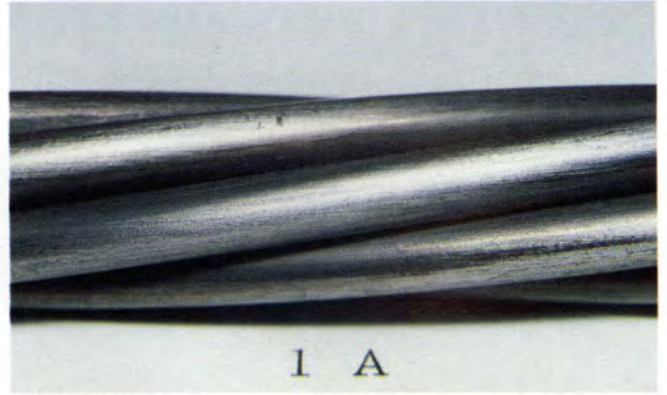
Bright strand refers to the surface quality of uncoated strand with no signs of rusting. This type of surface finish is obtained by the conventional dry drawing process, followed by stranding and the stress relieving operation.¹ Photo 1 shows a typical strand surface before cleaning.

Photo 1. Strand surface before cleaning.

Photo 1A. Strand surface after cleaning.

Photo 1 represents a new strand with no rust and has a bright surface. Photos 2 through 6 illustrate various amounts of corrosion on strand samples that were exposed to a corrosive environment for different lengths of time and include some pits that are to be considered cause for rejection.

It is the opinion of the writer that Picture Sets 1 through 3 are acceptable. Picture Set 4 is borderline and is subject to discussion, agreement or compromise. Some engineers may find this level of rusting objectionable for critical applications. Picture Sets 5 and 6 are pitted and unacceptable.

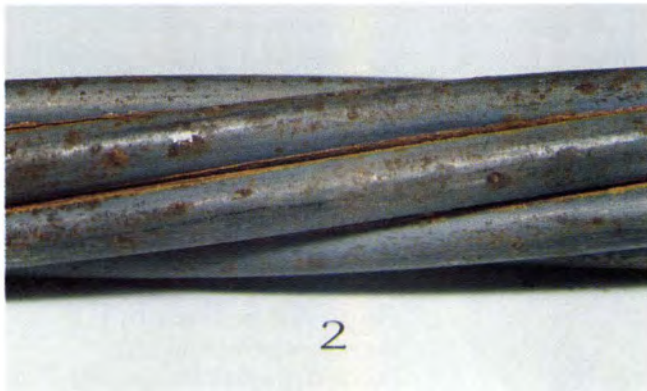
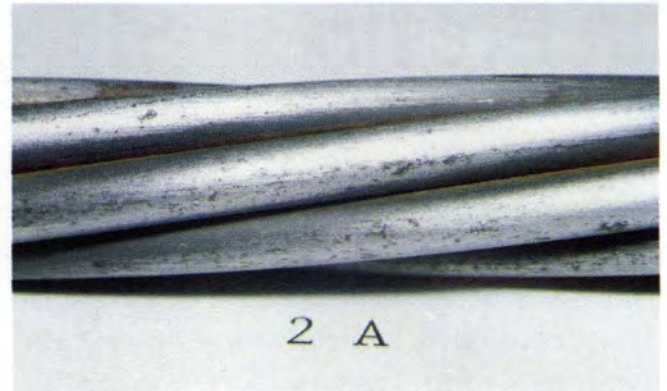
Photo 2. Strand surface before cleaning.

Photo 2A. Strand surface after cleaning.

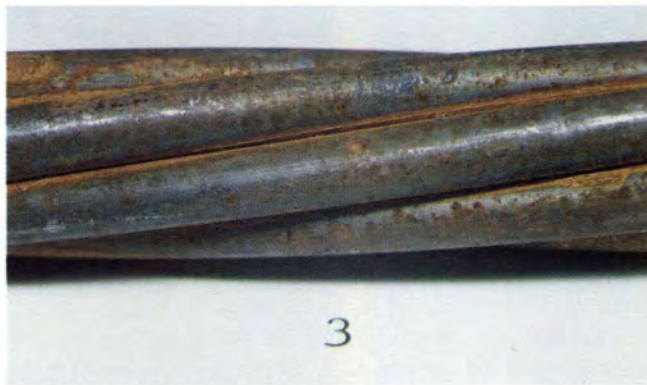
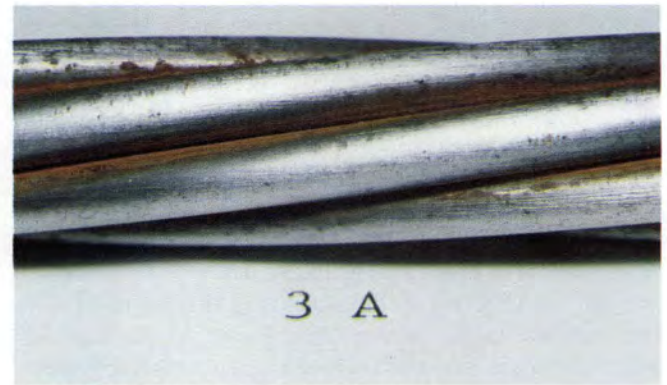
Photo 3. Strand surface before cleaning.

Photo 3A. Strand surface after cleaning.

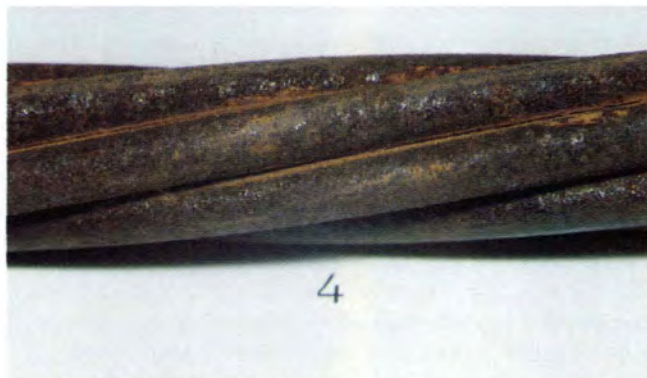
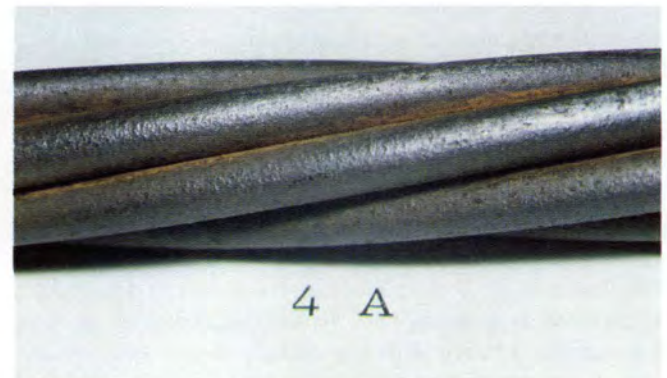
Photo 4. Strand surface before cleaning.

Photo 4A. Strand surface after cleaning.

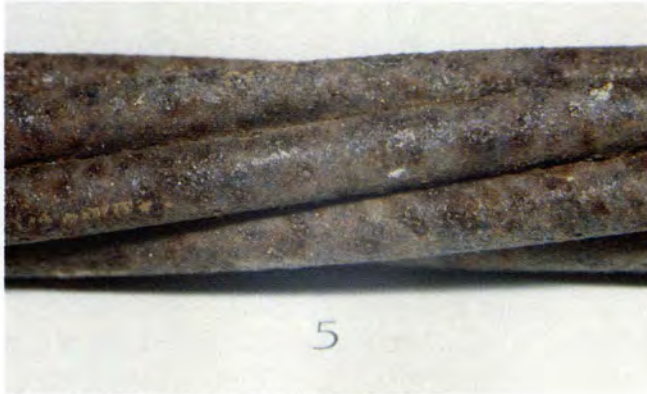
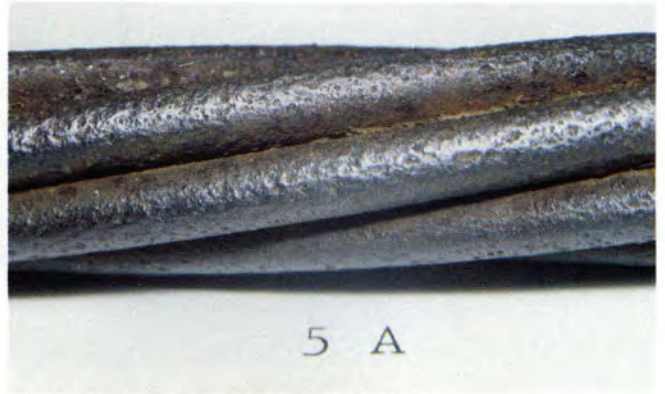
Photo 5. Strand surface before cleaning.

Photo 5A. Strand surface after cleaning.

The differences in values between Samples 1 through 4 are within the normal variation in the testing procedure and equipment. Samples 5 and 6 showed a significant drop in breaking strength compared to Sample 1 because of excessive pitting, as shown in Photos 5 and 6 and also in Photomicrographs 5 and 6. However, the breaking strengths are high enough to meet the minimum requirement of ASTM A 416 because the loading was axial and the decrease in cross-sectional area was very small.

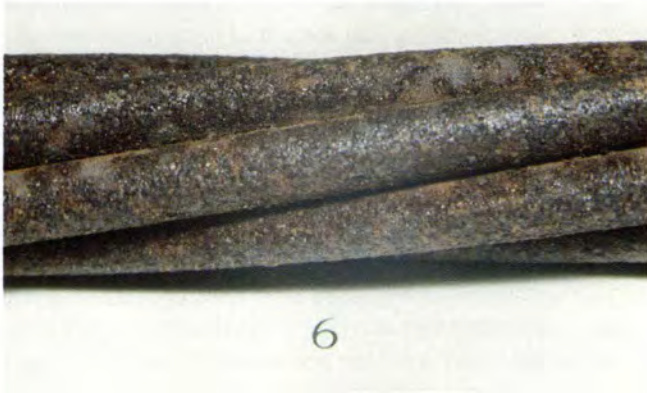
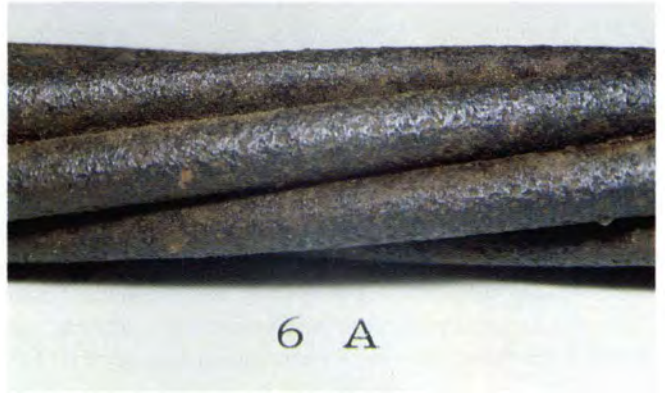
Photo 6. Strand surface before cleaning.

Photo 6A. Strand surface after cleaning.

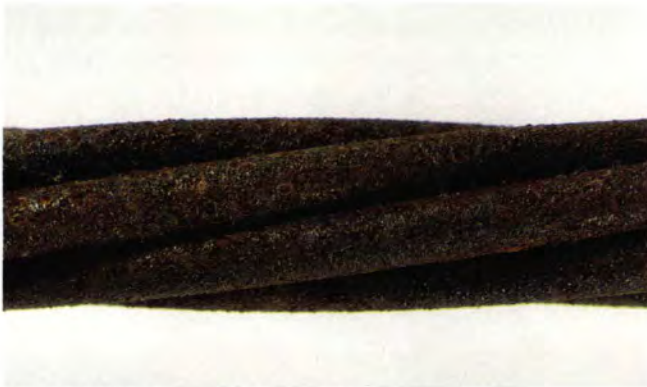
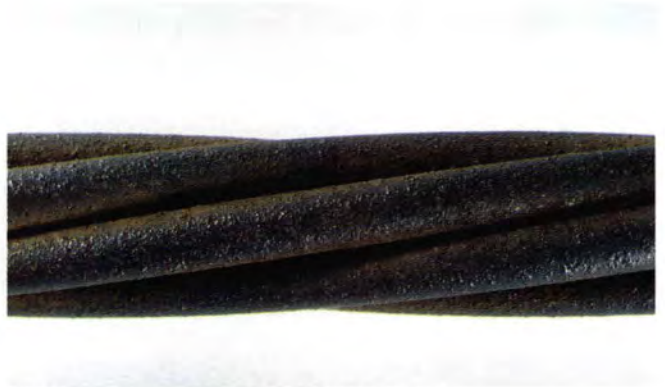
Photo 7. Strand surface before cleaning.

Photo 7A. Strand surface after cleaning.

The corrosion and pitting in the center wire were examined. A rusty strand sample shown in Photo 7 has corroded the outer wires with the same degree of pitting as in Picture Set 5. After cleaning with a Scotch Brite pad, the pitted surface is revealed as shown in Photo 7A.

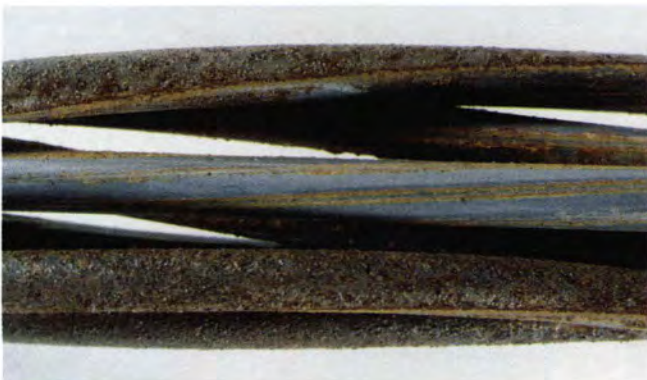
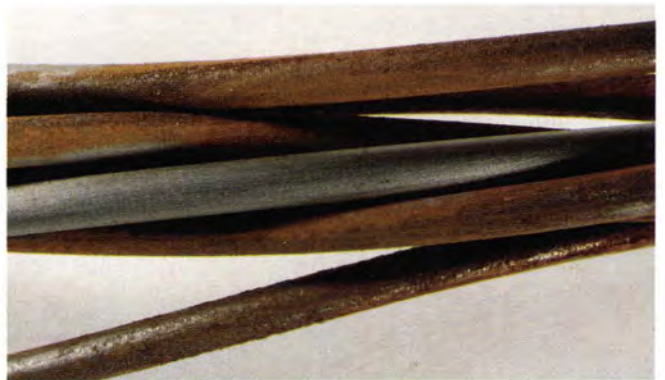
Photo 8. Strand surface before cleaning.

Photo 8A. Strand surface after cleaning.

When the strand was opened by unstranding the outer wires, the center wire showed that it was not pitted. A closeup picture of the center wire after unstranding is shown in Photo 8. The center wire did not show any pitting, as shown in Photo 8A, after cleaning with the Scotch Brite pad.

These two pictures indicate that pitting due to corrosion takes place at the outer wires, which are exposed to a humid atmosphere, while the center wire is protected. A similar condition exists on portions of strand located inside the reel, which are protected by the outer layers. The outer layers get full exposure to the atmosphere and have a heavier degree of rusting compared to the inner layers.

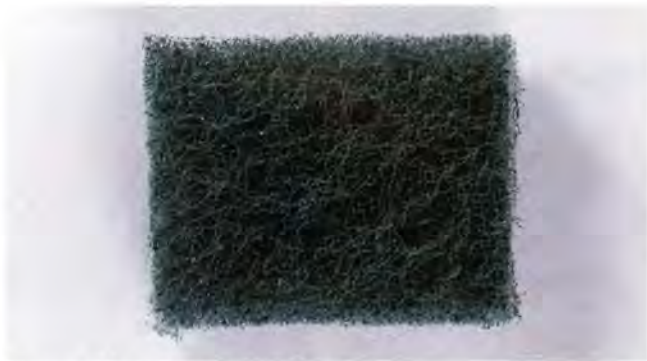
Photo 9. Scotch Brite Cleaning Pad.

In order to evaluate the extent of pitting, the superficial rust has to be removed. In the samples described herein, care was taken to not abrade the strand surface below the iron oxide or rust layer. This was accomplished by cleaning the surface with Scotch Brite™ cleaning pads in order to expose the pits. Scotch Brite Cleaning Pad No. 96, made by 3M, or its equivalent, is a synthetic material which is non-metallic. This material is available from cleaning supply retailers or supermarkets for general purpose cleaning. A sample of this material is shown in Photo 9.

Cleaning is accomplished by holding a new pad by hand and rubbing it against the strand surface longitudinally along the strand axis. The amount of pressure exerted on the pad against the strand is equivalent to that when cleaning pots and pans.

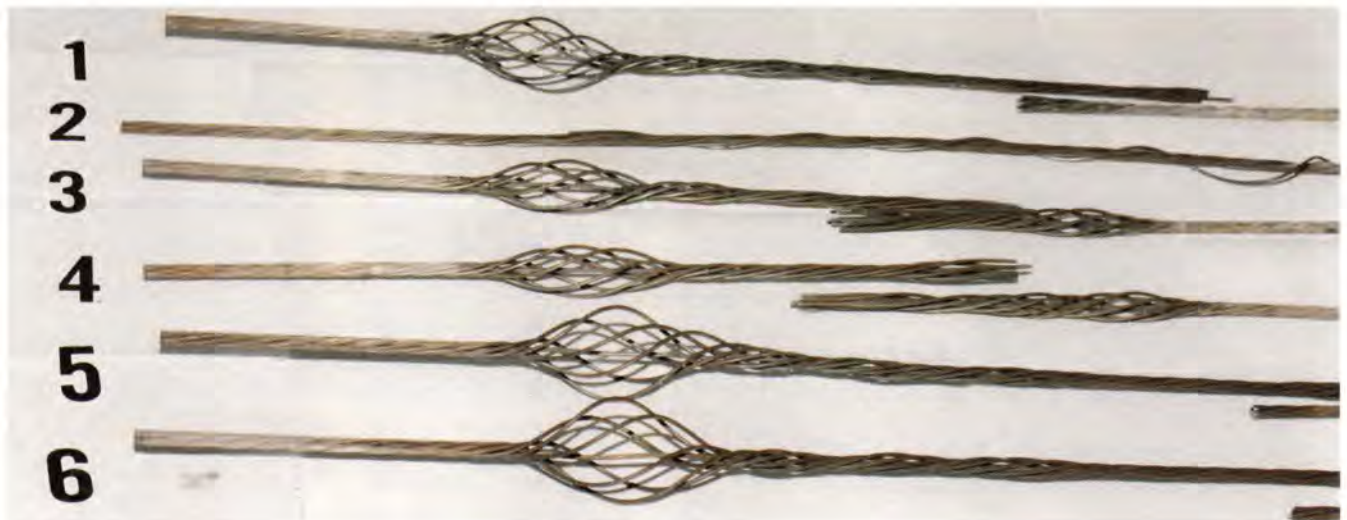
Photo 10. Samples after testing for mechanical properties.

Except for Sample 2, which broke with one wire fracture, all samples showed maximum breaking strength with seven wire fractures which occurred away from the grips of the tensile testing machine. This explains why Sample 2 has a slightly lower elongation value. The samples after testing are shown in Photo 10.

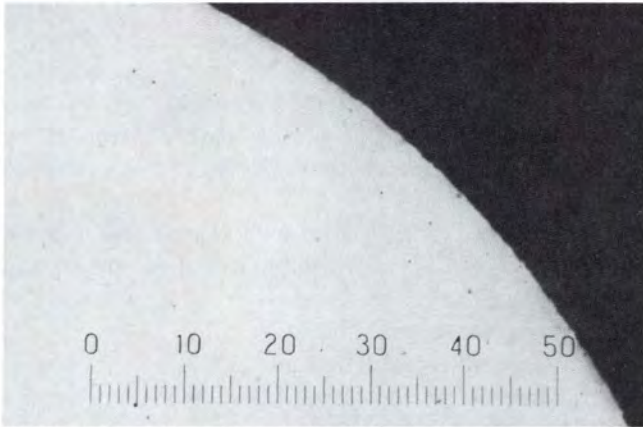
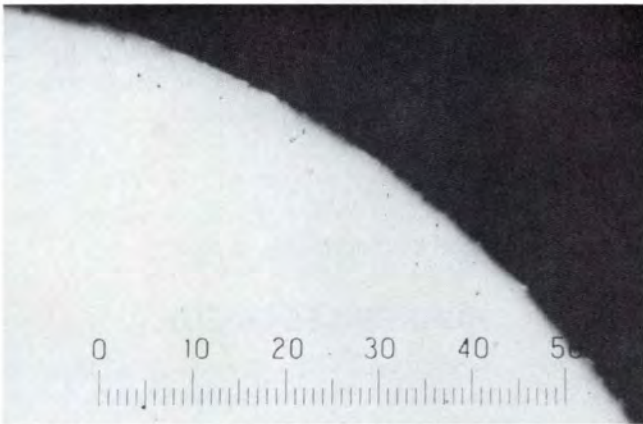
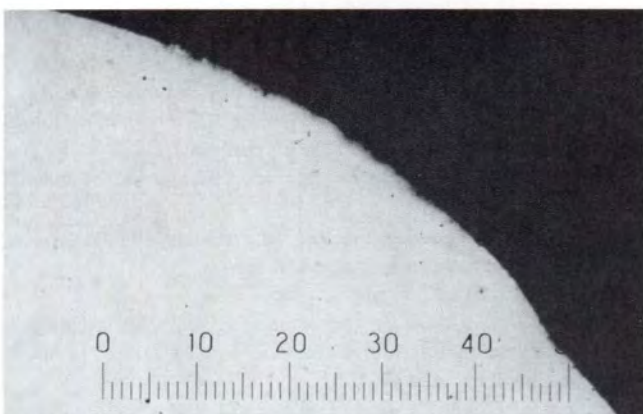
Photomicrograph 1. Sample from Photo 1.

Photomicrograph 2. Sample from Photo 2.

Photomicrograph 3. Sample from Photo 3.

Photomicrographs 1 through 6 show a section of the wire circumference from samples corresponding to Photos 1 through 6. Measurable depths of pits are observed in Photomicrographs 4, 5 and 6, and the corresponding measurements are shown in Table 3. One small division of the scale imprinted on the photomicrographs is equivalent to 0.00077 in. (0.02 mm).

The micro-examination was done by cutting a transverse section of the outer wire. The cut specimen was then mounted and polished using standard metallographic techniques for specimen preparation. The polished section was examined under a metallographic optical microscope at a magnification of 75X, but scaled down for publication.

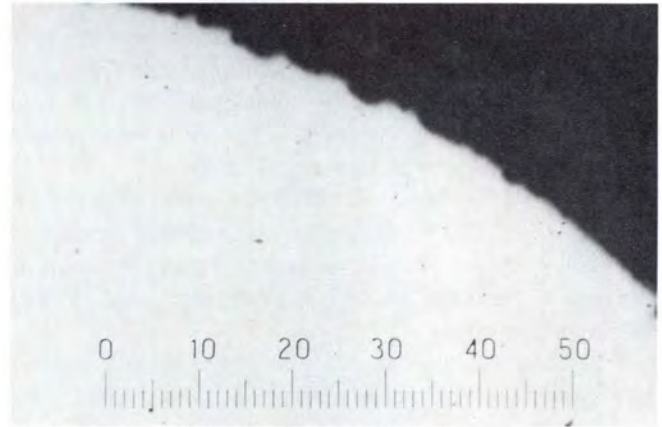
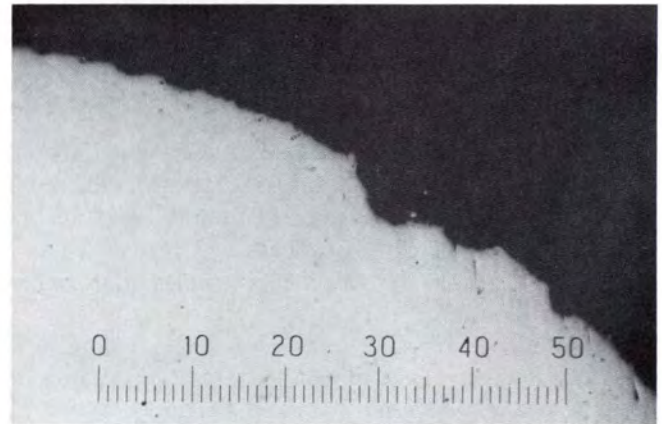
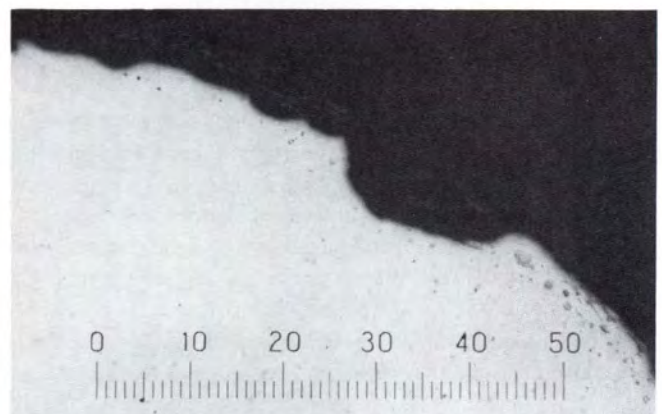
Photomicrograph 4. Sample from Photo 4.

Photomicrograph 5. Sample from Photo 5.

Photomicrograph 6. Sample from Photo 6.

Based on these examinations, it can be deduced that the sample with the deepest pits will fail first when subjected to cyclic loading. The pits are stress raisers which will serve as initiation sites for fatigue failure.
