Lateral capacity and repair of corrosion-damaged pile bents, part 1: Design and testing considerations

Gray Mullins, Rajan Sen, Andrew Goulish, and Danny Winters

- The effects of corrosion damage in prestressed piles are difficult to quantify because the amounts of steel loss are unknown.
- This paper, which is the first in a three-part series highlighting the test methodologies and effects of corrosion damage on bridge pile bents, provides the basis of comparison for two subsequent papers.
- Part 2 will address the design of carbon-fiber-reinforced polymer (CFRP) repairs for corroded piles, and part 3 will present test results for a severely corroded pile bent where full lateral capacity was restored using CFRP repairs.

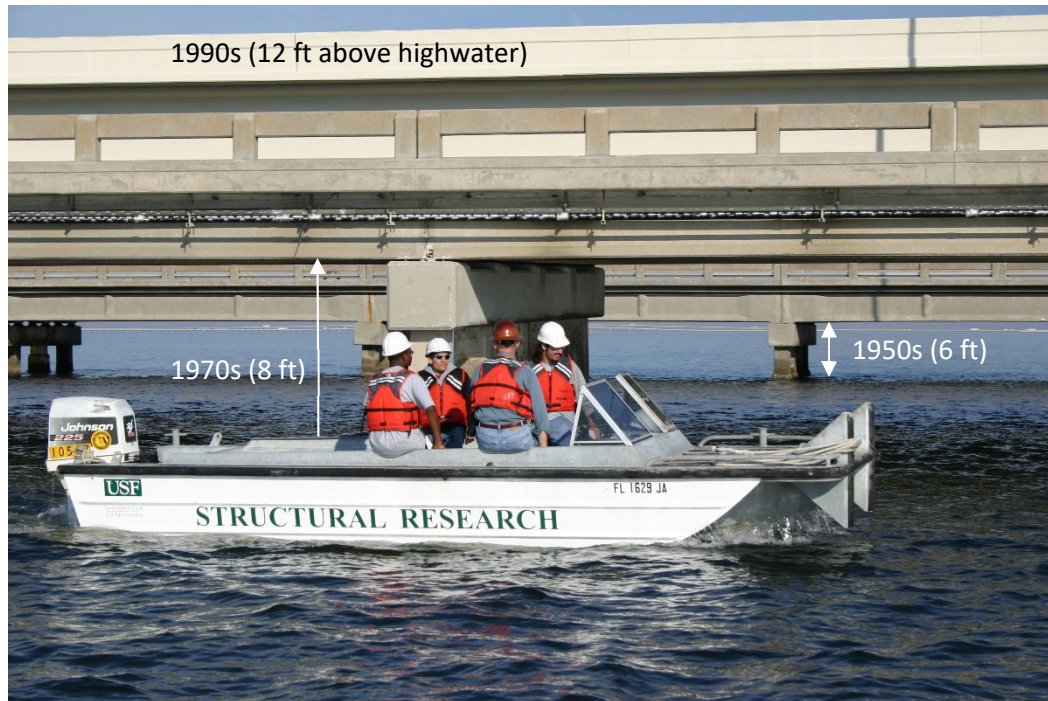
Figure 1. Bridge design transition from lower to higher overwater clearance. Note: 1 ft = 0.305 m.

Piers subjected to extreme-event lateral forces can require many more piles than those required to support only self-weight and vehicular loads. Therefore, when span lengths are determined, owners and designers must evaluate the costs of using more-expensive longer, deeper girders as well as the number of pier locations with large, vessel collision-resistant footings. Without considering vessel-collision forces or knowledge of the effects of corrosion damage on service life, cost analyses in the past tended to favor shorter spans with small, low-height pile bent-type piers. **Figure 1** shows three adjacent bridges built in the 1950s, 1970s, and 1990s, which were surveyed as part of the project described in this article. The girder clearances from high water were

1.8, 2.4, and 3.6 m (5.9, 7.9, and 12 ft) for the 1950s-, 1970s-, and 1990s-era structures, respectively. The 1950s- and 1970s-era bridges had pile-bent-type piers. The 1950s-era bridge was recently dismantled after severe corrosion damage of the seawater-sprayed girders led to falling debris.¹

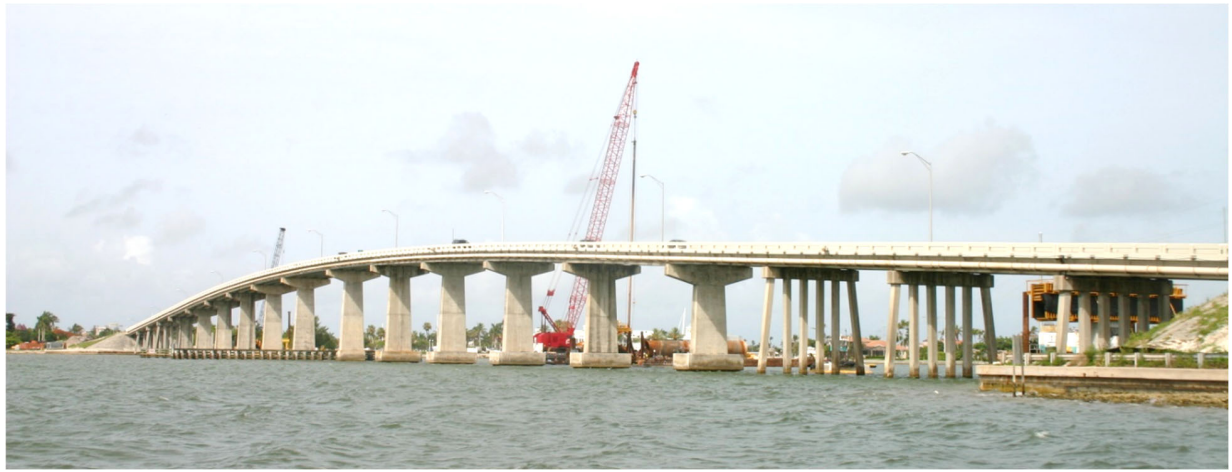
Figure 2. Pile cap and column- and pile bent-type piers (built 1969).

Pile bents are essentially portal frames, where exposed longer pile lengths create higher pile-bending moments near the cap from lateral loads. For bridges where the splash zone and highest bending moment regions coincide, the probability of corrosion damage adversely affecting performance is increased. **Figure 3** shows two bridges where the splash-zone damage location varies relative to the underside of the pile cap where bending moments are highest.

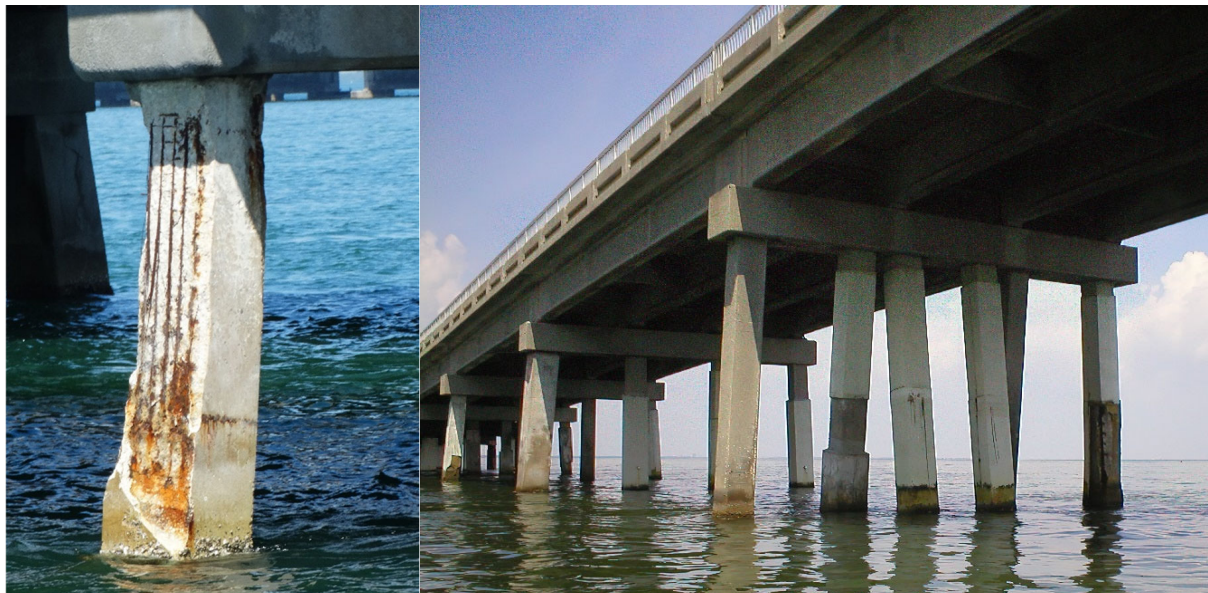
Figure 3. Corrosion damage near pile cap (left) and corrosion damage farther from high bending moment region (right).

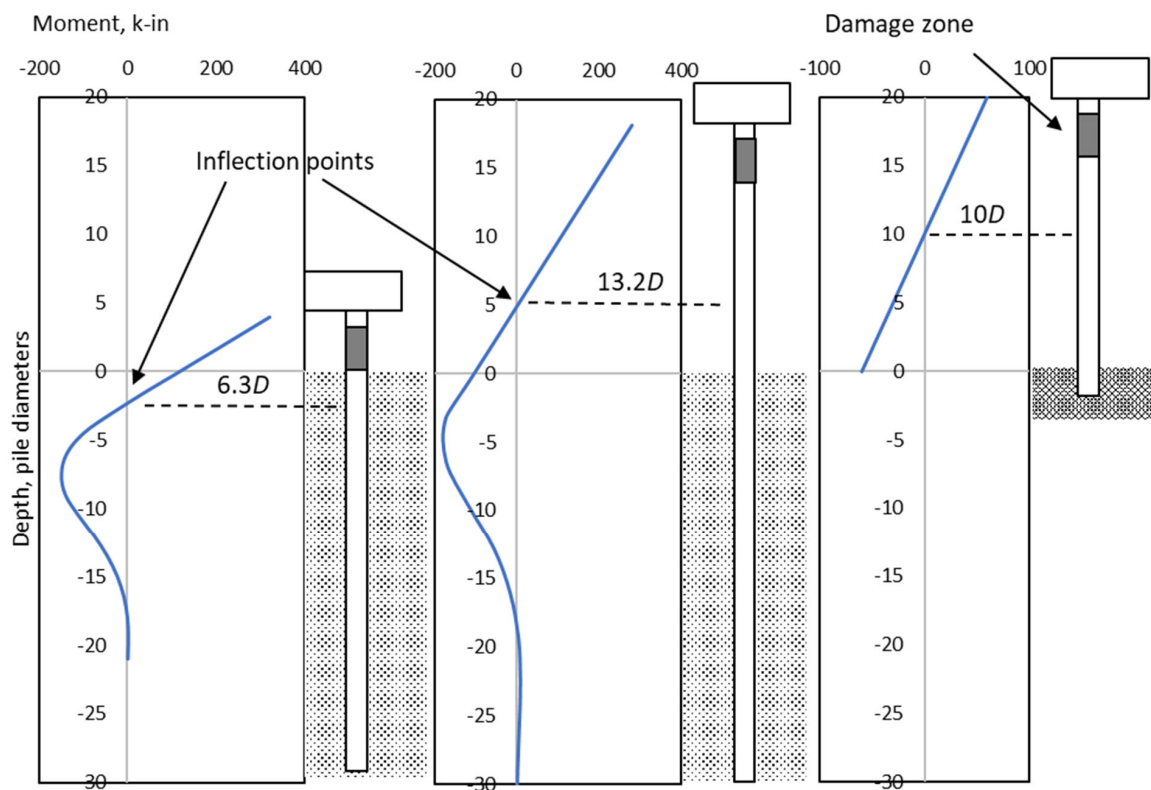
Figure 7. Bending moment distribution in prototype and model piles in a bridge bent. Note: D = pile width or diameter. 1 kip-in. = 0.1130 kN.

The points of inflection for the two bridges occurred 2.9 and 6 m (9.5 and 20 ft) beneath the pile caps, so the corresponding nondimensional ratios were 6.3 and 13.2 pile diameters. As the point of deflection primarily depends on the free length of the pile, a wide range of distances to the inflection point was representative of full-scale conditions for all 74 prototype piers surveyed. Shorter free lengths (in shallow water) translate into lower moments in the damage zone if the damage zone is typically 3 pile diameters beneath the pile cap. In contrast, longer free lengths (in deeper water) place the damage zone farther from the inflection point, in higher moment regions, and are therefore representative of more-severe conditions. The model inflection point was selected to be 10 diameters or 1.52 m (4.99 ft) beneath the pile cap, which corresponded to the maximum pile length that could be tested within the lab. Using a fixed-base condition, the inflection point would occur at the middle of the pile length, so the free length of the model pile would be 3.05 m (10.0 ft). The location of the center of damage was taken as 0.15 of the clear length or 457 mm (18.0 in.) beneath the pile cap. The extent of the damage zone was assumed to be 559 mm (22.0 in.) or one-third of the damaged length of 1.68 m (5.51 ft) chloride contamination region in the prototype bridges noted in previous studies.¹⁴ **Figure 7** shows the bending moment distributions in the two prototype bridge piles along with the finalized

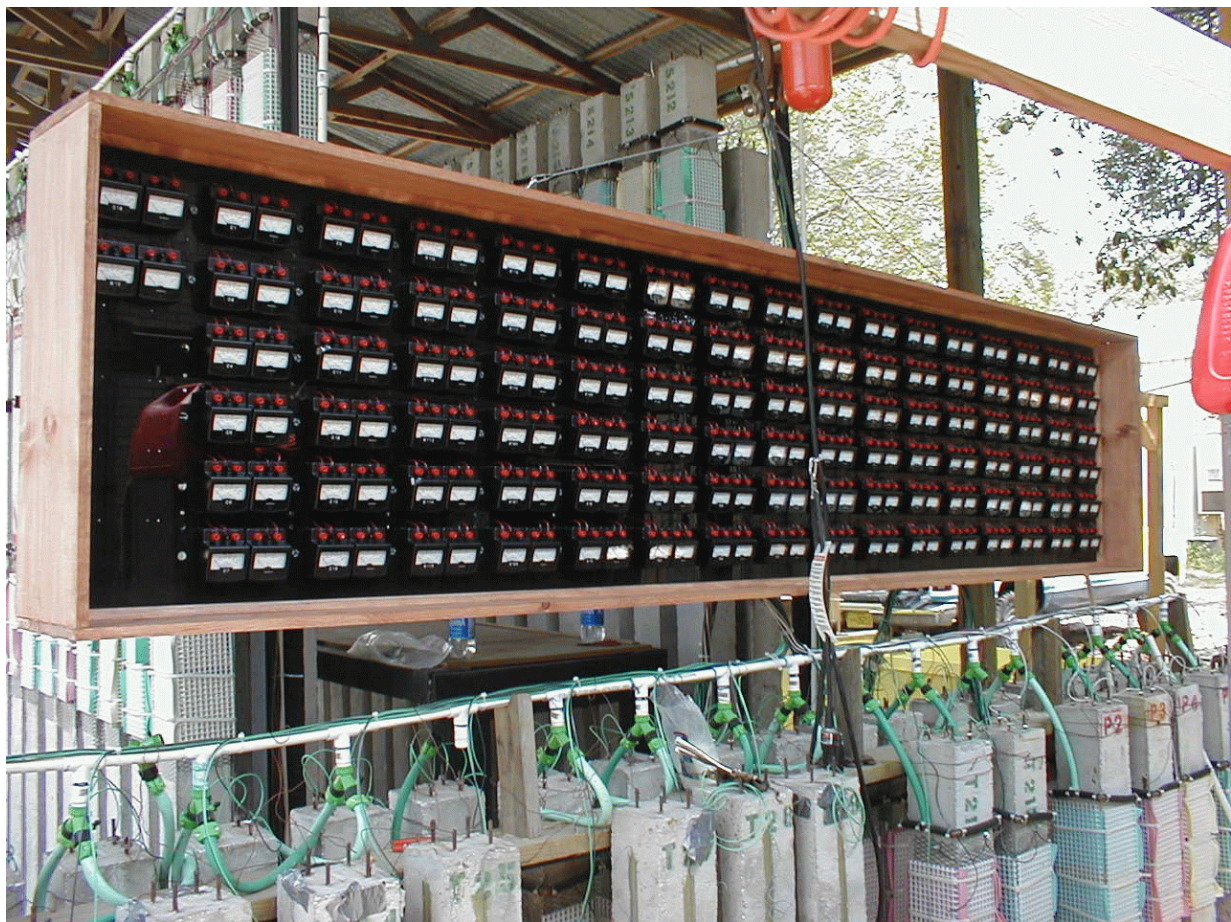
Figure 11. Constant-current control panel showing ammeter and voltmeter monitoring the circuit board output for each specimen.

A target corrosion current density of $1 \mu\text{A}$ per mm^2 ($0.002 \mu\text{A}$ per in.^2) of steel surface area was selected based on worst-case conditions cited for steel corroding in marine, tropical, or semi-tropical environments.¹⁸ Each pile or prism specimen was connected to a dedicated constant-current circuit where the target ($0.002 \mu\text{A}$ per in.^2) current density equated to 120 mA over the 0.56 m (1.8 ft) chloride-contaminated region (**Fig. 11**). Current was gradually increased by 20 mA/day over a 6-day period to minimize but not eliminate localized corrosion (pitting) and provide a more realistic uniform corrosion.¹⁹ Complete details of the constant-current circuit can be found elsewhere.^{8,19}

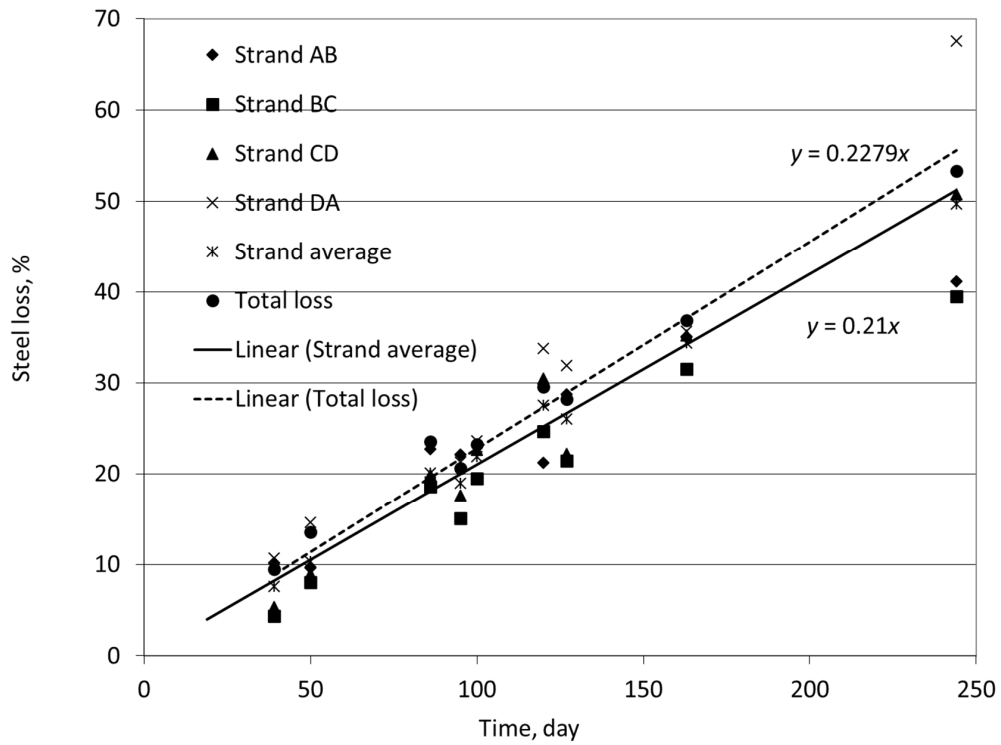
Figure 12. Gravimetric metal loss as a function of time.

Initial calculations using Faraday’s law predicted that 33 days would be required to affect 10% total mass loss of steel. **Figure 12** presents typical results of the gravimetric testing of these prisms. Consistently, the results showed that the stirrups experienced higher percentages of steel loss than the total loss, and the strands just behind the stirrups experienced lower losses. The slopes of the fitted lines indicate 44 days were required to produce 10% total steel mass loss, whereas 48 days were required for a similar degree of corrosion in the primary prestressing strands.

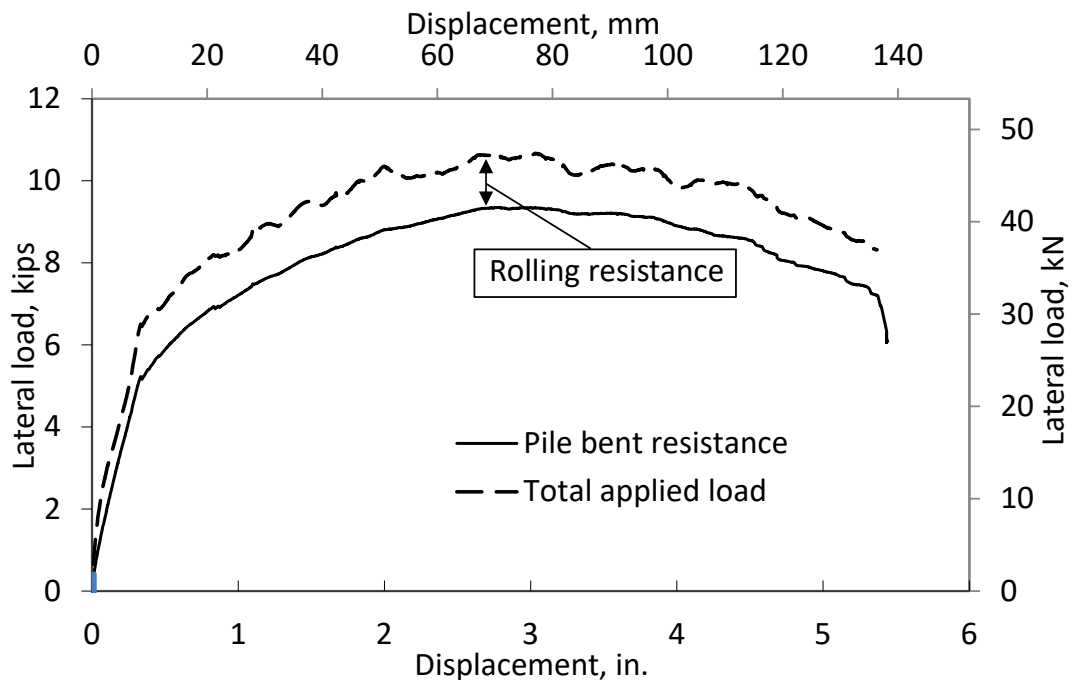
Figure 14. Uncorroded, undamaged control pile bent’s load-displacement response corrected for rolling resistance.

similar to a global lateral-loading event such as wind loads. This complexity introduced rolling resistance, which investigators originally expected to be insignificant. However, by separating the total applied lateral load and the load resisted by the piles below, the importance of the shear cell measurements became apparent. **Figure 14** shows the total applied load and the pile bent resistance after the undulat-

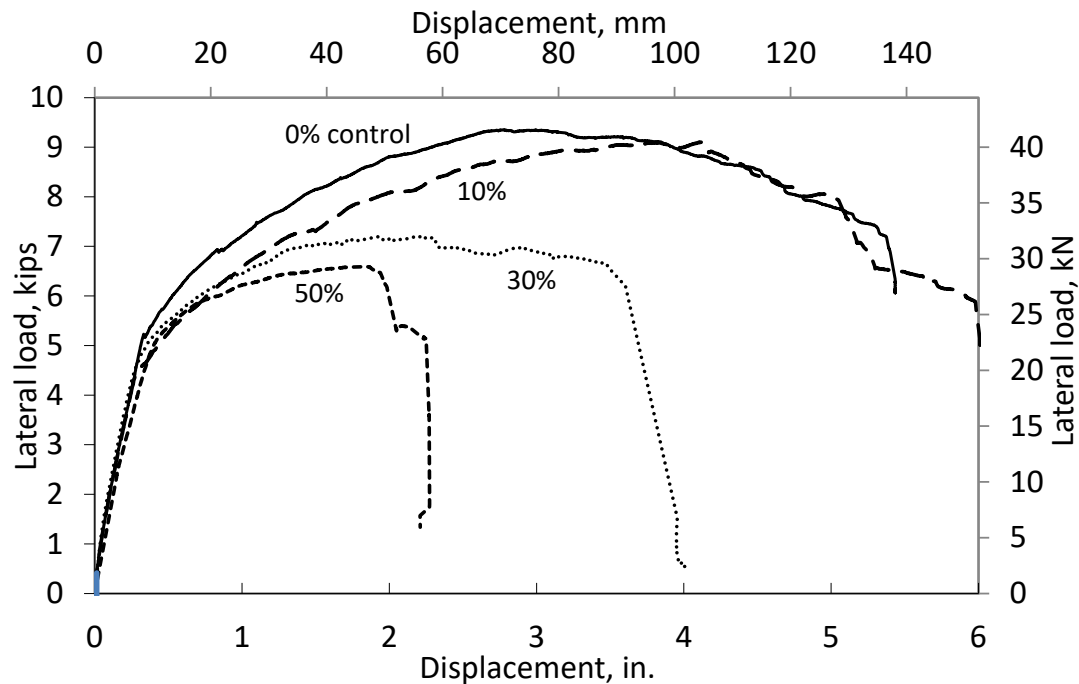
Figure 15. Lateral load versus pile cap displacement for the four pile bents.

Data collected during each of the tests provided the corrected load-displacement response as well as the load-strain response, axial loading, and moments developed in each pile as a function of the lateral load. **Figure 15** shows a graph of the corrected lateral load versus the pile cap displacement for all model bents. **Table 2** summarizes the key data points. The reduction in the lateral capacity due to corrosion damage ranged from 1% for the model bent with 10% steel loss to 30% for the model bent with 50% steel loss. The elastic response of each frame was nearly identical until first cracking. The reduction in stiffness after first cracking corresponded to the reduction in ultimate capacity of the various model bents. The failure modes consisted of cracking and spalling, mainly in the upper and lower ends of the piles. Cracking and spalling were more widespread with higher levels of corrosion damage, which included the amount of concrete cover in the damage zones that fully delaminated. In the 30% model bent, three of the five piles failed catastrophically in the damage zone. All five piles failed catastrophically in the damage zone of the 50% model bent. The top portion of the piles with 50% steel loss during the test developed a hinge in the piles, indicating a shear-type failure mode rather than classic frame-bending behavior. **Figures 16** and **17** show the 50% model bent before and immediately after testing, respectively.

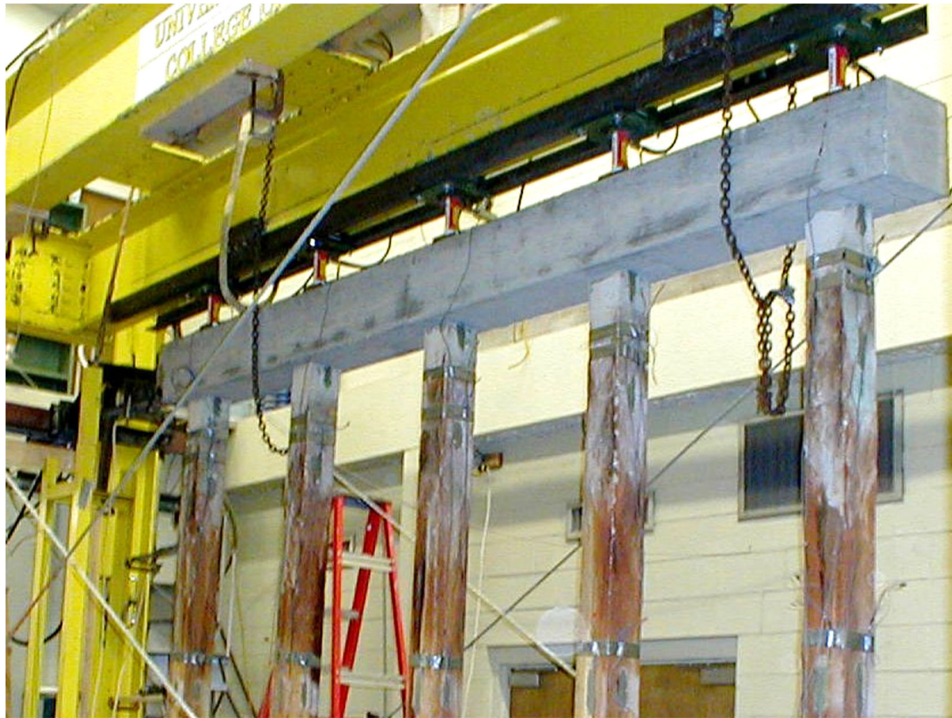
Figure 16. The 50% pile bent before testing.

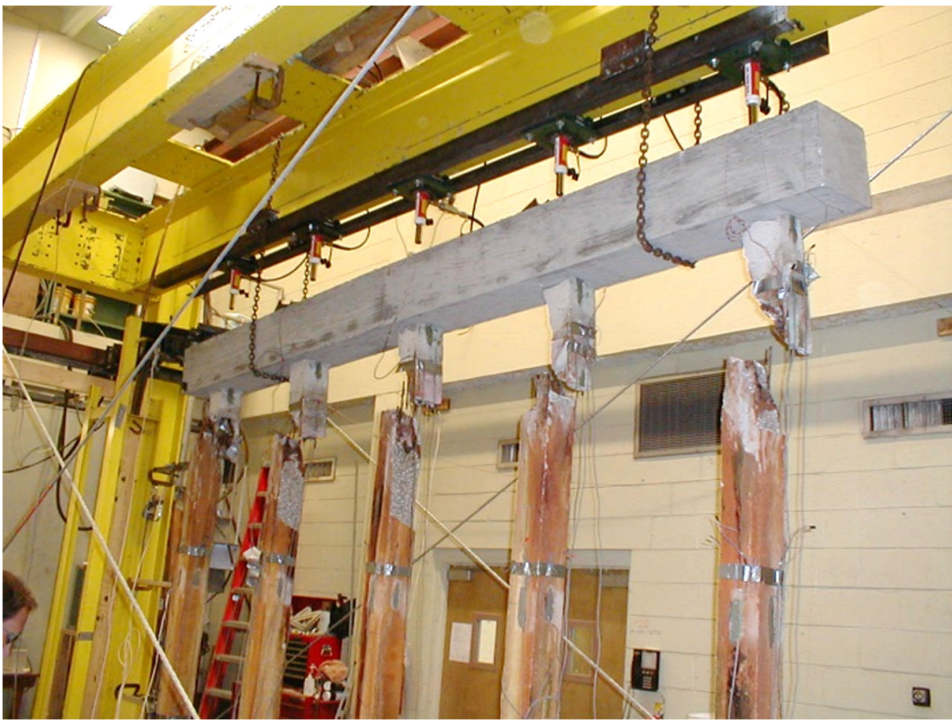
Figure 17. The 50% bridge bent after catastrophic failure (cap caught by safety chains).
