Preview of PCI's New Zealand earthquake reconnaissance team report

Precast concrete structural design in New Zealand

Case study: PricewaterhouseCoopers office building

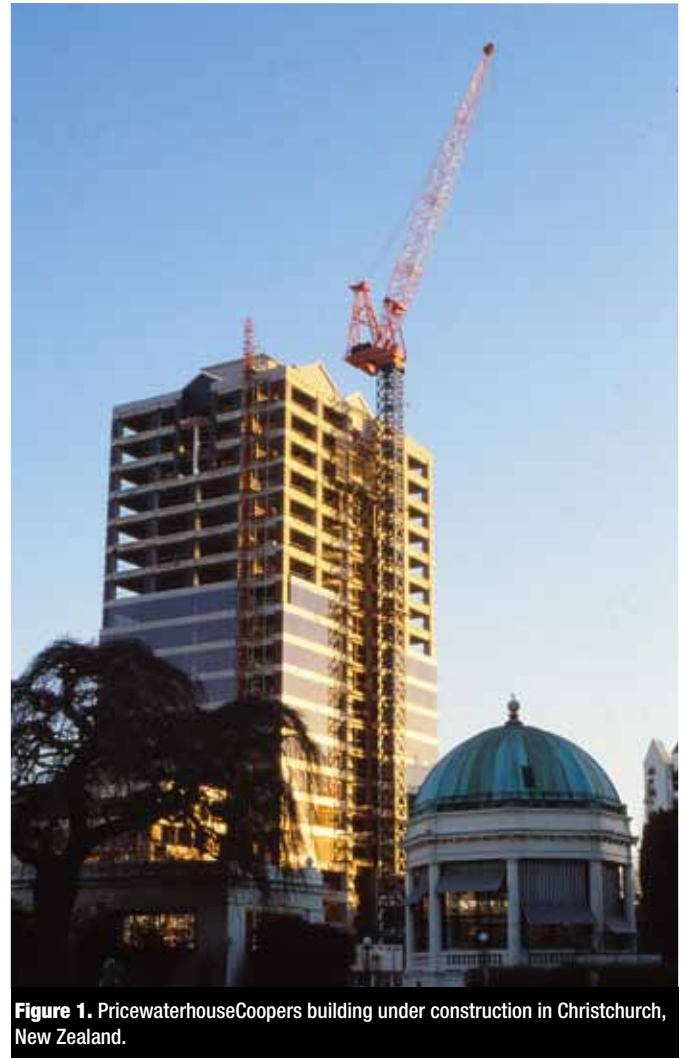
Figure 1. PricewaterhouseCoopers building under construction in Christchurch, New Zealand.

The 21-story PricewaterhouseCoopers office building was constructed in the 1980s (**Fig. 1**). It was designed with an exterior moment-resisting frame and constructed using a detail in which the precast concrete joint (**Fig. 2**) is placed over the column below. Vertical ducts in the precast concrete joint allow the vertical reinforcement from the column to be threaded through and into the column above. The ducts are grouted once the joint is in place.¹

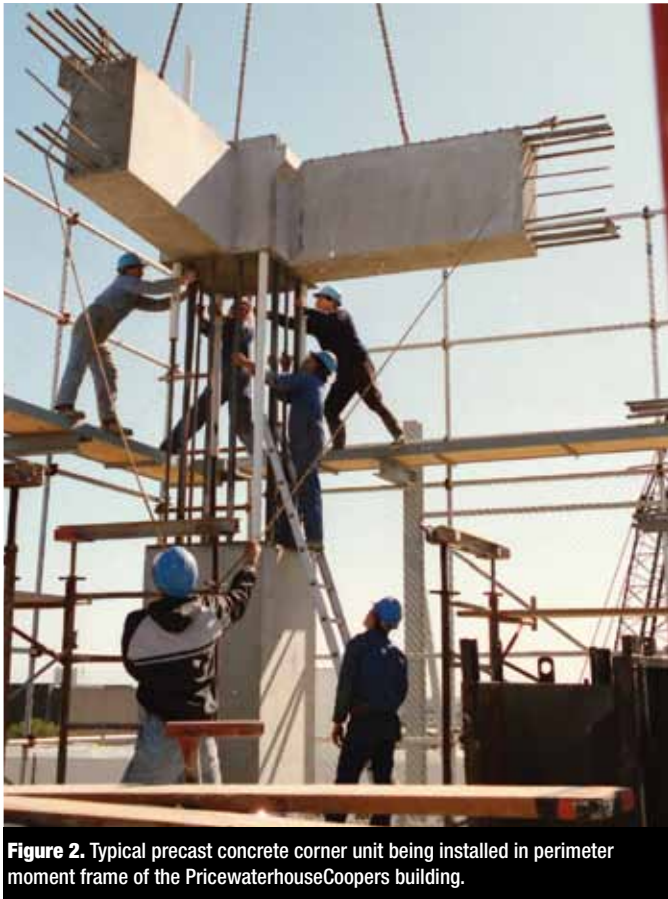
Figure 2. Typical precast concrete corner unit being installed in perimeter moment frame of the PricewaterhouseCoopers building.
