## **Reconstruction of the Historic Animal Bridge**

### **PROJECT OVERVIEW**

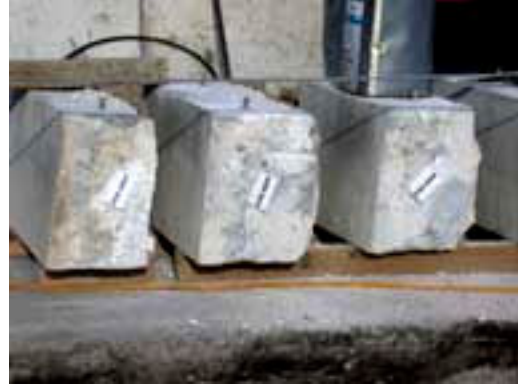
**Figure 13 Stone Numbering**

original position. Plastic encased numbered tags were attached to non-visible surfaces of the stone after they were removed from the wall. Identifying numbers from the original construction were often visible once hidden surfaces of the stone were exposed.

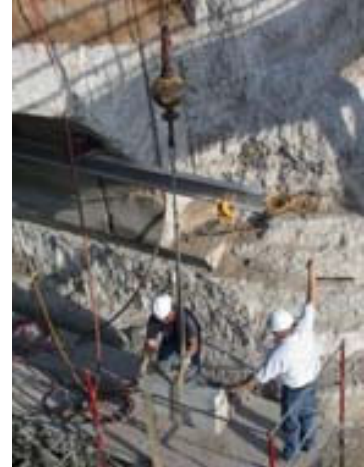
**Figure 2 Raising Stone**

The granite cutwater stones were easily removed as they were laid up against the previously poured concrete abutment walls and were set without any anchors. The cutwater capstones beneath the bridge presented a small challenge because the project schedule required they be removed while keeping the arched structure above intact, however the concrete arch had been poured over the top of the capstones. Over the course of a weekend, a large diameter circular saw was set up on a temporary aluminum track suspended under the span and the capstones were cut out at a 45 degree angle at the joint with the concrete arch. No part of the stone that would be visible in the reconstructed bridge was removed. The track was subsequently used to support carriers from which removed stones were suspended and rolled to the ends of the rails beyond the sides of the bridge. From this point the stones were lifted by crane to the beds of waiting trailers where they were tagged, secured on pallets and prepared for transport. The stone was taken to a warehouse where it would be stored, cleaned and repaired while the bridge structure was replaced.

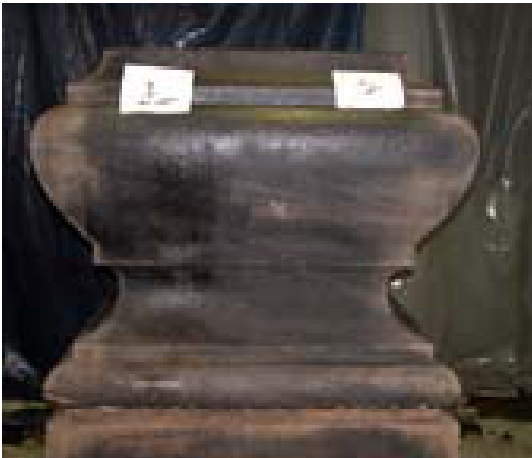
**Figure 19 Second cleaning Test**

After the cleaning of the disassembled stone was underway it soon became evident that the stones on which previous tests had been conducted were not representative of the full range of conditions that would be encountered. Although newly cut sandstone exhibited a remarkable consistency of color, the cleaning results were highly variable from stone to stone and sometimes from one part of a stone to another. The patterns of sediment deposition in the stone were highlighted as surface layers with different densities or absorption characteristics reacted differently to cleaning. In many cases the soiling that was proving difficult to remove was more like a stain that had been absorbed into the surface of the stone. Every stone was examined and rated according to the degree of cleaning achieved. From this a map was prepared in an attempt to identify patterns to the soiling. As might be expected, the inner parapet stones along the roadway were typically less clean and parts of stone that were covered by the earth were cleaned as if they were new. The majority of residual soiling, however, was randomly distributed across the stones. A second round of cleaning tests was conducted, in one case with a product that was under development, and while more effective, the results were still somewhat variable. Those stones requiring supplementary cleaning were identified and re-cleaned using the most effective of the new methods.

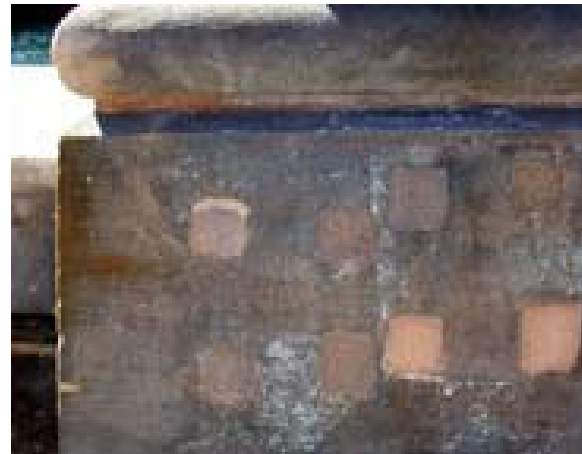
**Figure 20 Test Stain Patches**

Great care was taken in the repair of the sandstone. A specialized stone patching mortar was specified and after numerous attempts the manufacturer was able to produce two shades that were nearly identical to the body of the stone. Because of the variability of the cleaning results, and the desire to have the patches match the color of the adjacent stone surface, a mineral stain was used to tint the surface of certain patches to better blend with the darker stones. If in the future more effective cleaning technologies are developed, this approach will allow the patching mortar and stone to be cleaned to match each other.

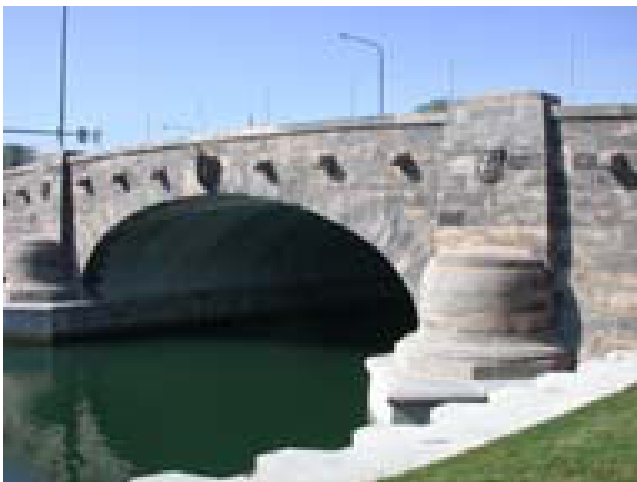
**Figure 9 Restored Bridge**

Supplemental mortar patching was completed on site and staining of selected patches was accomplished. A pointing mortar harmonizing with the color of the sandstone and matching the original color from the bridge was applied and the bridge was given a final cleaning with a masonry detergent.
