DINGMAN DRIVE BRIDGE – REINSTATEMENT OF SEVERED STRANDS ON PRESTRESSED GIRDERS DAMAGED BY VEHICLE IMPACT

Andrew F. Turnbull, P.Eng., Ministry of Transportation Ontario, London, Ontario, Canada
Wade F. Young, P.Eng., Ministry of Transportation Ontario, London, Ontario, Canada
Clifford Lam, P.Eng., Ministry of Transportation Ontario, St. Catharines, Ontario, Canada

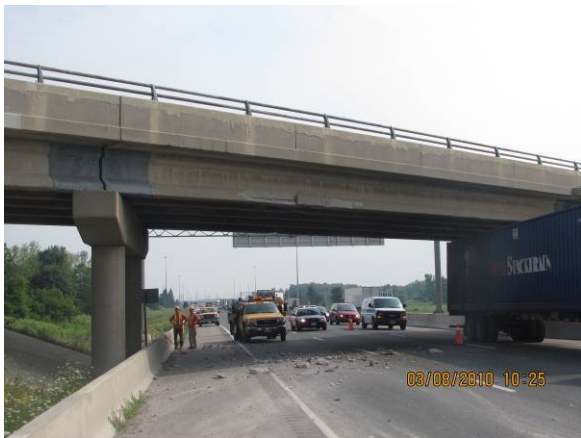
Fig. 3: Dingman Drive West Elevation

Highway 401 carries three lanes of westbound traffic under Dingman Drive. The point of impact was centred over the right lane (Lane #3) of Highway 401, at approximately the third point of the span, eight metres from the north pier.

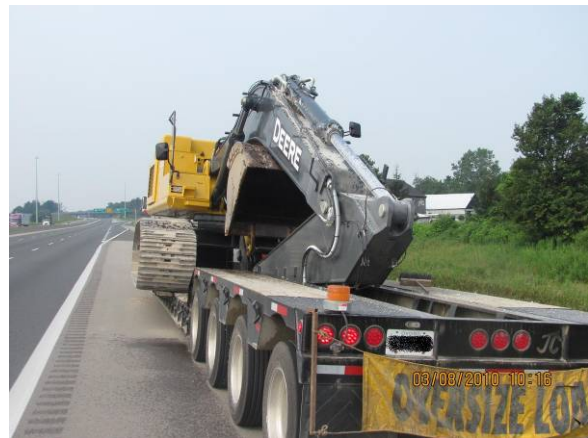
Fig. 4: Oversize load

On August 3rd, 2010, the Dingman Drive Underpass, located on Highway 401 near London, Ontario, Canada was struck by a vehicle carrying an over height load. A tractor-trailer carrying a hydraulic excavator travelling in the westbound lanes of Highway 401 caused significant damage to the four-span bridge when the knuckle of the excavator struck three of the five AASHTO Type III girders over the westbound lanes. In addition to the spalling, cracking in the webs and loss of concrete section in the bottom flange at the impact locations, three prestressed strands in each of two girders were severed by the impact, resulting in temporary closure of the bridge to vehicle traffic.

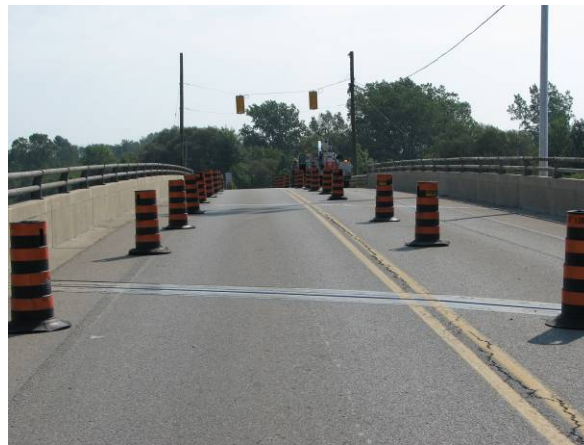
Fig. 8: Single Lane Traffic on Dingman Drive

Following the impact damage to the bridge girders, Dingman Drive was closed and traffic detoured until an assessment of the damage was undertaken by Ministry of Transportation Ontario (MTO) engineers and the MTO's consultant. A structural evaluation was carried out by MTO's consultant to determine if the post-impact structural capacity of the bridge was sufficient to support a single lane of traffic located directly above the two undamaged girders. The evaluation, which assumed that 60% of the live load (a single CL-625-ONT truck) would be distributed to a single girder, determined that the two undamaged girders were adequate to support a single lane. Traffic signals were installed at each end of the bridge and flexible drums (TC-54's) were used to demarcate a single lane of alternating traffic on Dingman Drive (Figure 8). The bridge was reopened to a single lane of traffic two weeks after the initial closure.

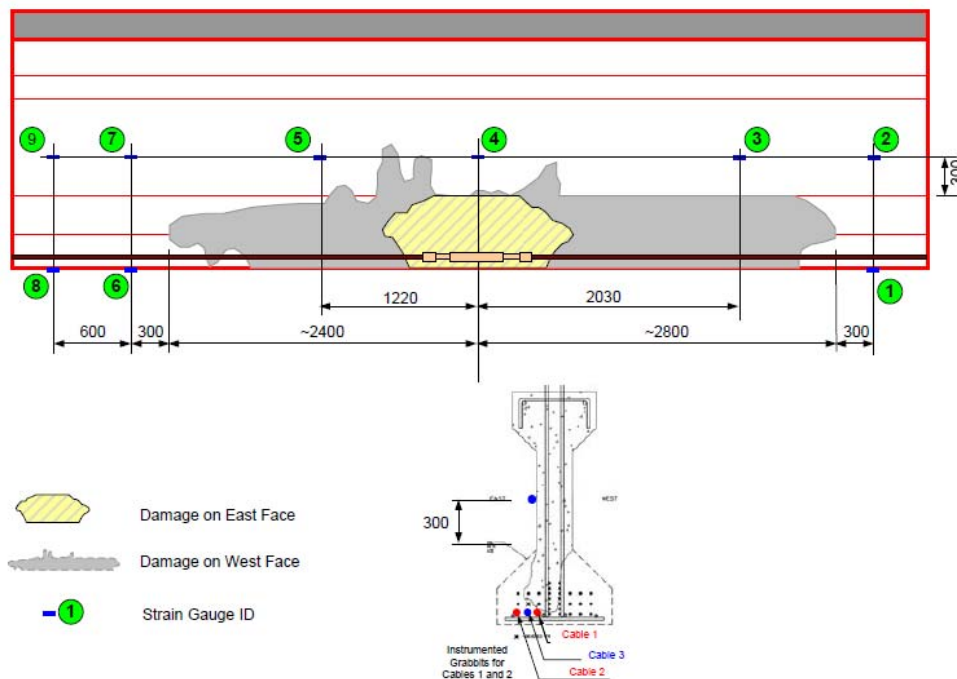
Fig. 18: Instrumentation Plan Details (All dimensions in mm)

Based on the greater extent of damage sustained by Girder #5, it was selected for instrumentation to study the characteristics and effectiveness of the splicing procedure.

A total of thirteen electrical resistance strain gauges were installed, nine at different locations around the damaged area to study the stressing effect on the concrete and four on two of the mechanical couplers to investigate the force development in the couplers.

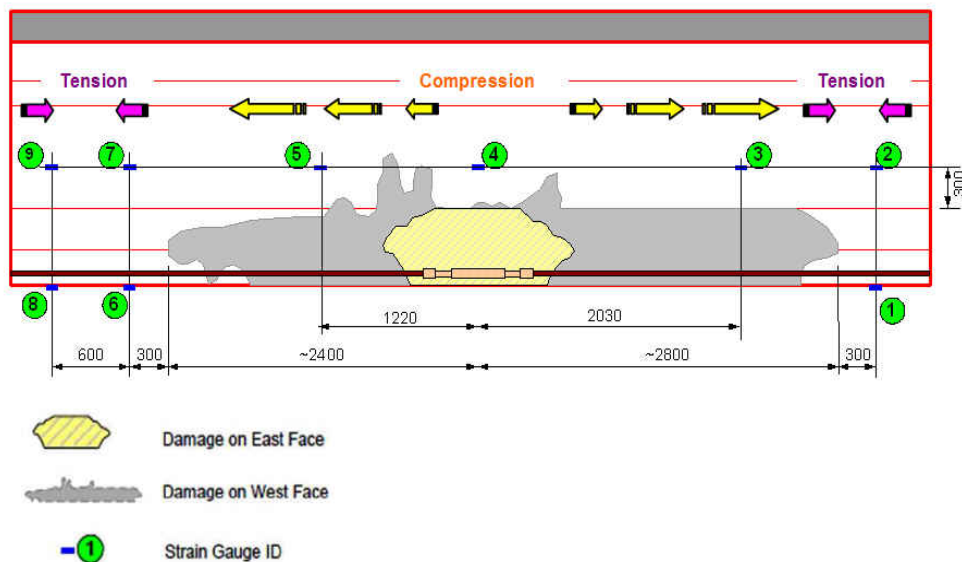
Fig. 19: Effect of Mechanical Coupler Tensioning

- (1) The maximum force measured in the mechanical coupler was about 65 kN.
- (2) The stressing of the strands did not have a significant effect on the concrete around the damaged area with maximum strains of about $-25 \mu\epsilon$ measured by gauge 5 and $28 \mu\epsilon$ by gauge 2. This corresponds to a concrete stress of less than 1 MPa, which indicates that the prestressing force caused by the tensioning of the mechanical couplers was effectively neutralised by the large stiffness of the deck system around the damaged area.

The design force for each prestressing strand after all losses was 105 kN. The prestress in the strands was checked by measuring the elongations, which were close to calculated values. Due to the variability of the two measured results, the final force in the strands is estimated to

be between 60% and 90% of the design force. Since the three broken strands in each girder represented less than 10% of the total number of strands, this was considered acceptable.
