EMERGENCY REPLACEMENT OF BRIDGES

Geetha Chandar, PE, Texas Department of Transportation, Austin, TX
John M Holt, PE, Texas Department of Transportation, Austin, TX
Jamie Farris, PE, Texas Department of Transportation, Austin, TX
Mark A Steves, PE, Texas Department of Transportation, Austin, TX

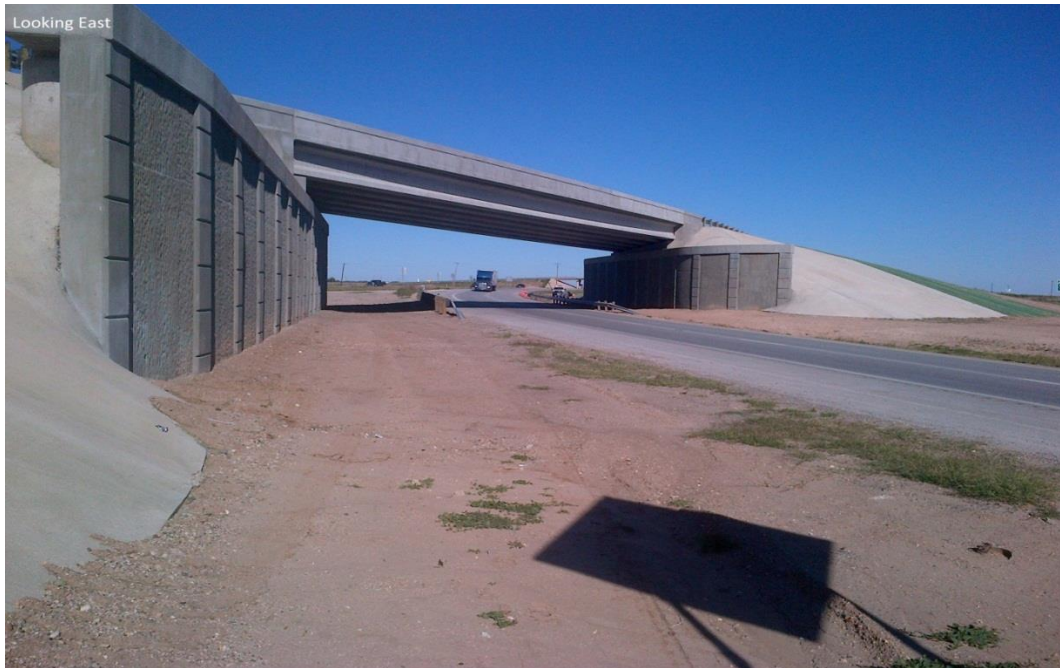
Figure 3 New Retaining wall wraps around the abutment

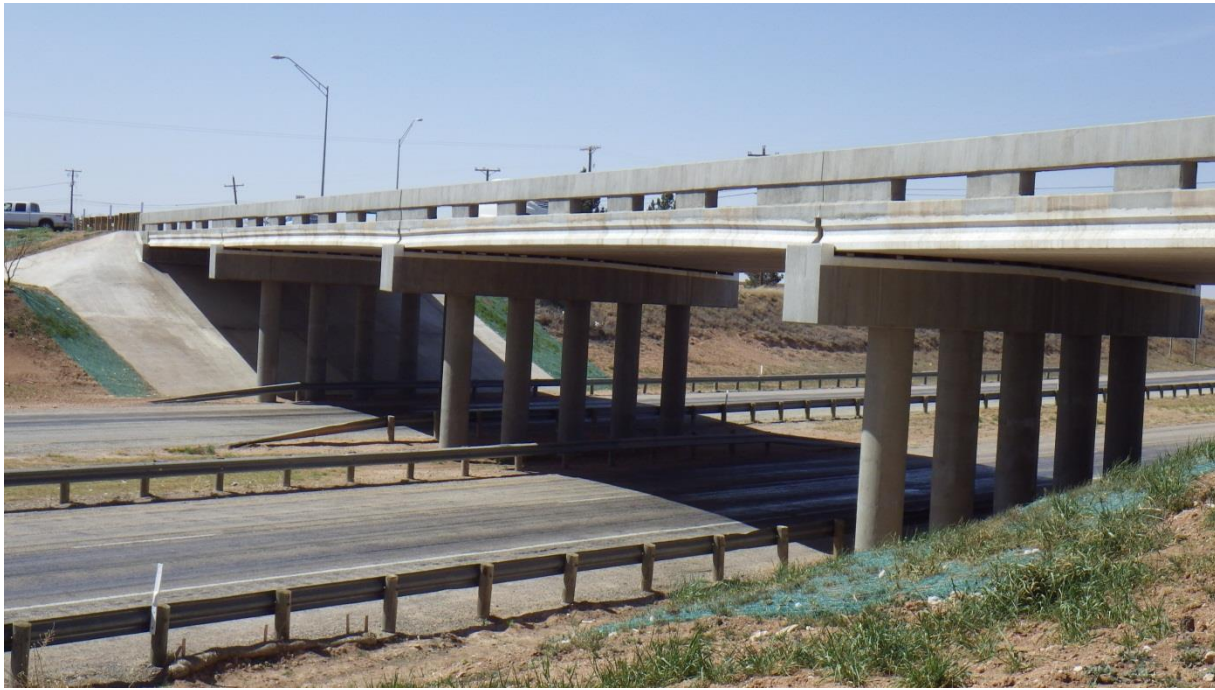
Figure 10 Completed Bridge Structure – US 184 Underpass at US 84 in Snyder County.

The replacement bridge used the same alignment but the vertical profile was higher than the existing bridge in order to maintain a vertical clearance of 17'-6". Since the XB20 box beams in the new bridge have considerably less section depth than the existing steel beams, there is an increase in vertical clearance. Using precast concrete beams reduced the material delivery time, but increased the bridge dead load. The station of interior bents and abutments, located in the main lanes remain unchanged. Two additional drilled shafts were added, one in between each existing drilled shaft, which were designed to carry the additional load of the new bent caps and super structure. The existing columns were removed to 2'-0" minimum below existing grade. The reinforcing steel of the existing drilled shafts were cleaned and extended into new column. The new Grade 60 reinforcement steel from the columns was connected to the existing bars by welding or mechanical couplers per Item 440, under "Reinforcing Steel" specifications³. A sealed armor joint was used at each abutment.

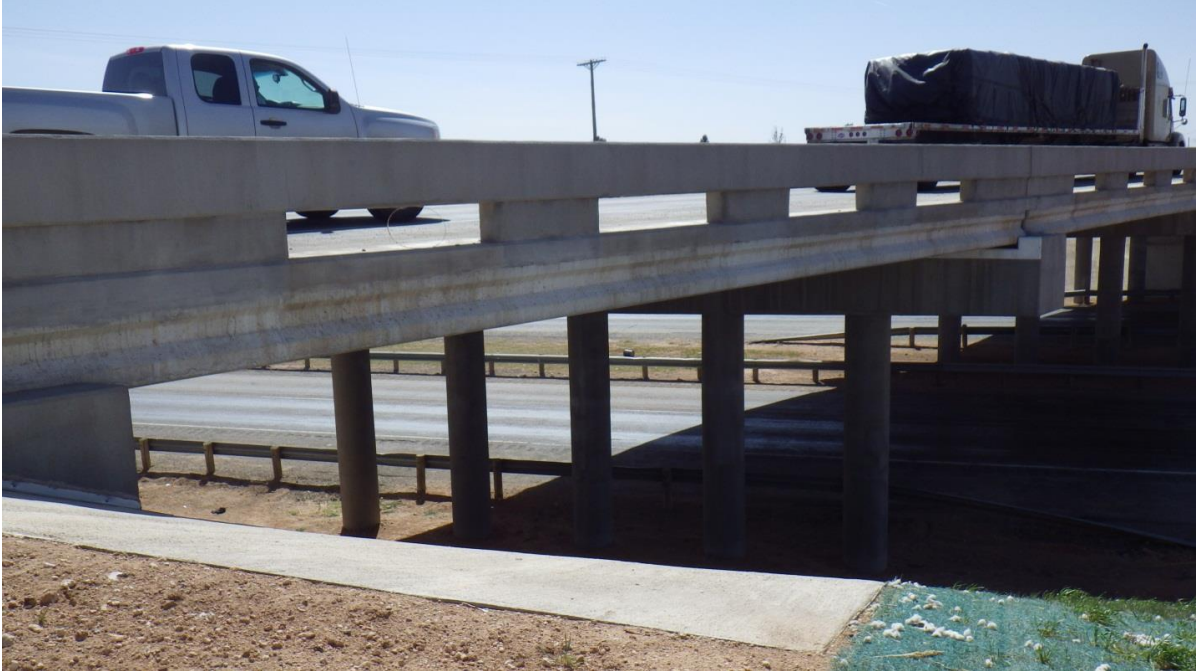
Figure 11 Completed Bridge Structure with T 223 Rail (Vertical Clearance 18.0')

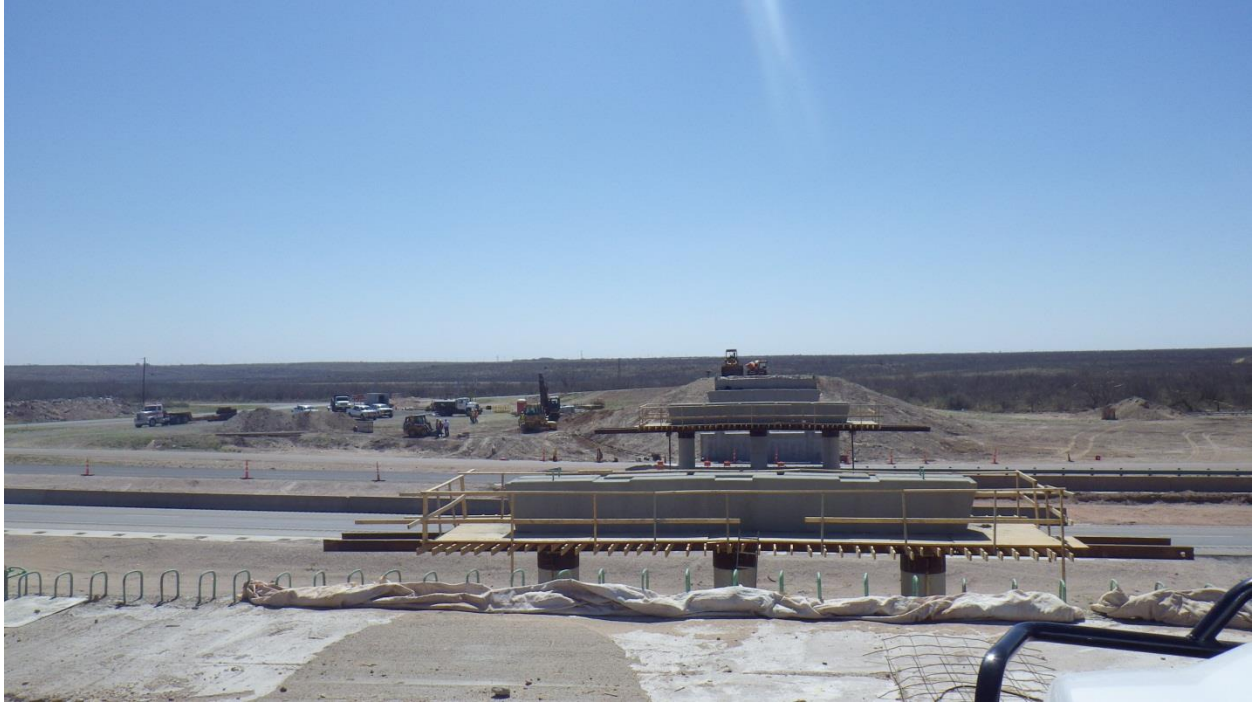
Figure 17 New Bridge with Four Spans

Lastly, the replacement bridge is 25 ft. longer than the original. This ensures that the existing abutment pilings won't be in the way of the new abutment drilled shafts.
