ASSESSMENT OF A PARKING GARAGE WITH A BROKEN PRESTRESSED SPANDREL BEAM

Bishal Parajuli, EIT, Dept. of Civil Engineering, University of Toledo, USA
Seyedowjan Hashtroodi, EIT, Robert Darvas Associates, Ann Arbor, MI
Douglas K. Nims, PhD, PE, Dept. of Civil Engineering, University of Toledo, USA

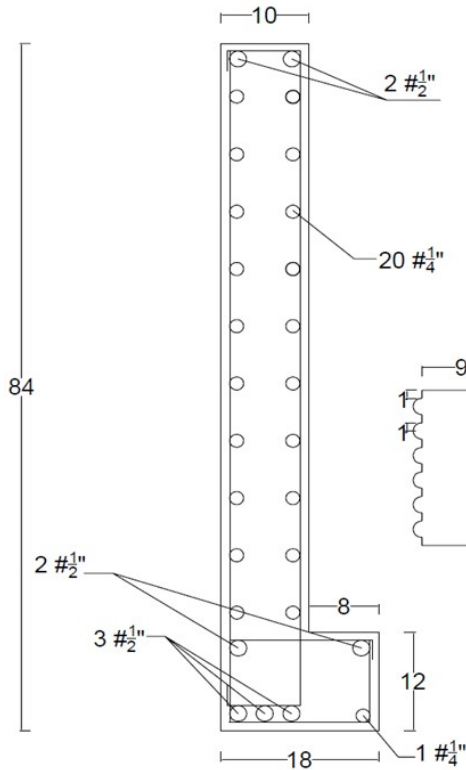
Figure 3 shows the cross section of the spandrel. Figure 4 shows a detail of the 10 inch width of the stem which consists of 9 inches of solid section and 1 inch of grooved exterior. The longitudinal reinforcement in the section consists of 28 prestressing strands: seven one-half inch prestressing strands and 21 one-quarter inch strands. There was no conventional longitudinal reinforcing steel. At the mid-span of the beam, where the crack occurred, there are number 4 bar vertical stirrups at twelve inch spacing.

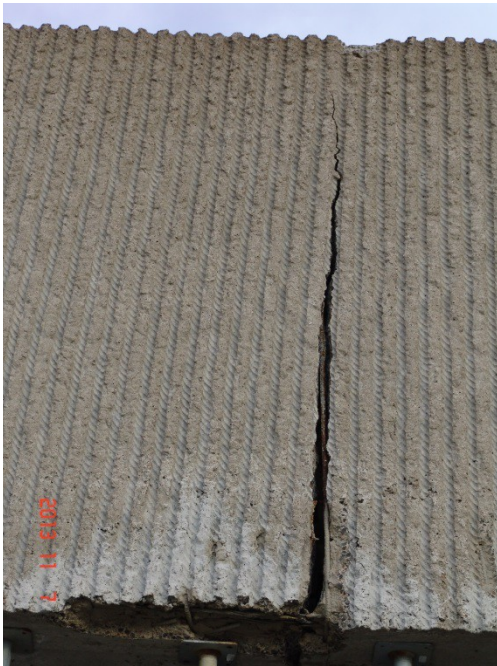
Figures 5 and 6 show the interior and exterior details of the crack. Note in Figure 5, the concrete is spalled at the top of the crack. In Figure 6, evidence of water leaking through the deck joint near the crack location can be observed. Figure 7 shows the crack extending upward from the deck to within a few inches of the top of the beam. Note the repairs in the deck joint near the crack indicating a history of leakage. The failure surface was inspected thoroughly. Even though small cracks could be easily observed on the painted interior surface, there was no sign of any distributed small cracks near the main crack, which would normally form in a ductile failure. There was only one dominant crack which had propagated through the depth of the beam at the mid-span. This is evidence of a brittle flexural failure.

The crack was approximately two inches wide at the bottom of the beam. Viewed from inside the garage and from the top deck there was an easily visible kink in the beam. Inspecting the joint between the failed beam and the adjacent beams, it was clear the failed beam had broken into two pieces which had rotated as rigid

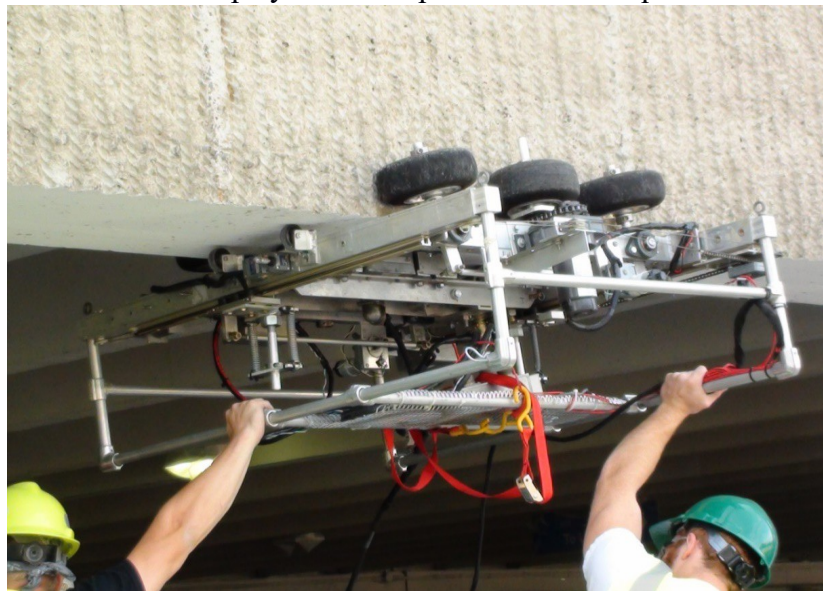
MFL is particularly well suited to this application because it uses a permanent magnet which is much lighter than the electromagnets required by the main flux and residual magnetism methods. The magnet and Hall-effect sensors are mounted on robotic beam traveler which can hang from the lower flange of the beam. The movement of this beam traveler can be controlled from the ground. As it travels along the length of the beam, it scans the condition of steel strands inside the beam. As the traveler scans, the flux data is acquired by a PC based data acquisition system. A graph of the data is displayed to the operator as it is acquired. The sensors can cover only half width of the beam so two passes had to be made. Thus, for a particular beam, the full width scan result comprises of the scan result of east half and west half. As can be seen in figure 16, the tires of the robotic beam traveler gripped the exterior faces of the beam while it moved. The wheels are angled upward to keep the traveler from slipping down.
