## DISTRESS AND REPAIR OF PRECAST PARKING STRUCTURE DECKS

Peter Tarara, Michael Lee, Carl Peterson and Donald Meinheit

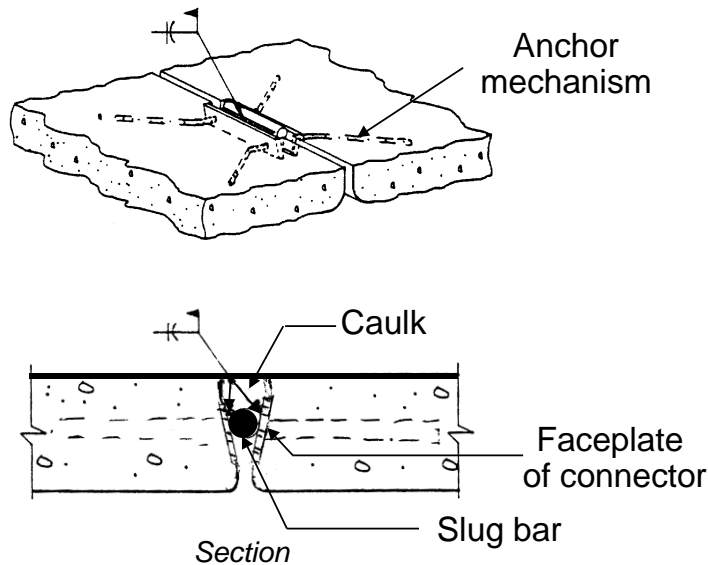
Figure 6. Sketch of flange-to-flange connection with sloping faceplates to hold the slug bar

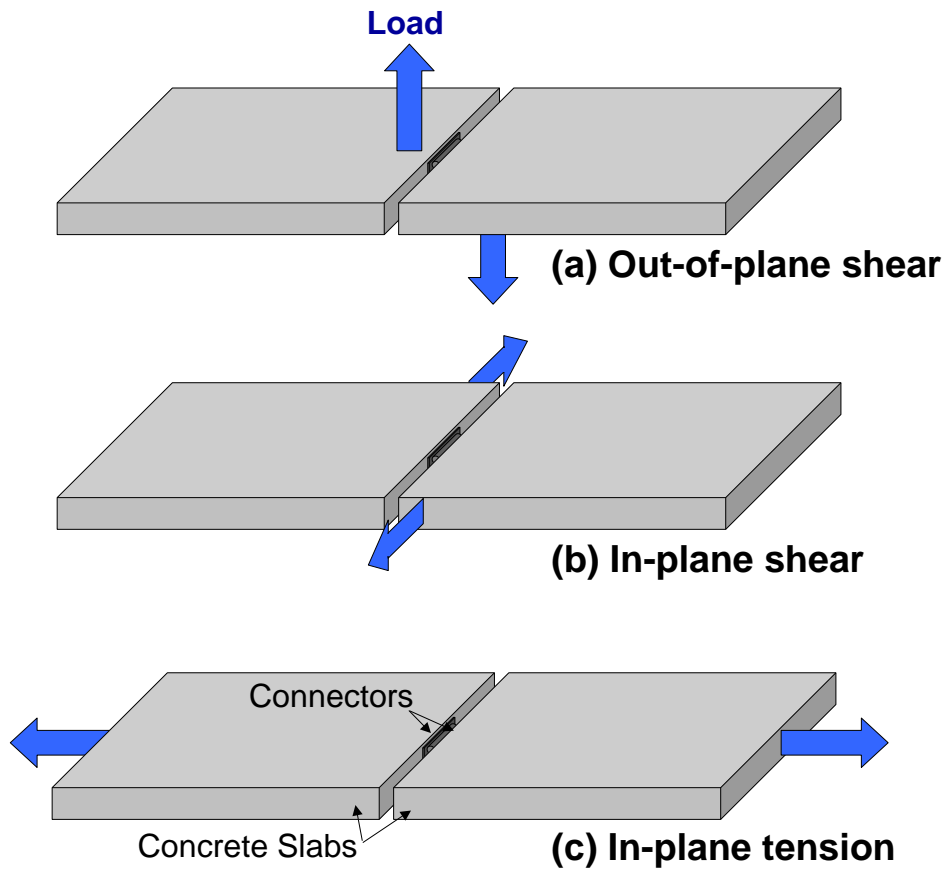
Out-of-plane forces, as indicated in Figure 7a, occur due to gravity load sharing between adjacent double tees, most commonly from vehicular traffic live loading. Out-of-plane forces may also be generated during erection alignment of adjacent double tees where a member may be jacked into place, welded and then released, allowing the dead load of the double tees to redistribute throughout the deck. In-plane shear forces in the longitudinal direction of the double tee, as shown in Figure 7b, are created when the floor system is required to act as a diaphragm in transferring lateral loads to the lateral force resisting structural elements (e.g. shear walls).

In-plane tension forces, shown in Figure 7c, are often generated because of restraint to volume-change. Drying shrinkage of concrete and temperature change are the primary sources of in-plane tension, although such forces can also occur if the floor is a diaphragm and the connections act as chord reinforcement. In some cases, compression is possible from lateral-load induced diaphragm forces or extreme temperature changes.

Figure 7. Types of forces on flange-to-flange connectors
