PERFORMANCE OF COMPOSITE CONCRETE BRIDGE DECK UNDER HYDROCARBON POOL FIRE EXPOSURE

Eyosias Beneberu, Ph.D., P.E., Dept. of Civil Engineering, University of Texas at Arlington,
Arlington, TX

Nur Yazdani, Ph.D., P.E., Dept. of Civil Engineering, University of Texas at Arlington,
Arlington, TX

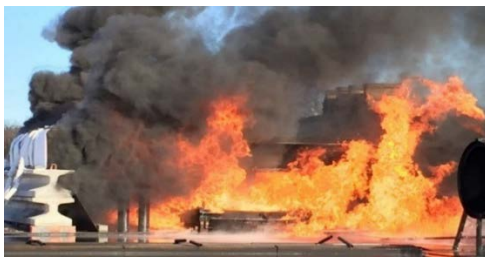
(a) even distribution of fire

The pan was filled with water to a depth of 0.25 m first, followed by the fuel and finally the fire was started. The winds were calm at the beginning of the test, as can be seen from the even distribution of flames in Fig. 7(a). But few minutes after the fire initiation, a 5 m/s southeast wind started and disrupted the fire distribution, as seen in Fig. 7(b). The wind persisted until the end of the test. Thus, girders 1 and 2 experienced more fire exposure than girder 3.

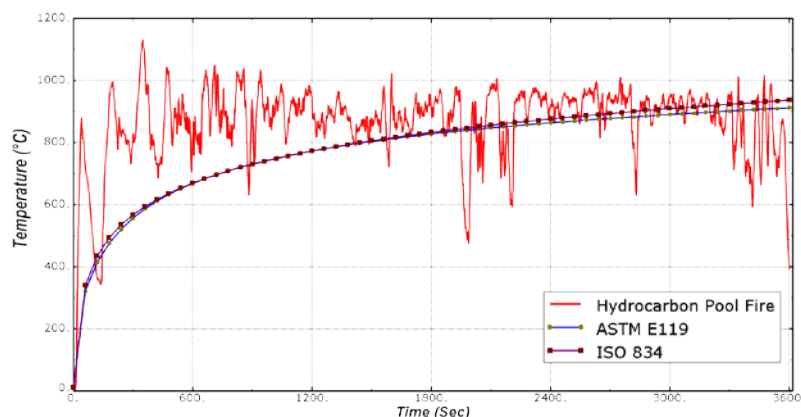
Fig. 8. Time dependent variation for the hydrocarbon pool fire and standard fire temperatures

Figure 8 shows the temperature versus time reading of the fire measured at the mid-span of the bridge. The fire temperature reached a maximum of 1131°C. During the growth phase, the peak temperature was 876°C within 41 secs after the fire initiation. During the decay phase, the temperature plunged by 800°C in three minutes. The fire temperature fluctuated due to the prevalent wind. A temperature difference of 640°C was observed between the readings taken at 2.3 minutes and 3.3 minutes. These erratic thermal fluctuations caused thermal shock which eventually contributed to concrete cracking and spalling.

The temperature versus time for two of the most commonly used standard fire curves, ASTM E119¹⁶ and ISO 834²⁶, are also shown in Fig. 8. Both standard curves peak to the maximum temperatures at a very slow rate, as compared to the open pool hydrocarbon fire curve. No fluctuations of temperature are included in the standard fire curves, because the tests are performed under controlled environment. The temperatures from the hydrocarbon fire were generally greater than the standard fire curves for most of the 60 minutes duration.

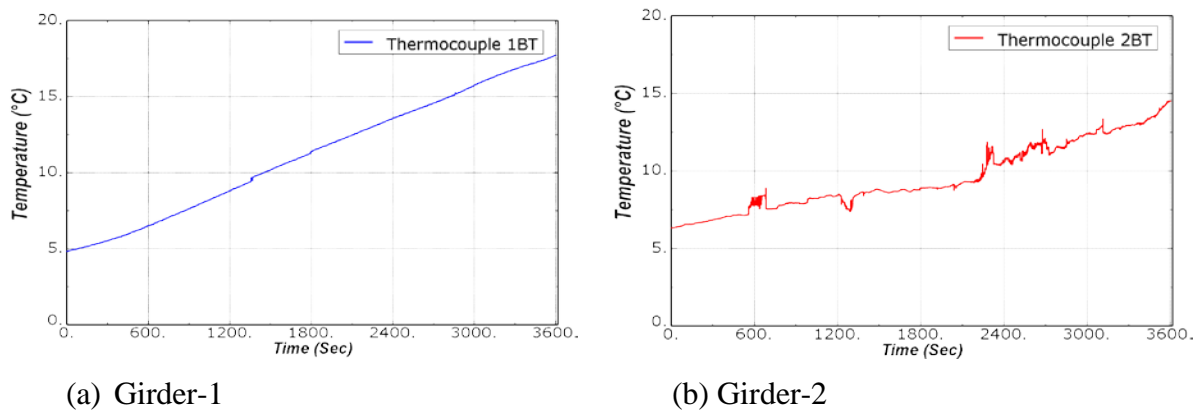
Fig. 10. Temperature versus time curves at girder-concrete interface

Figures 10(a) and (b) show the temperature versus time measurement at the deck-girder interface for Girder 1 and 2, respectively. The maximum temperature readings from both thermocouples were minimal, 18°C in the former and 15°C in the latter. This was due to the

low thermal conductivity and high thermal capacity of concrete, which played a key role in slowing down the heat penetration to the interface. Among the girders, Girder 2 was provided with a cement-based dry mix fireproofing mortar for wet sprayed application. The detail information on the design and application scheme may be accessed in the literature²¹. As a result, its peak temperature was lower than that in Girder 1. As shown in Fig. 9, there is no loss in the yield strength for mild reinforcement up to a temperature of 400°C. Thus, the measured temperatures at the deck-girder interface did not adversely affect the shear resistance derived from the dowel action of rebars. Visual observation after the fire test revealed melted and charred bedding strips (Fig. 11). However, no cracking or interfacial slippage between the deck and the girder was observed that could affect the composite action. Differential thermal expansion during a fire event may cause distortion in the overall geometry of the deck. However, none was observed in the current investigation.

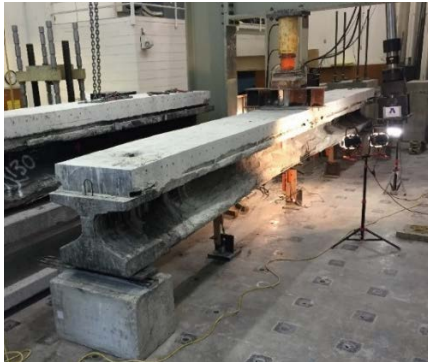
(a) Test set-up

Following the fire test, the deck was saw cut and each girder was tested in the laboratory under a three-point bending set-up to determine their residual strengths [Fig. 12(a)]. During loading, it was observed that cracks originate from the girder and propagate towards the deck [Fig. 12(b)]. However, no slippage or cracking was observed at the interface between the two until

the conclusion of the test. All three girders failed by yielding of the prestressing strands. From the results of the fire and the residual strength test, it can be concluded that the fire did not affect the composite action between the girder and the deck.
