Rehabilitation of the Boivre Viaduct — A Multispan Prestressed Box Girder Bridge

Synopsis

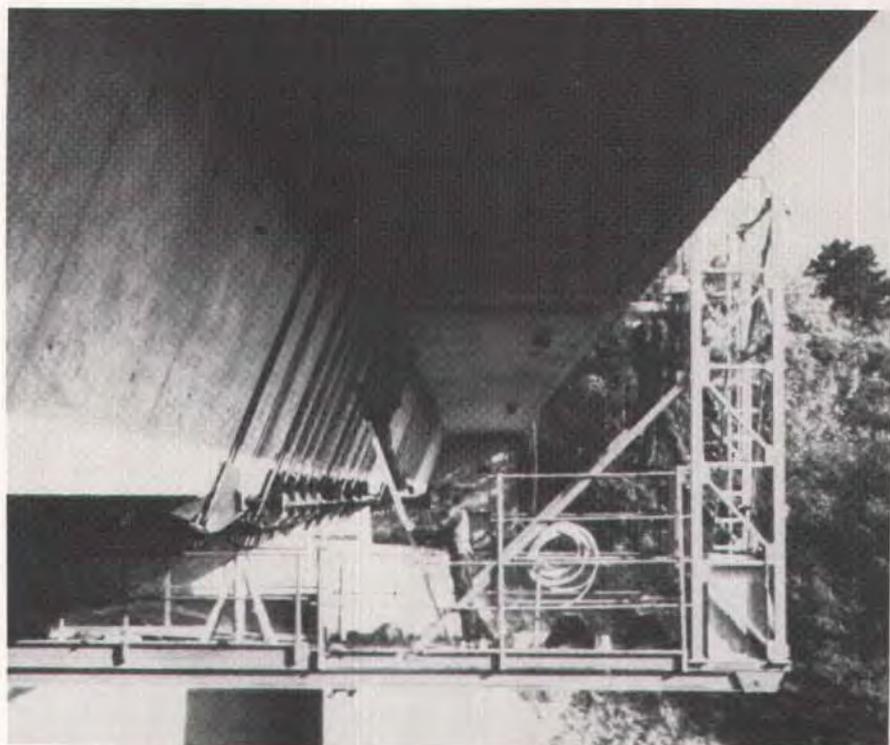
Fig. 8. Inspection of exterior faces of box girders from snoopers.

making up the structure. For large structures such as the Boivre Viaduct the use of mobile walkways and snoopers is required (see Fig. 8). Also included in the in-depth inspection are measurements of bridge bearing deformations and joint movements due to temperature variations. Elevations along the bridge spans are also determined.

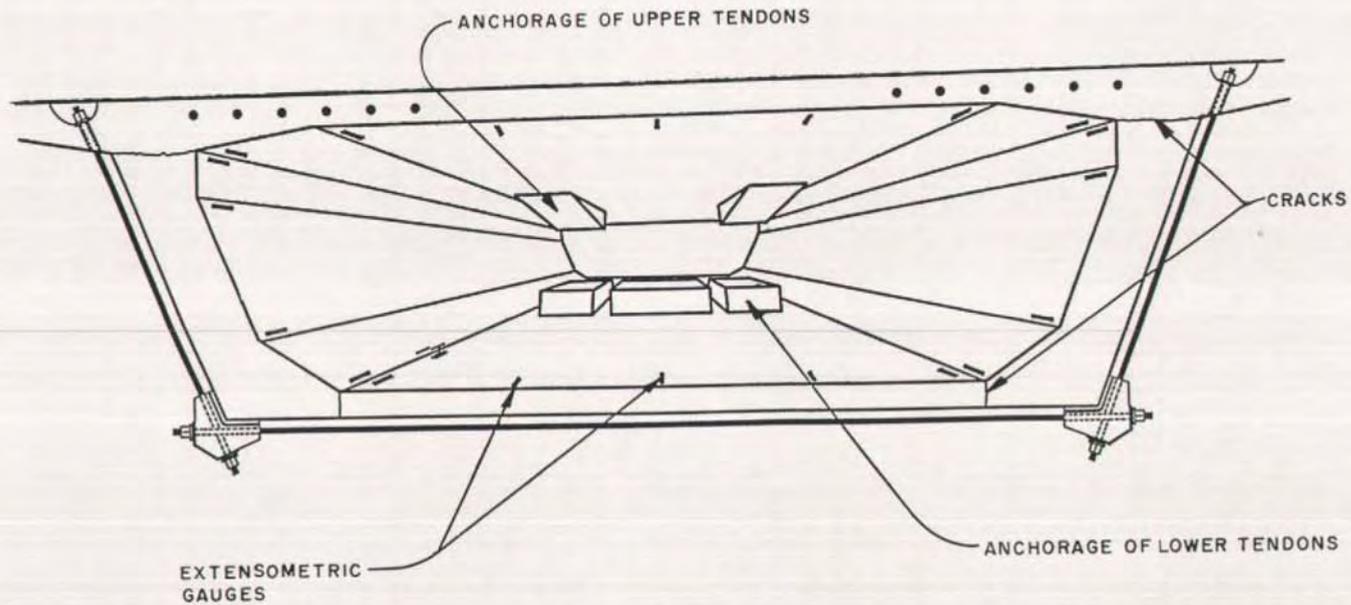
Fig. 9. Location of gauges in one of five box girder sections to measure strains in longitudinal direction.

4. Extensometric Gauges — As shown in Figs. 9 and 10, a large number of extensometric gauges were installed in the box girders to measure strains in both the longitudinal and transverse directions. Altogether, a total of 110 longitudinal extensometric gauges were installed in five transverse sections, i.e., 22 gauges per section, as shown in Fig. 9 in order to measure strains in the longitudinal direction. In addition, 77 gauges were installed to measure the transverse strains in seven sections (see Fig. 10).

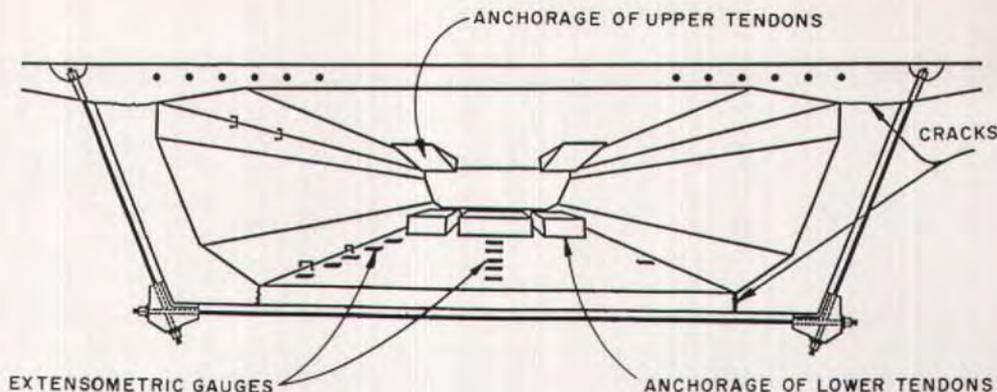
Fig. 10. Location of gauges in box girder to measure strains in transverse direction.

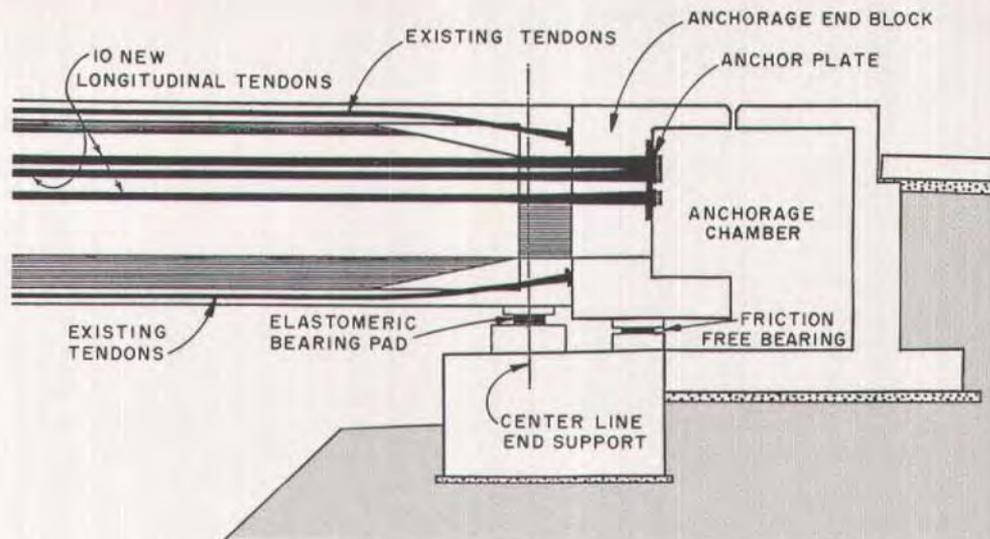
Fig. 14. Longitudinal section at end anchorage block showing new longitudinal tendons.

Lastly, the installation of appropriately located longitudinal tendons (see Fig. 14) from one end of the viaduct to the other would produce the additional horizontal compressive stresses desired. The new tendons, when combined with the restored, existing longitudinal tendons in the slabs (the only existing flexural reinforcement so far) would make the structure capable of carrying the superimposed design loads which the originally constructed viaduct could not.

The design called for the construction of 3 ft 3 in. (1 m) thick reinforced concrete end blocks to be stiffened by three 6 ft 6 in. (2 m) thick beams and reinforced with 500 lb of mild reinforcing steel per cubic yard (about 300 kg/m³). For details refer back to Fig. 14. The ten anchorages bear on two 4 ft x 3 ft 3 in. (120 x 1 m) steel plates (see Fig. 18).

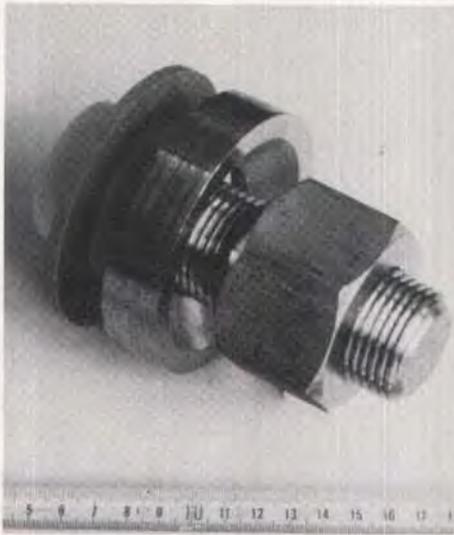
Fig. 17a. Bar anchorage developed in France for stainless steel of the type used in the rehabilitation of the viaduct.

(c) Nut and washer interfaces are spherical, to minimize undesirable bending stresses. Thus, the anchorage consists of a bar threaded at its ends, a nut with a spherical base, a circular washer with a spherical upper face, an insulated washer, and a nylon washer (see Fig. 17a). A detail of the threads is shown in Fig. 17b.

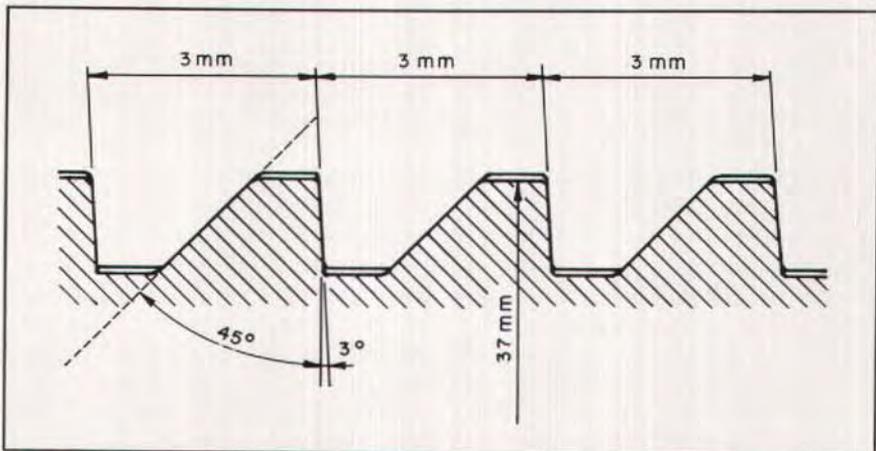
Fig. 17b. Threads at end of bars.

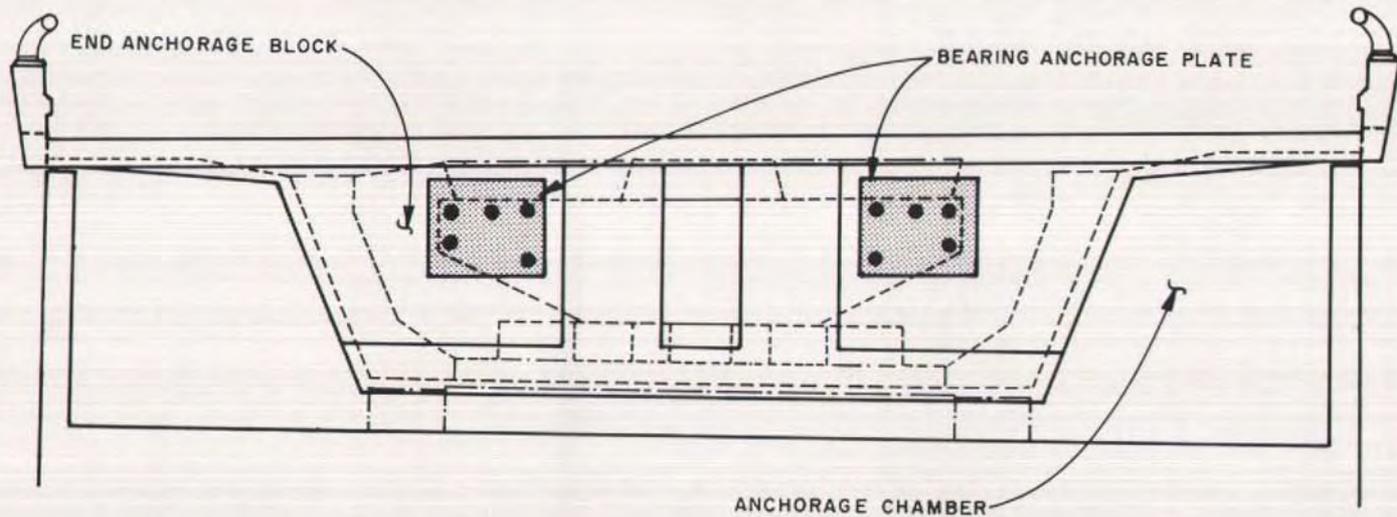
Fig. 18. End view of end anchorage block showing location of tendon bearing plates.

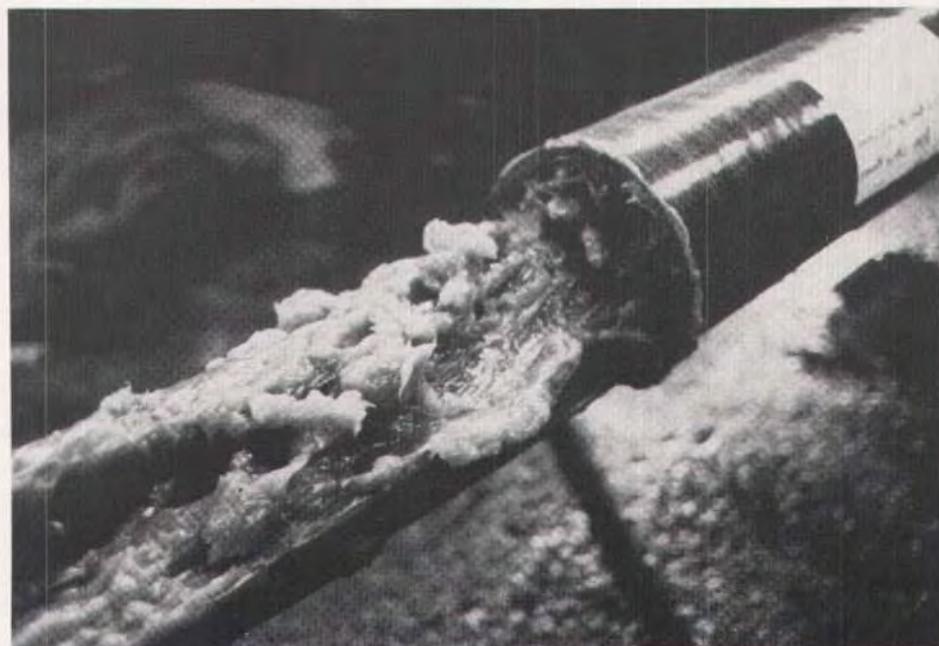
Fig. 20. Wax-based product as developed by the ELF Corporation for corrosion protection of stainless steel bars.

Eventually, based on further investigations, the ELF Corporation (the largest oil company in France) proposed the use of a wax-based product (see Fig. 20). Some of the advantages of wax-based products are as follows:

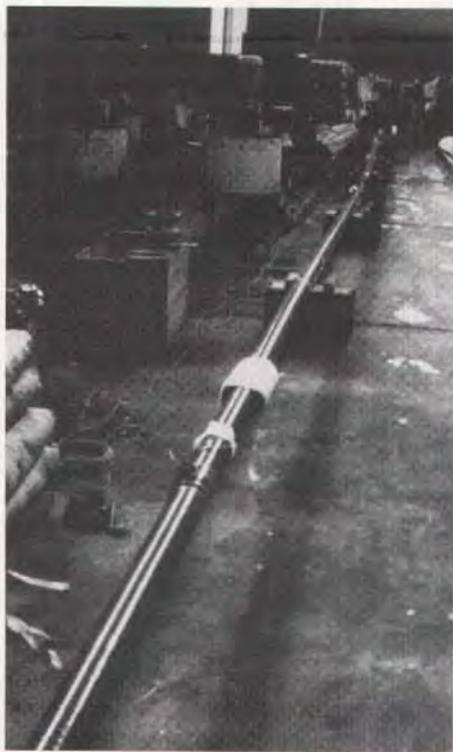
Fig. 21. Laboratory test for corrosion of waxed tendon in duct.

The feasibility and practicality of infusing a wax-based product in a duct under site conditions remained to be investigated. Therefore, tests at temperatures of 54°F (12°C) were conducted and the material was infused in an 82 ft (25 m) duct. Under a pressure of less than 14.2 psi (1 kg/cm²), it was possible to fill the duct very easily within 3 minutes (see Fig. 21).

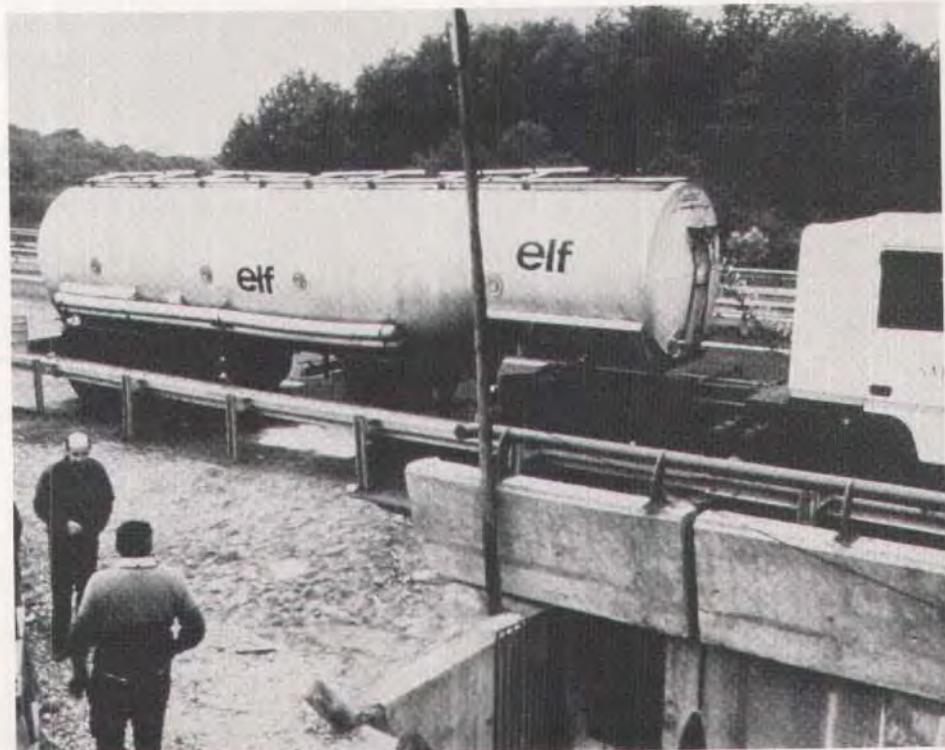
Fig. 22. Specially equipped truck for waxing tendons.

the use of specially equipped trucks, was developed to meet field site conditions (see Fig. 22).
