Performance of Precast and Prestressed Concrete in Mexico Earthquake

Mark Fintel

Consulting Engineer
Chicago, Illinois

Note: This report is based upon the author's observations during a visit to Mexico, October 13-17, 1985, on behalf of the Prestressed Concrete Institute.

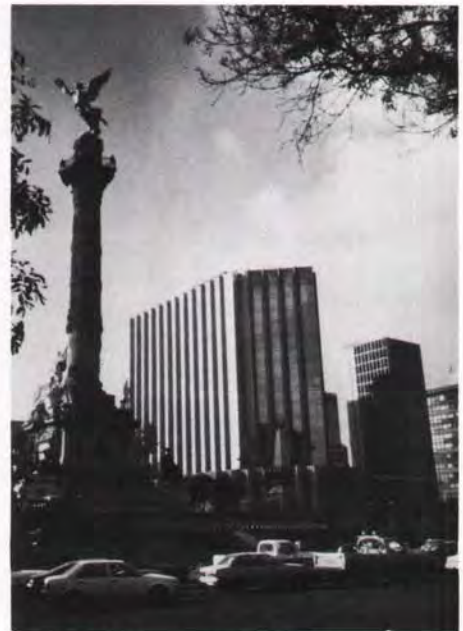
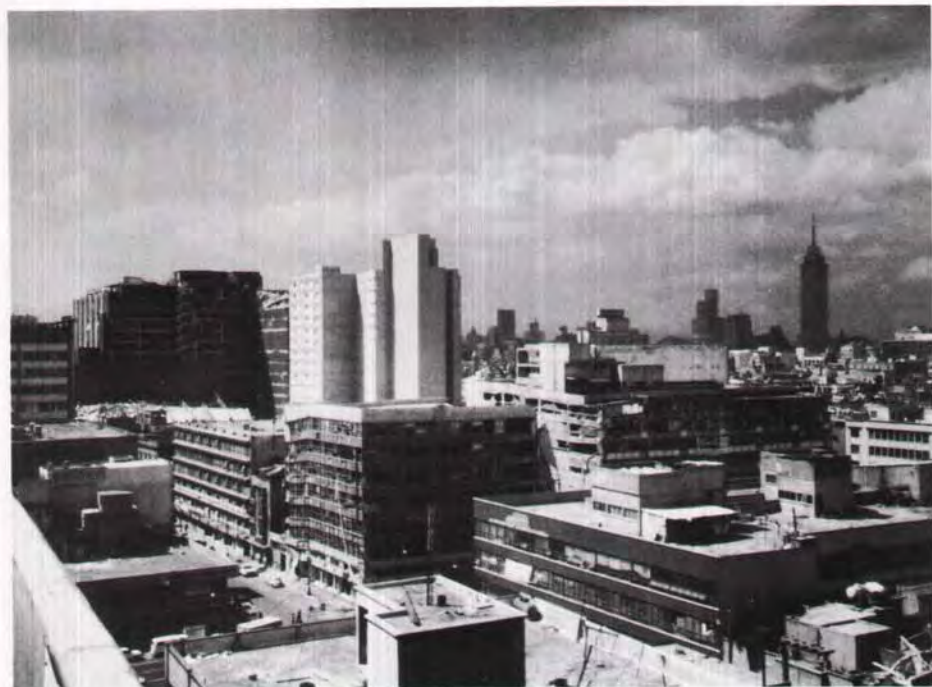
An important observation is that an overwhelming majority of the buildings located in the area of maximum damage, even those in the period range susceptible to this earthquake, fared extremely well. In most cases, collapsed buildings were surrounded by others which went through the earthquake undamaged (Figs. 8 and 9).

Fig. 8. Most buildings behaved well.

Fig. 9. Most buildings behaved well.

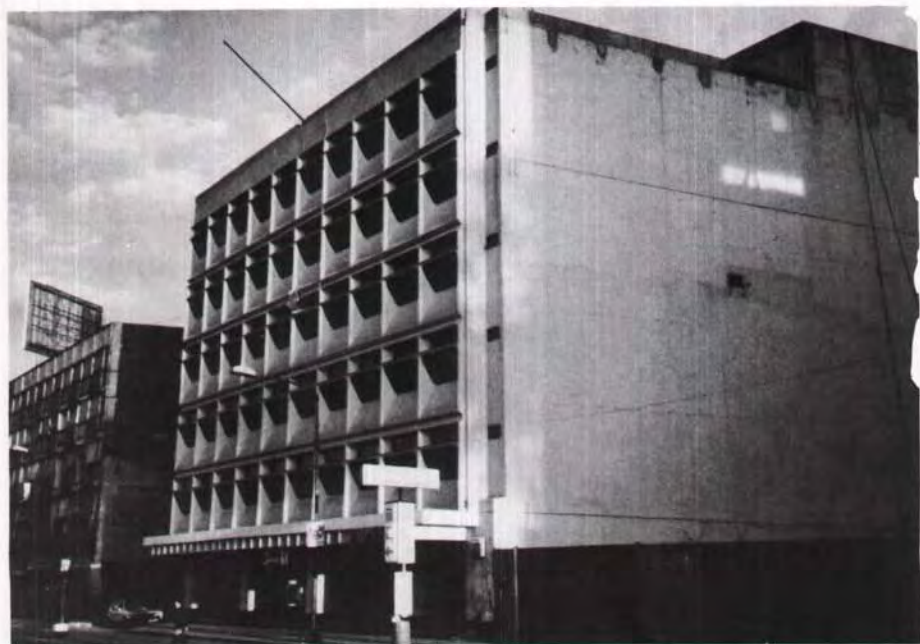
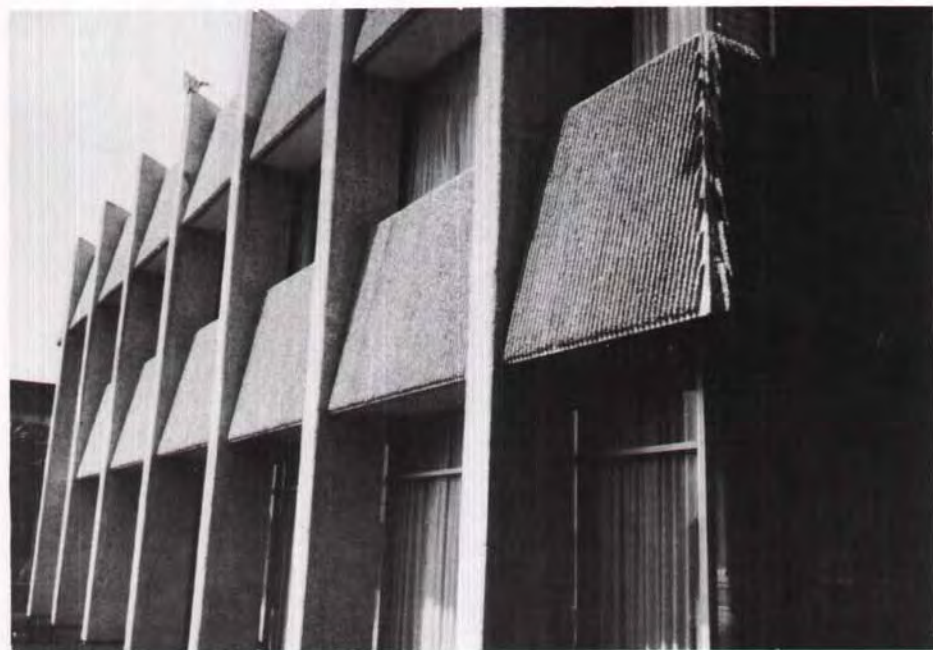
Fig. 10. Architectural precast concrete cladding.

Fig. 11. Architectural precast concrete cladding.

tectural precast concrete panels, many were in the zones of severe damage. The architectural cladding panels performed very well during the earthquake (Figs. 10 and 11).

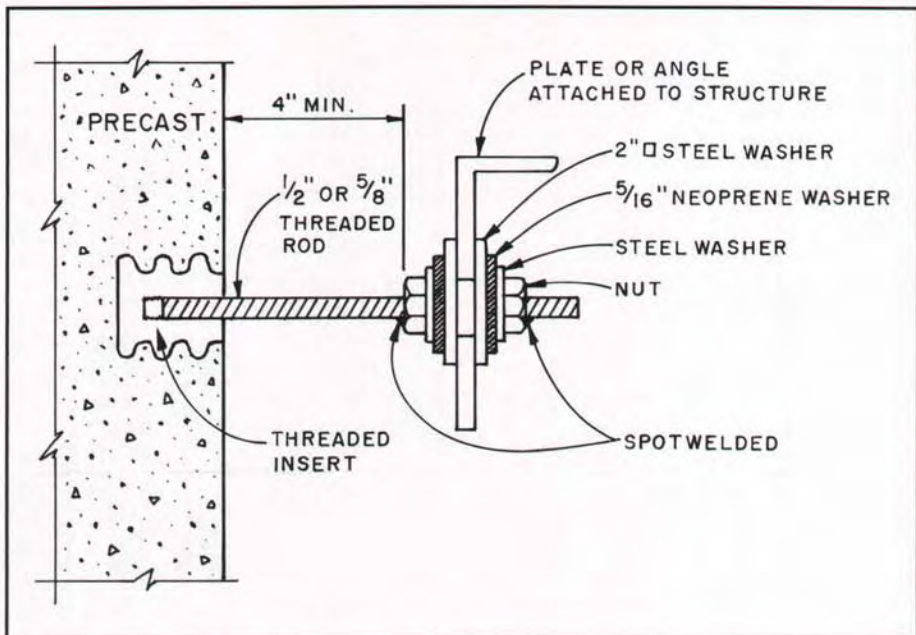
Fig. 16. Detail of architectural panel attachment.

It is customary in Mexico to attach architectural panels by welding the insert plates at the bottom of the panel to the structure and to use the detail shown in Fig. 16 at the top of the panels to allow for relative movements of the panels due to thermal and shrinkage effects of the panels, in addition to shrinkage and creep of the columns. This detail also allows for frame distortions due to wind or earthquakes without damaging the precast panels. Fig. 17 shows a picture of this detail.

In a number of instances, where significant nonstructural damage to multistory buildings attested to interstory distortions, the architectural cladding of these buildings remained fully intact. This stability indicates that the detail shown in Figs. 16 and 17, which was used in these buildings, provided sufficient distortion capacity to allow the distortions of the structure without damage to the panels.

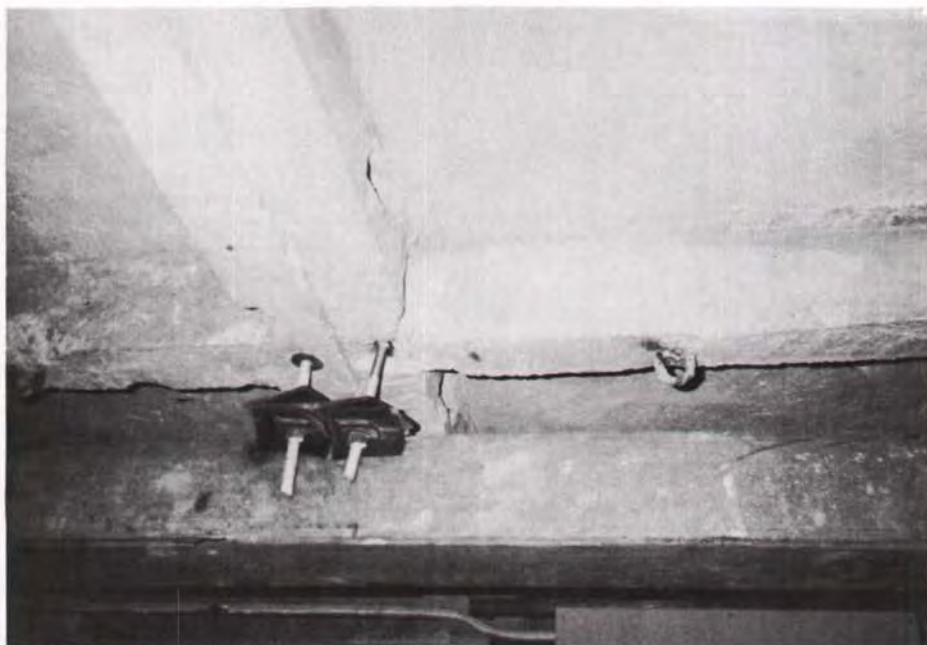
Fig. 17. Panel attachment detail.

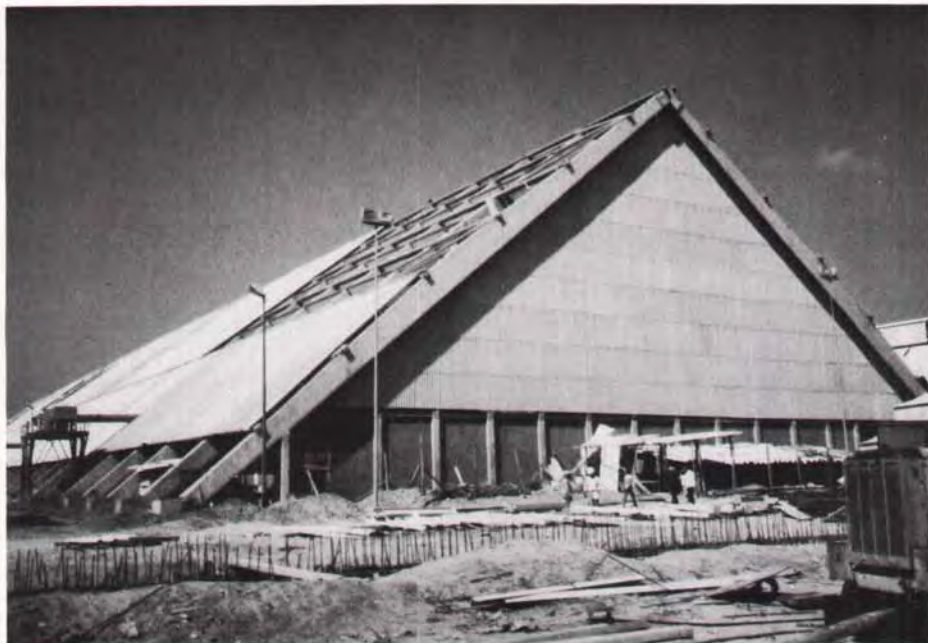
One of the reasons prestressed concrete was selected for these structures was the need for protection against corrosion, which is a usual requirement in the environment of chemical plants. At this fertilizer plant there were three giant horizontal industrial "A-frame" silos* (Fig. 18). The fourth is now under construction. Each of the three-hinged silos measures 68 × 280 m (224 × 918 ft) in plan and is 28 m (92 ft) high at its apex.

Fig. 18. Giant horizontal silo.

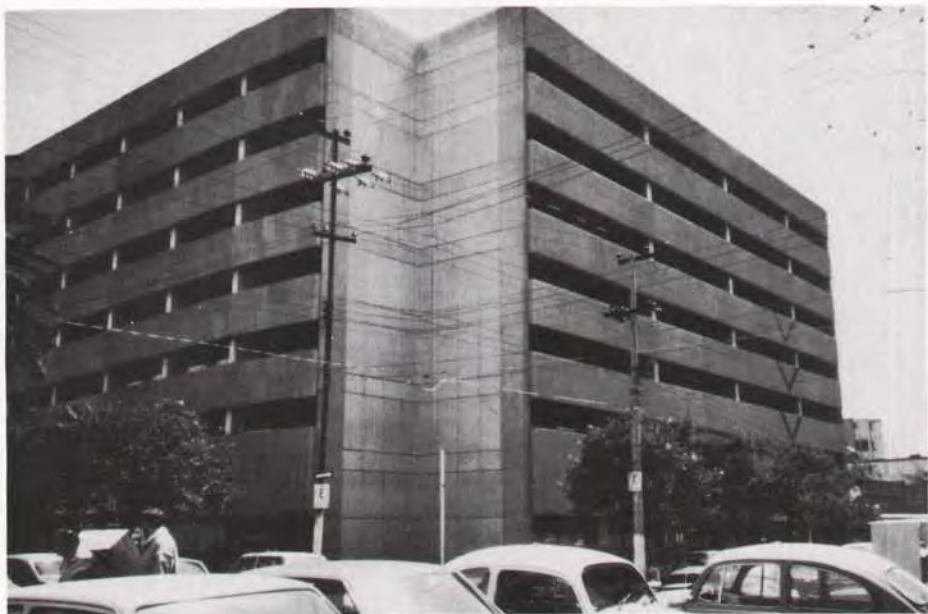
Fig. A3. Seven-story parking garage at Moreno Street.

curred during the earthquake (Fig. A3). The structural system has three 17 m (56 ft) spans of prestressed single tees supported on inverted tees on the interior and L-beams at the exterior ends. These in turn are carried

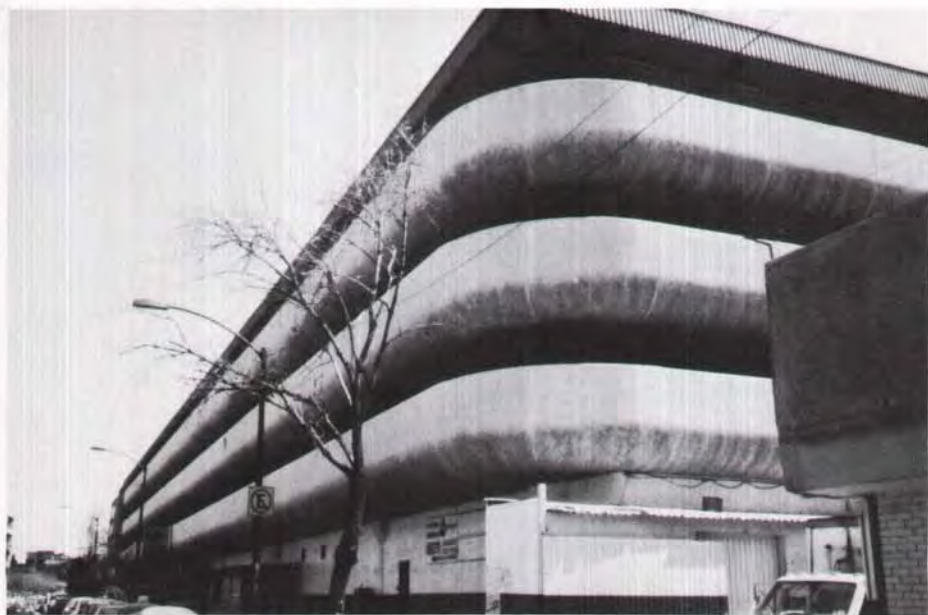
This structure is located at Antonio Anza and Cuauhtemoc Avenue (Fig. A5) across the street from the General Hospital collapses and adjacent to the Multifamily Housing Complex collapse. The lower story of the parking garage is used for commercial space and the upper three stories for parking.

Fig. A5. Four-story parking garage in the zone of maximum damage.

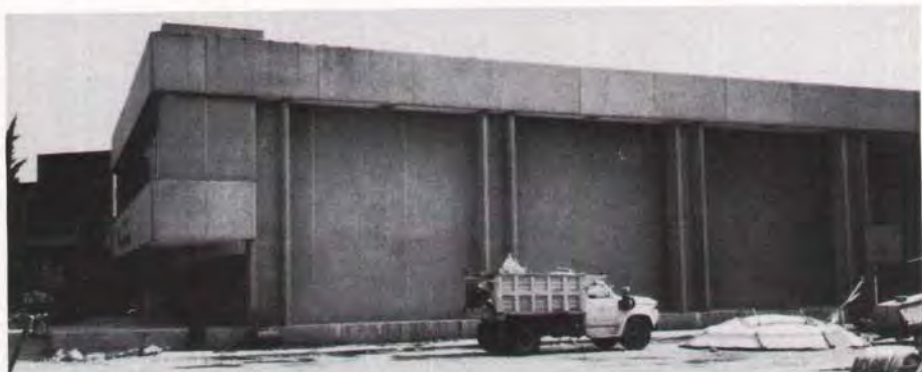
Fig. A7. Abraham Ayala Gonzalez Auditorium.

single tees spanning up to 25 m (82 ft). There is no sign of any distress whatsoever in the structure.

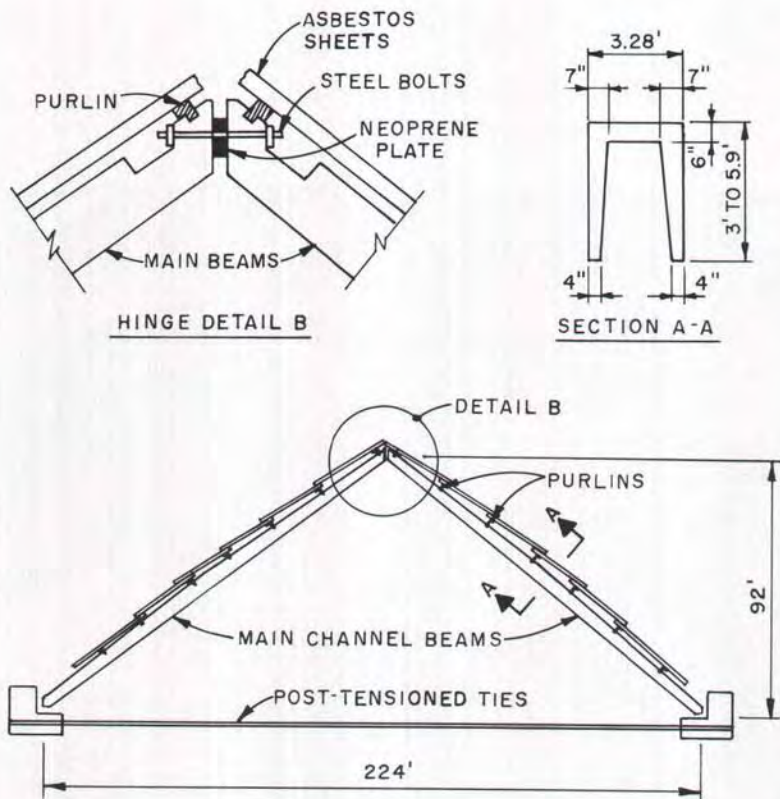
Fig. B1. Section of silo and details.

As a result of the earthquake, only a very

few purlins have fallen off in these four silos. Also, some of the columns of the longitudinal wall near the outside abutments settled up to 10 cm (4 in.) leaving a gap between these columns and the main beams. The silos withstood this earthquake remarkably well.

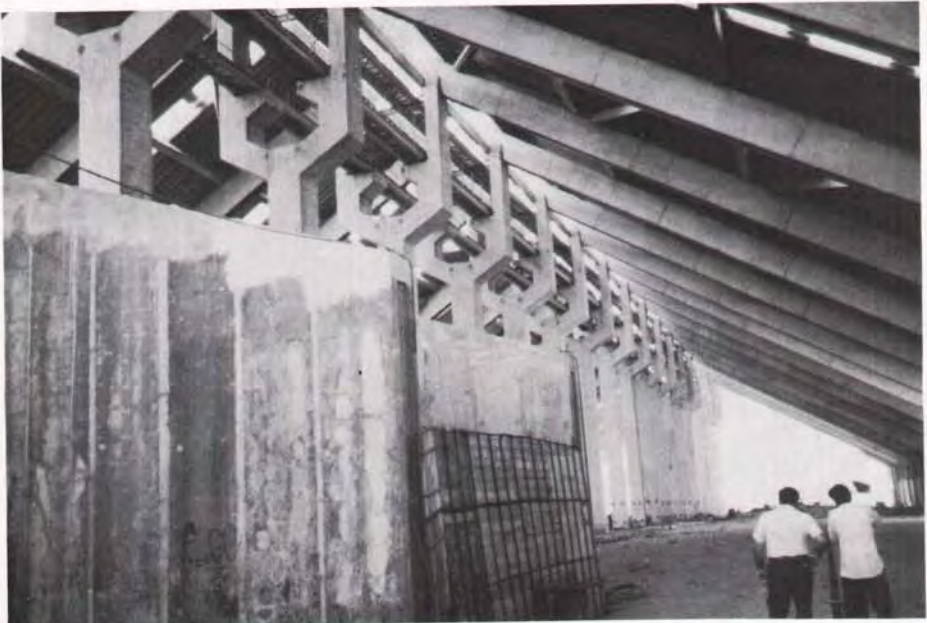
Within the two-bay building, the previously level, slab-on-grade became wavy (Fig. 19), inducing a difference in elevation of 1 m (3.3 ft) between the lowest and highest points. The middle row of columns settled relative to the exterior rows registering

measured differentials up to 60 cm (24 in.). There was also extensive damage to the roadway running along the storage building with the roadway settling in some locations up to 50 cm (20 in.).

Fig. B3. Middle column row of two-bay building.
