Precast concrete was used effectively to restore the deteriorated elements of this historic bridge.

Renovation of Albert Memorial Bridge

Regina's Albert Memorial Bridge was built in 1930 as a depression years make-work project. Built across Wascana Creek, the 850 ft (259 m) structure actually spans only about 40 ft (12 m) of water. In fact, it may hold a record for being the longest bridge spanning such a narrow stream.

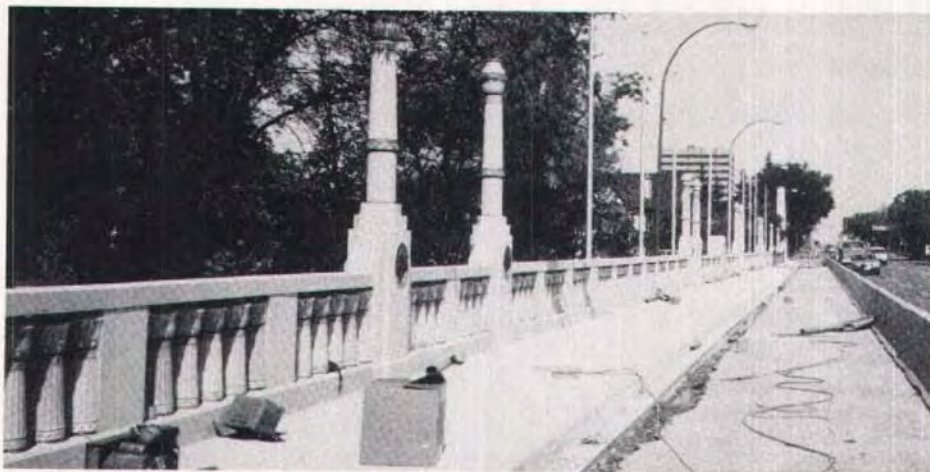
Completed precast balustrade ready for cementitious finish.

A cementitious coating was field applied to both the new precast concrete and the existing concrete to ensure a uniform appearance. All joints, including the tops of the terra cotta balusters (see Fig. 3), were sealed with a polyurethane sealant to accommodate thermal movements.

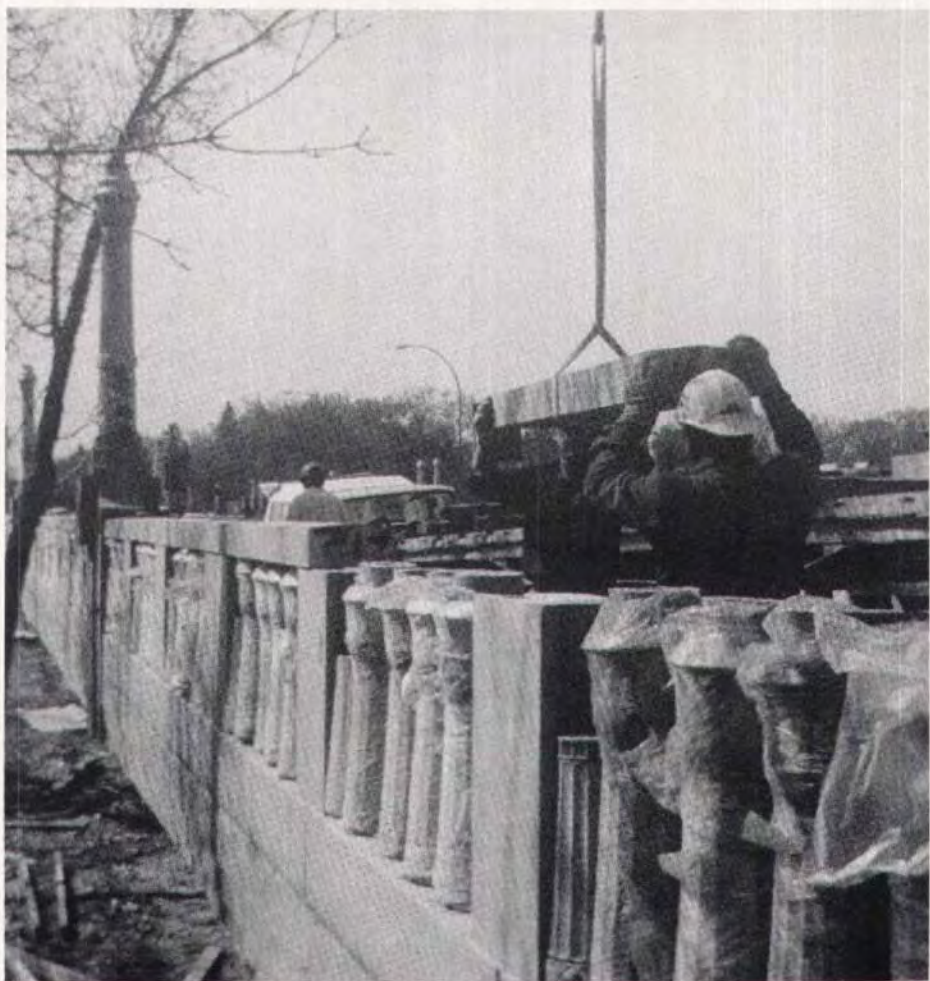
Installation of precast top rail unit.

The top rail was bolted to the posts (see Fig. 5). Thermal movements in the rails were accommodated by providing a rubber gasket around the bolt.

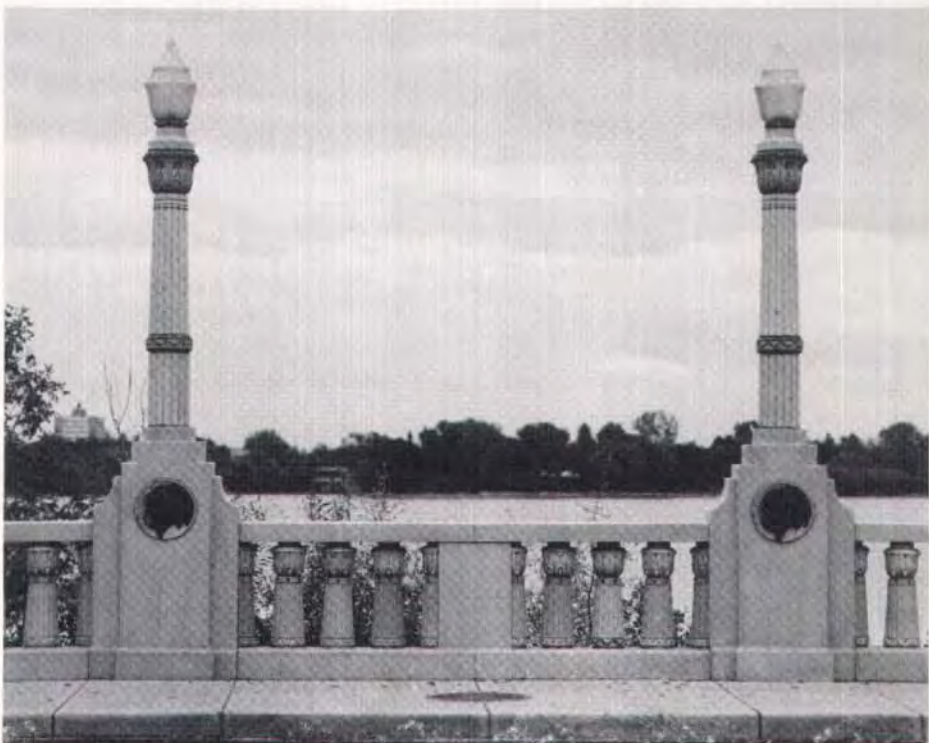
Completed balustrade.

The use of precast concrete to restore the balustrade on the 60-year-old Albert Memorial Bridge has resulted in an aesthetically pleasing, durable structure. Future vehicular damage to the balustrade can be repaired easily simply by removing the top rail to facilitate replacement of damaged balusters. The jointed system easily accommodates the thermal movements.
