# Field Performance of Full Depth Precast Concrete Panels in Bridge Deck Reconstruction

*There have been many applications of full depth precast and precast, prestressed concrete deck panels for bridge rehabilitation in North America. This paper presents the findings obtained through an investigation conducted in the United States to evaluate the field performance of bridge deck panels. The states included in the investigation were Illinois, Connecticut, Virginia, Maryland, Iowa, California, New York, Alaska, Ohio, Pennsylvania, and Washington, D.C. The investigation mainly consisted of a visual inspection of bridges selected through an*

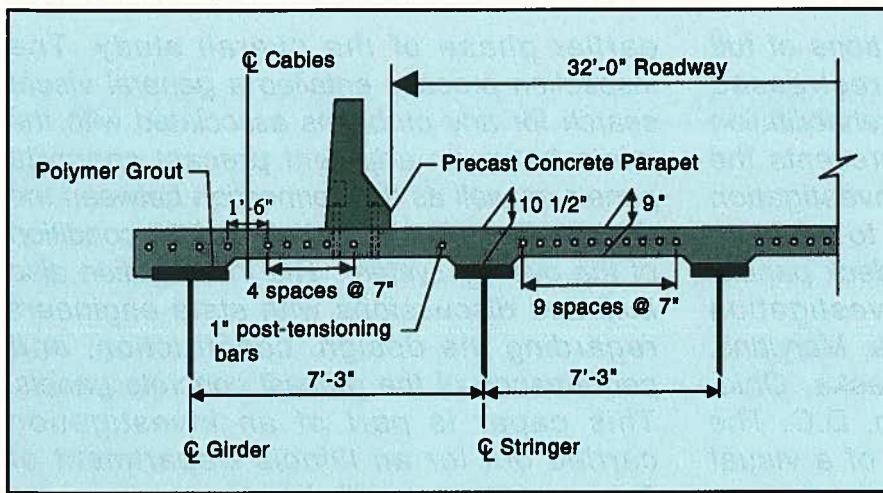
Fig. 1. Precast concrete deck section of Bayview Bridge, Quincy, Illinois.

The full width, full depth precast concrete deck panels are 46 ft 6 in. (14.2 m) wide and vary from 9 to 11 ft (2.7 to 3.4 m) in length. Post-tensioning bars, spaced at 7 in. (178 mm), had an initial tensioning stress of 105 ksi (723 MPa). A minimum concrete strength of 3500 psi (24.1 MPa) was specified. Three to five panels are post-tensioned to form a group. Fig. 1 shows a section of the precast concrete deck.

In general, the decks are performing satisfactorily. Also, no problems were encountered in the joints, although some rusting is visible, indicating leaking had occurred. The butt joints between adjacent precast concrete panels are performing adequately and no cracking or leaking is apparent. It is believed that this type of joint is satisfactory for the existing bridge system because the cable-stayed precast, prestressed deck is in compression.

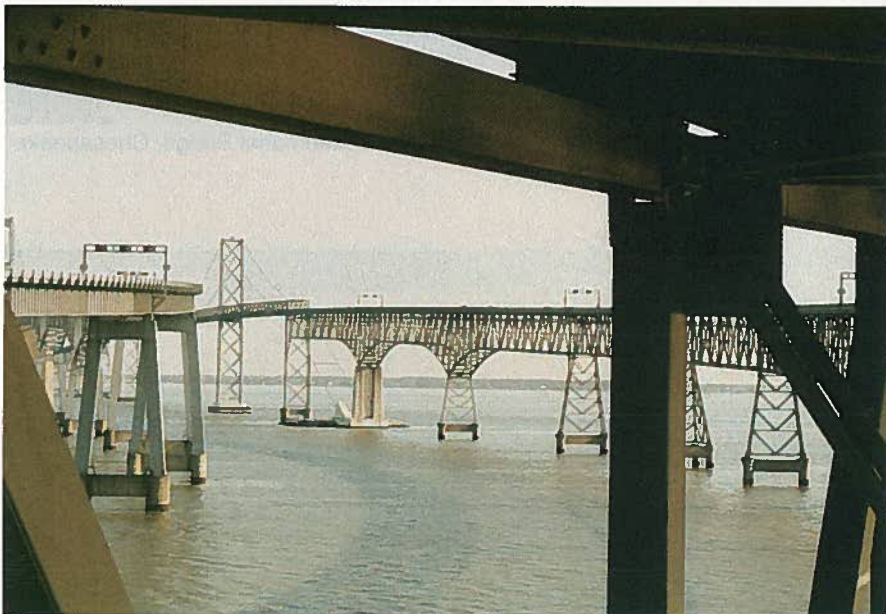
Fig. 4. General view of William Preston Jr. Memorial Bridge, Chesapeake Bay, Maryland.

A general view of the bridge is shown in Fig. 4. The deck for most of the spans was replaced with precast concrete panels that vary in sizes in order to fit the geometric requirements. The bridge was completely closed to traffic for 6 months in order for the replacement process to begin.

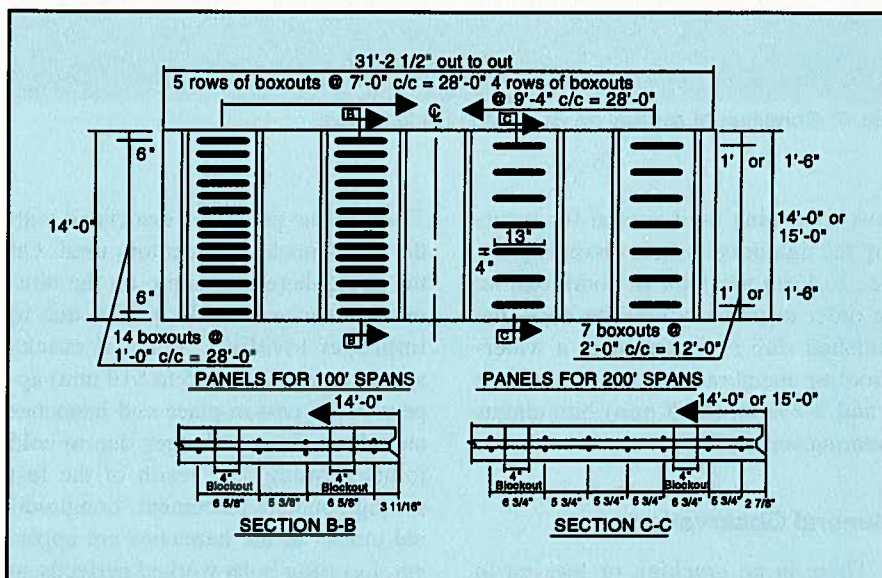
Fig. 5. Panel layout for William Preston Jr. Memorial Bridge, Chesapeake Bay, Maryland.

The panel layout and configuration of the pockets are shown in Fig. 5. Each span consists of four full width precast concrete panels. The overlay for the deck consists of a 2 in. (50.8 mm) layer of latex modified concrete in addition to the 6 in. (152 mm) deck.

The deck was inspected from the top surface and from underneath using a catwalk positioned directly below the deck. Diagonal and map cracking occur on both sides of the deck. The diagonal cracking is attributed mainly to handling and the absence of any prestressing tendons in the precast concrete panels. The panels are post-tensioned in the longitudinal direction to secure the tightness of the joints.

At one location on the deck, the latex modified concrete did not adhere at the joints between the precast concrete panels and the supporting system, causing popouts in the concrete. The engineers at the site also noticed corrosion problems associated with excessive chloride contents. The top 2 in. (50.8 mm) layer of the deck has an excess of chlorides, prompting the re-

removal (milling) of the top 2 in. (50.8 mm) of the deck and replacing it with latex modified concrete.

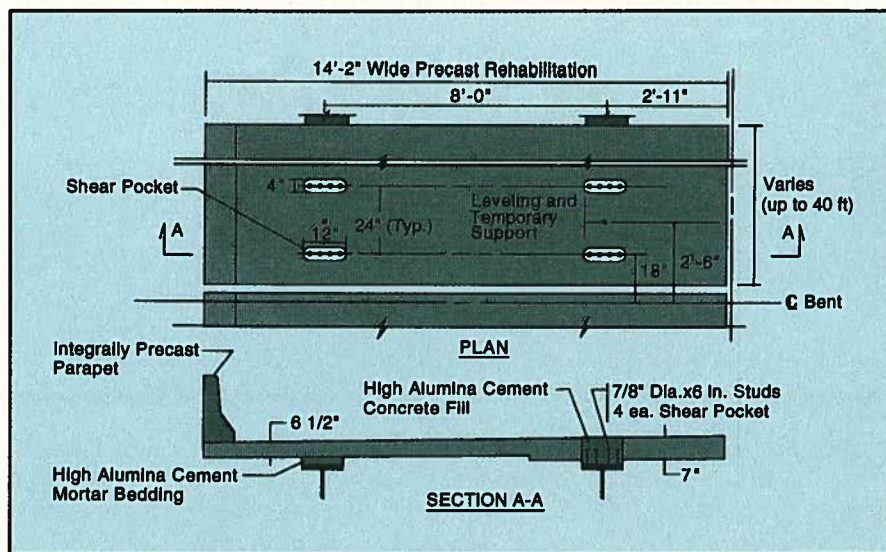
Fig. 8. Typical precast concrete deck panel for High Street Overhead Separation Bridge, California.

This bridge was widened on the left and right sides in 1955 and 1963, respectively. The structure currently consists of four lanes. The fourth lane on Spans 1 through 29 of the 30-span bridge was replaced with precast concrete deck panels in 1978 (see Fig. 8). Traffic flow was maintained during the rehabilitation process. The slab units were placed in direct contact with the girders. No haunches were provided to allow for any dimensional

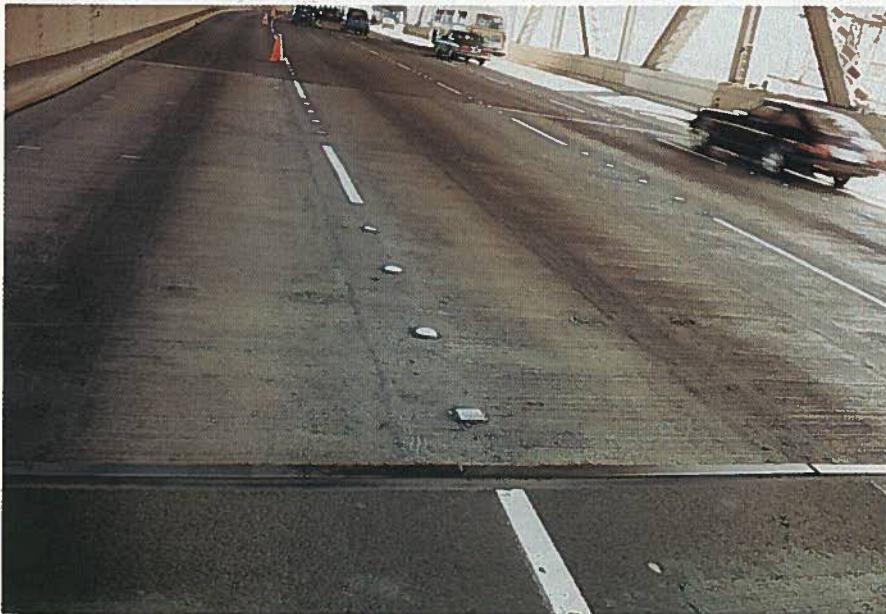
Fig. 11. Section of deck replaced due to earthquake, Oakland-San Francisco Bay Bridge, California.

In 1989, a severe earthquake (Loma Prieta earthquake) hit the area. As a result, a small section of the lower deck of the bridge was damaged and the entire width in that section (see Fig. 11) was replaced with precast concrete panels. However, that area has not been overlaid. Closure pours [12 in. (305 mm)] are provided between adjacent precast concrete elements. The bridge was closed for a period of one month while construction took place on the deck.

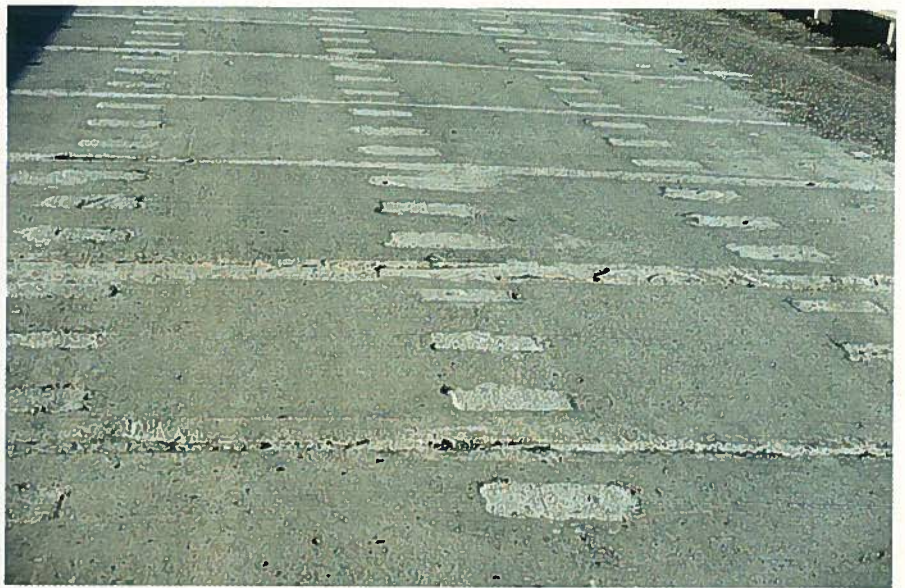
Fig. 34. Typical overview of deck panels, Dalton Highway Bridges, Alaska.

tain patching between the pockets, as shown in Fig. 38. Most of the transverse joints between the precast concrete panels are experiencing debonding, as shown in Fig. 36, while some of the bridges (North Fork Bonanza River Bridge) contain minor spalls in the deck, as shown in Fig. 34.

The Minnie Creek Bridge showed signs of leaking, while all spans contain splitting at the joints (see Figs. 34 and 36). The Middle Fork Koyukuk River 2 Bridge was reported as damaged because one of the piers has settled. Currently, travel on the bridge has been reduced to one lane with a

The transverse joint at the junction between the two 60 ft (18.3 m) spans is severely split, as shown in Figs. 34 and 36. The last two 30 ft (9.1 m) spans appear to be in good condition. The rubber material (stopper) that is provided to hold the grout is not efficient because it holds an undesirable volume. More grout and less stopper would contribute towards providing more composite action.

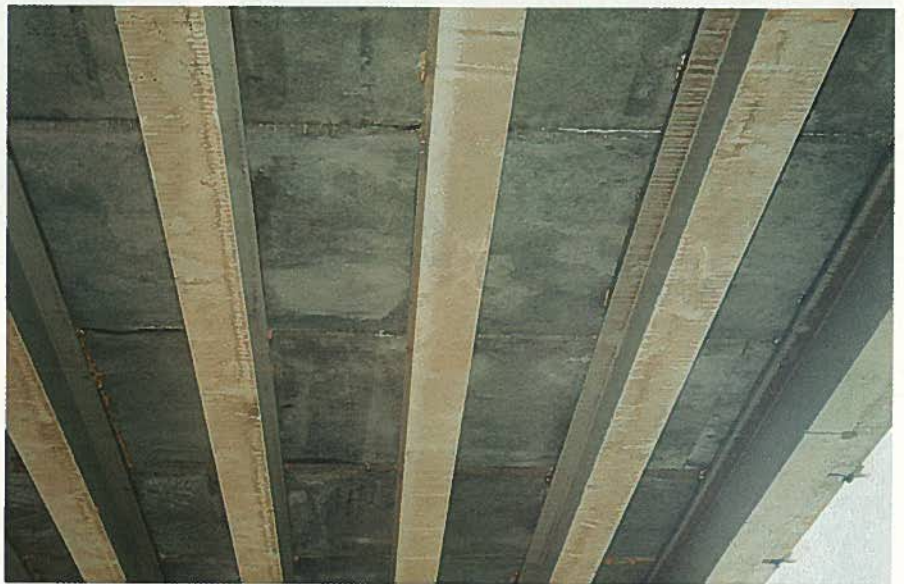
The joint between the precast concrete panels was the female-to-female type, which is similar to that used in the Chulitna River Bridge rehabilitation project. The shear pocket size was 7 x 5 in. (178 x 127 mm) with two studs  $\frac{7}{8}$  x 6 in. (22 x 152 mm) in each pocket for the 30 ft (9.1 m) spans; the pocket size was 12 x 5 in. (305 x 127 mm) with three studs of the same size for the 60 ft (18.3 m) spans. However, there were a number of exceptions to those criteria. Fig. 35 is a typical view of the deck condition from underneath.

Fig. 35. Typical underside view of deck condition, Dalton Highway Bridges, Alaska.

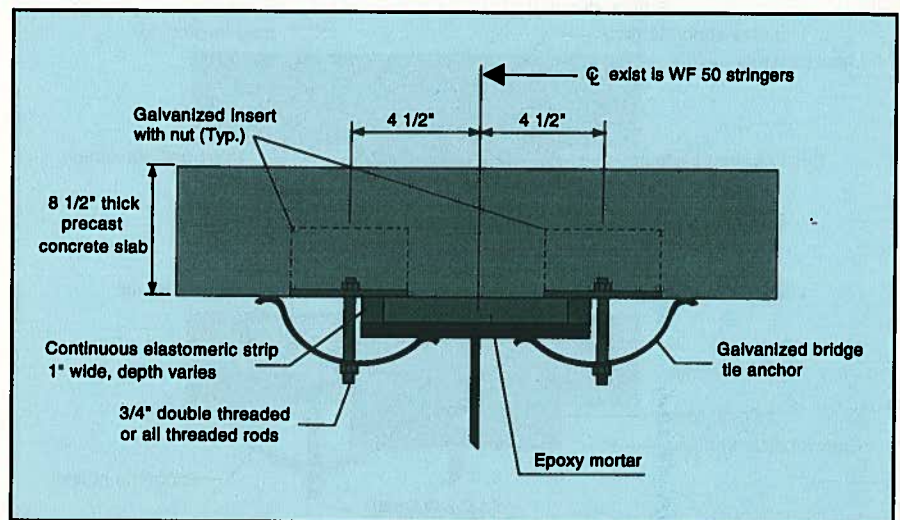
This simple span bridge is an exit ramp for the Pennsylvania Turnpike at Somerset. The joint between the precast concrete panels is shown in Fig. 42, while the slab-to-stringer connection is shown in Fig. 43.

The superstructure has extensive surface corrosion with rust laminations in the bottom flanges of all members. Some tie-downs are missing or loose. Leakage is excessive at the joints between precast concrete panels, as shown in Fig. 44. This is attributed to the inadequate connection between the deck and supporting system as well as the configuration of the transverse joint. The overlay contains some cracks. In some cases, patching was done on the top surface; however, some cracks are still seen propagating from the patching area.

Fig. 43. Slab-stringer connection, B-501 Bridge, Somerset County, Pennsylvania.

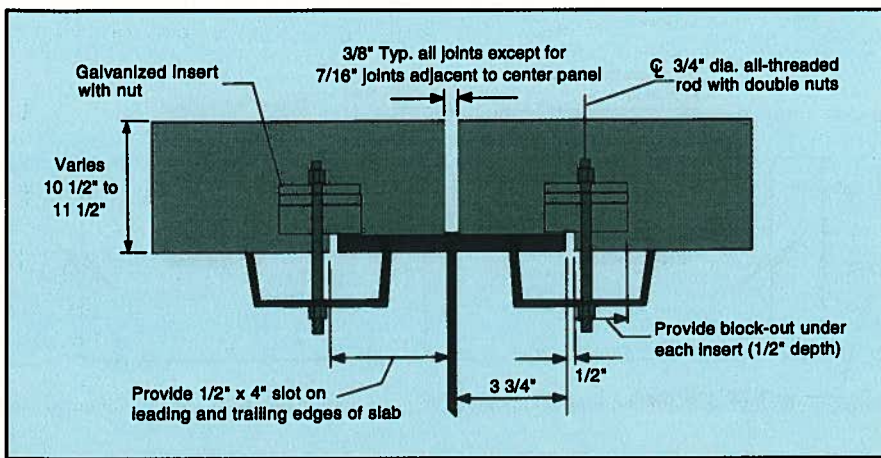
bridge was designed for low volume traffic. The precast concrete panels are connected to the structural steel by a tie-down, as shown in Fig. 45.

Fig. 45. Slab-stringer connection, B-552 Bridge, Everett, Pennsylvania.

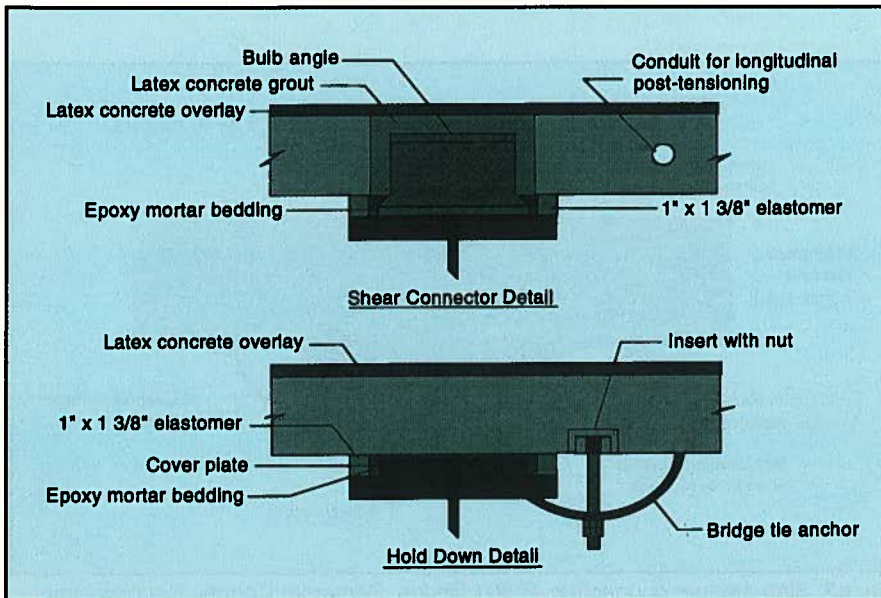
The precast concrete panels are 6 1/2 in. (165 mm) thick, with a varying haunch thickness, 7 ft 7 1/2 in. (2.3 m) long, and 17 ft 6 in. (5.3 m) wide, and cover one-half the width of the structure. Existing bulb angle shear connectors were left in place as the old slab was removed in 1981. The slab panels with shear pockets were cast with sufficient precision so that the precast slab fitted properly when placed. Elastomeric strips are glued to the top of the flanges to contain the epoxy mortar that provides uniform bedding of the precast concrete panels. Fig. 46 shows the connection details.

Fig. 46. Shear connector and hold down details, NB-216 Quakertown Interchange Bridge, Bucks County, Pennsylvania.
