## OPTIMUM CFRP REPAIR CONFIGURATION FOR DAMAGED PRESTRESSED CONCRETE BRIDGE GIRDERS DUE TO VEHICLE COLLISION IMPACT

**Adel ElSafty, PhD, PE**, Civil Engineering, University of North Florida, Jacksonville, FL  
**Matthew K. Graeff**, Graduate Student, University of North Florida, Jacksonville, FL

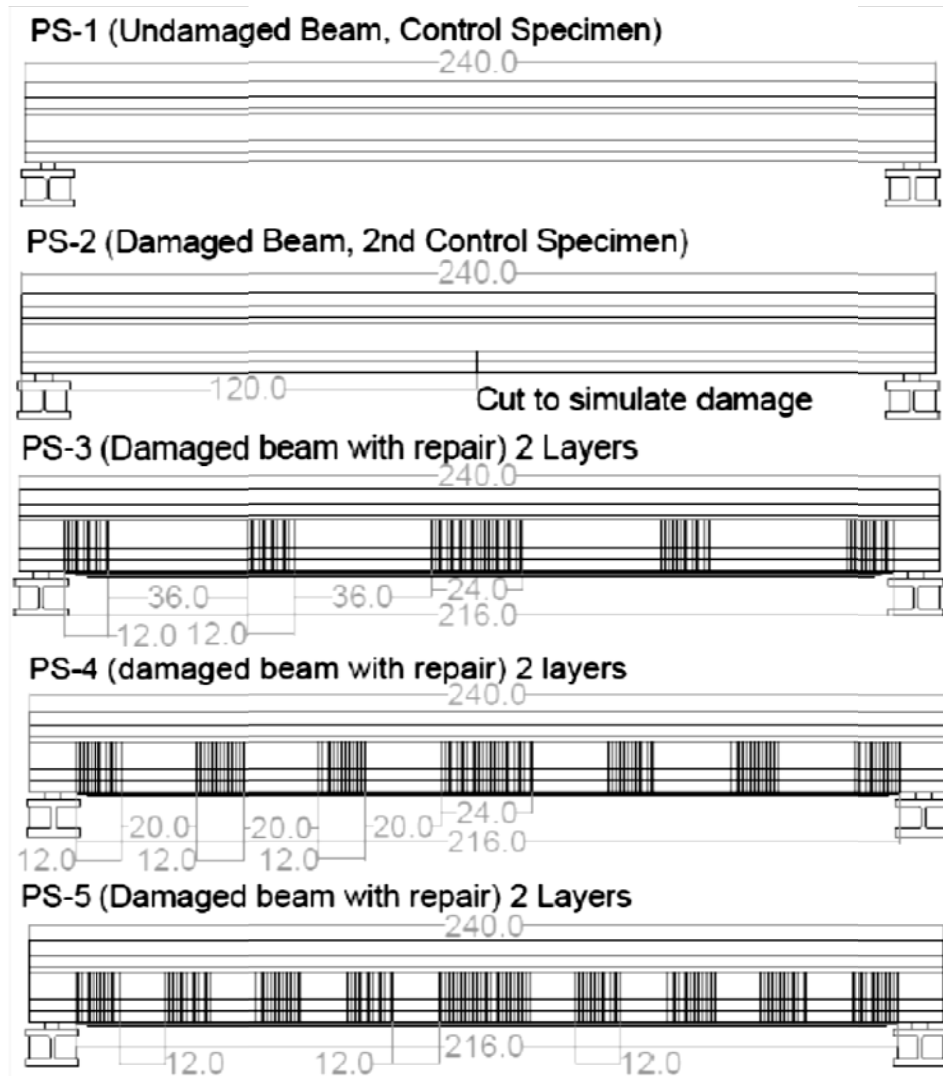
**Fig. 3:** CFRP configurations used for tested girders PS-1 to PS-5

Multiple CFRP configurations and strengthening levels were used to repair the ten girders. The longitudinal strips were all eight inches wide and started at seventeen feet long, reducing six inches per each additional layer applied to each beam. The transverse U-wrappings were twelve inches wide and extended to the top of the web of the each girder. Fig. 3 & 4 show the CFRP configurations for the half-scaled AASHTO type II girders tested.

In Fig. 3, the first girder (PS-1) is a control girder that represents an undamaged and unrepaired specimen. Similarly, the second girder (PS-2) is a damaged specimen which has received no CFRP repair (only concrete repair) representing the lower bound of the tested samples. The remaining girders had both simulated impact damage imposed on them and 2 layers of CFRP at various spacing to constitute the repair. The spacing between U-wrappings was set at a distance of twelve inches, twenty inches, or thirty-six inches.

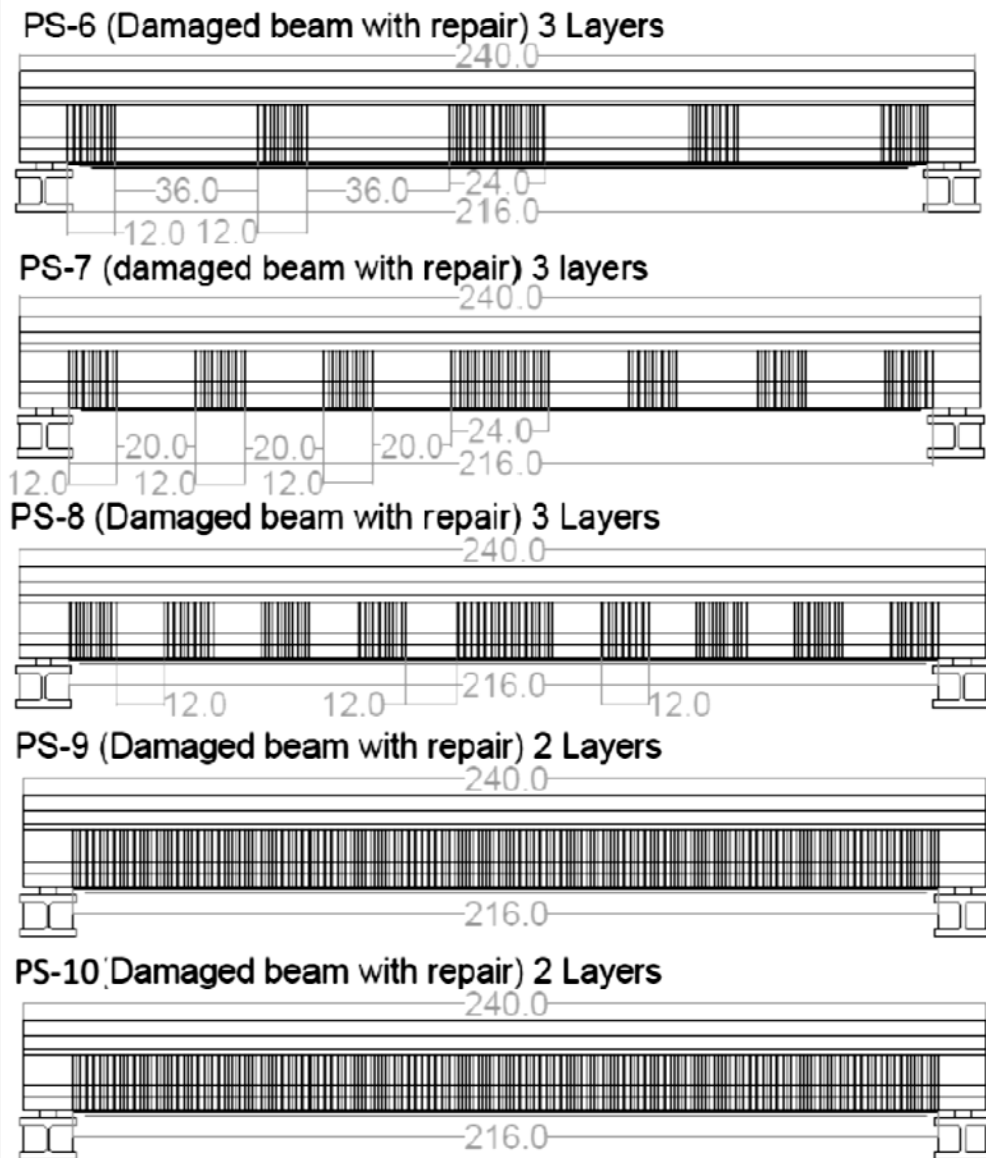
**Fig. 4:** CFRP configurations used for tested girders PS-6 to PS-10

Similarly, Fig. 4 displays the CFRP configurations for the remaining girders tested. The first three girders presented (PS-6 through PS-8) are damaged and repaired with 3 layers of CFRP at the girder soffit and U-wrappings at the same spacings of twelve inches, twenty inches, or thirty-six inches. The final two beams (PS-9 & PS-10) are fully wrapped girders (U-wrappings cover entire beam) using 2 layers of CFRP for the repairs (soffit and U-wrapping). However, the U-wrappings applied to PS-10 were overlapped by inch, whereas those applied to PS-9 were not. This was intended to investigate a simple question of continuity in the direction opposite to that of the fibers.

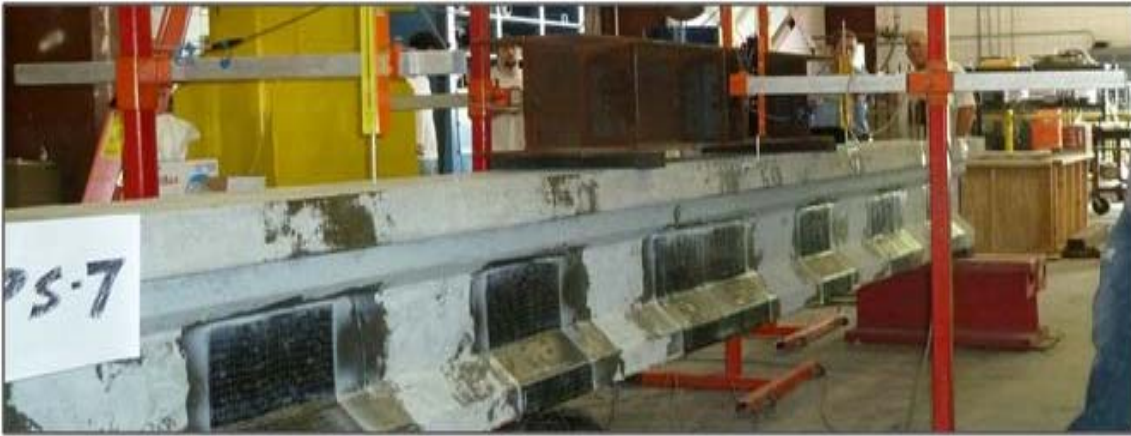
**Fig. 5:** Girder test setup diagram and photo of specimen during testing

The girders were tested under four point loading using an 800 kip load actuator at the FDOT structures research lab. The 20-ft long PSC girders spanned nineteen feet between the centerlines of the bearing pads which rested on stationary supports. The girder loading was applied using a steel spreader beam resting on another set of two pads with a center to center distance of fifty inches. Fig. 5 shows one of the tested girders (PS-7) just prior to loading.

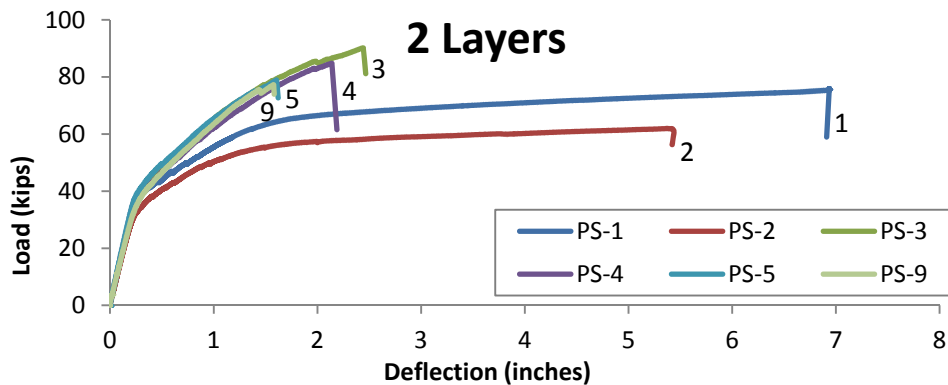
**Fig. 7:** Load vs. deflection for controls and girders with 2 layers of CFRP

The load-deflection behaviors for each girder tested are presented in various comparisons in Fig. 7 through Fig. 12.

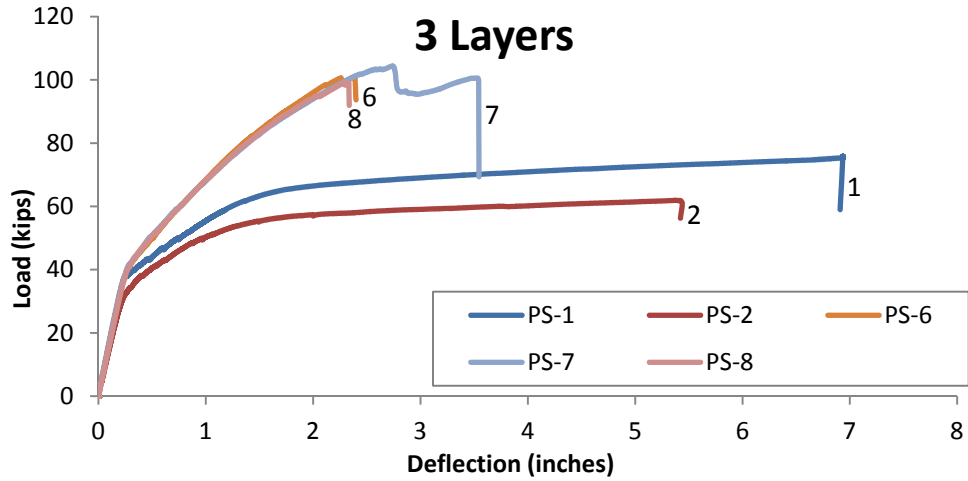
**Fig. 8:** Load vs. deflection for controls and girders with 3 layers of CFRP

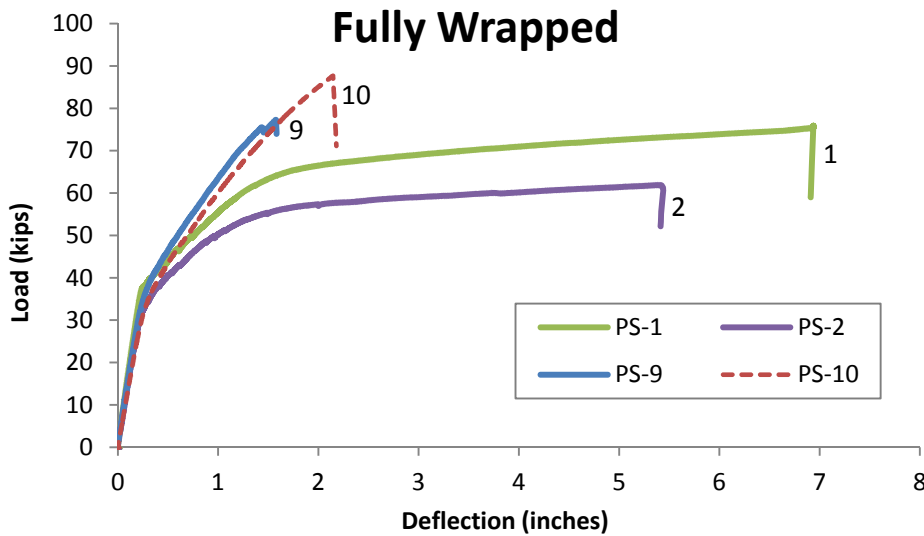
**Fig. 12:** Load vs. deflection for controls and fully wrapped configurations

As seen from the results, the damage and cutting of one of the prestressing strands (Girder PS-2) resulted in 18.44% loss in flexural capacity compared to the undamaged control girder (PS-1). The CFRP repair of a damaged girder, as shown in girders PS3 to PS9, restored the damaged girder’s capacity and exceeded the capacity of the undamaged control girder PS-1 by up to 37.63%. The results also show that U-shaped wrapping of CFRP laminates (Girders PS-3 to PS-8) enhanced the flexural capacity even if the U-wrapping was not continuously covering the entire girder side (not fully wrapped). By comparing the two fully wrapped beams, it is understood that overlapping transverse U-wrappings is needed to develop proper continuity; even in a direction perpendicular to the direction of the fibers.

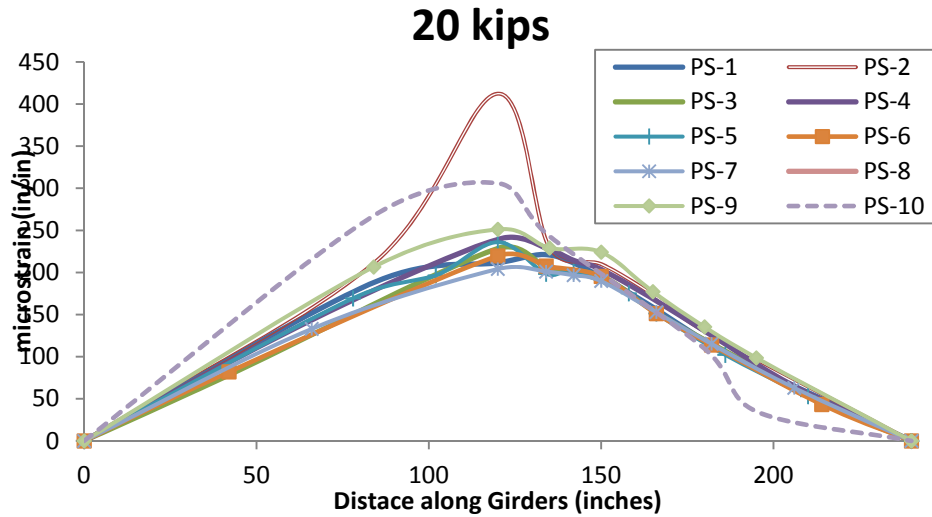
Fig. 12: Strain at extreme bottom fiber of girder soffit vs. length for all girders

The strains measured at a load level of 20 and 70 kips are presented in Fig. 12 & 13. Half of the span lengths of the symmetrical girders were instrumented with a multitude of strain gages while the other half of the span length had one strain gage. Therefore, the profiles shown depict much more detailed behavior of the girders' right side of the center span.

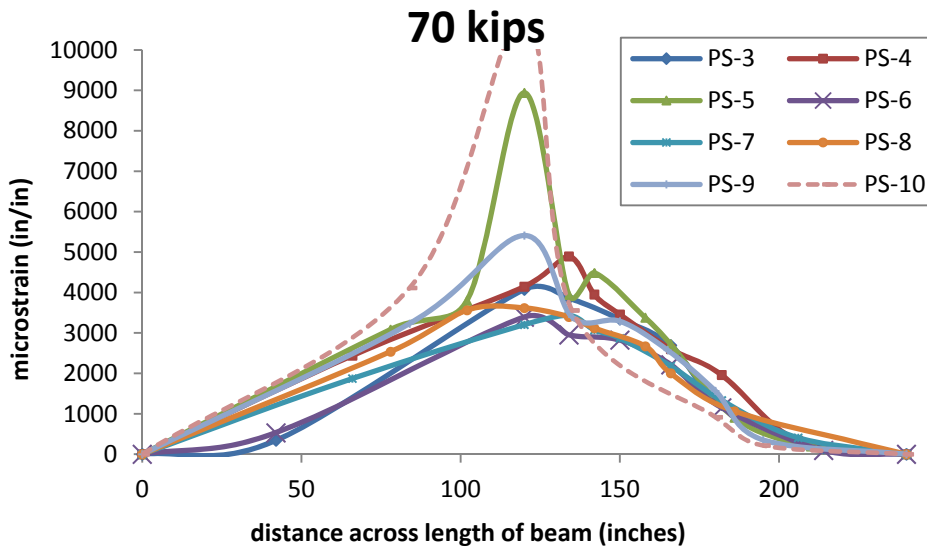
Fig. 13: Strain of CFRP at girder soffit vs. length for repaired girders

Though the comparisons are quite similar, one important thing to note is that when comparing the strain profiles with the configuration layouts it can be noticed that on the side of U-wrapping towards diminishing moment the strain in the longitudinal CFRP may spike briefly (more detailed measurements will be needed to verify).

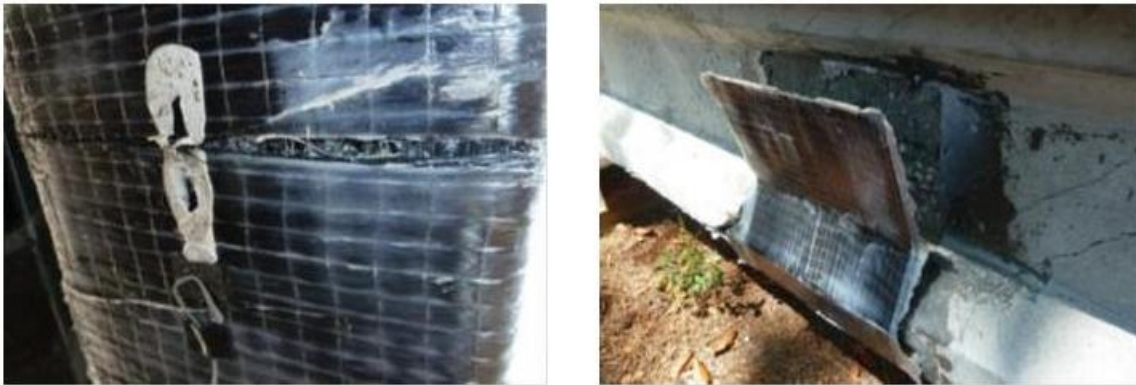
**Fig. 11:** (left) Rupture of longitudinal CFRP; (right) Debonding of CFRP U-wrapping

The modes of failure for the girders were also documented and reported. The control girders PS-1 and PS-2 experienced ductile flexural failure with excessive deflection and cracking. The repaired girders experienced CFRP rupture or localized debonding followed by rupture of CFRP; as shown in Fig. 11 & 12. Some repaired girders also experienced debonding of some of their U-wrappings, as shown in Fig. 11 (right).

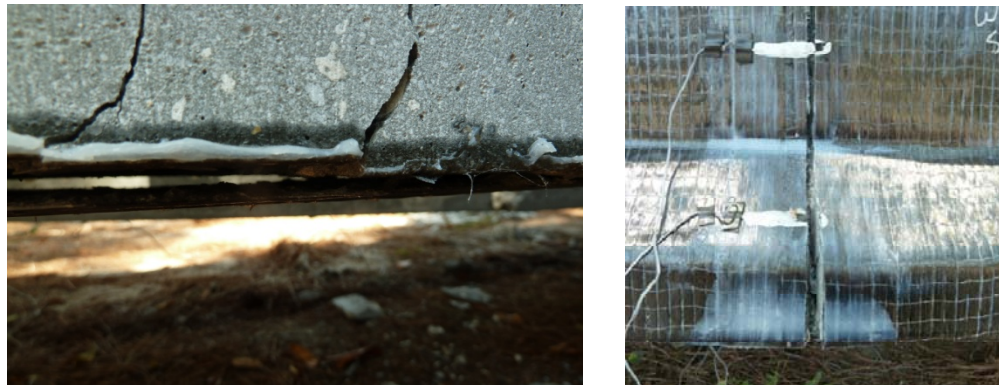
**Fig. 12:** (left) Debonding of soffit CFRP; (right) Rupture of longitudinal & transverse CFRP
