1  
2  
3  
4  
5 **FRP REPAIR & STRENGTHENING OF DAMAGED END REGIONS OF**  
6 **PRESTRESSED BEAMS**  
7

30 *of conventional and innovative repairing methods to restore the shear*  
31 *capacity of PC beams with severely damaged end regions using experimental*  
32 *and numerical approaches. The use of Fiber Reinforced Polymer (FRP)*  
33 *laminates for repair was explored experimentally in addition to exploring*  
34 *numerically with FE modeling an innovative repair concept using prestressed*  
35 *Shape Memory Alloy (SMA) wires. Three half-scale PC I-girders are cast with*  
36 *reduced area stirrups in the end regions to represent damage. Various shear*  
37 *FRP laminate schemes are experimentally tested, including several which*  
38 *utilize longitudinal FRP strips to prevent premature laminate debonding from*  
39 *the concrete substrate. In the FE model curved prestressed SMA wires are*  
40 *embedded in the concrete cover to help restore the girder's shear strength.*  
41  
42

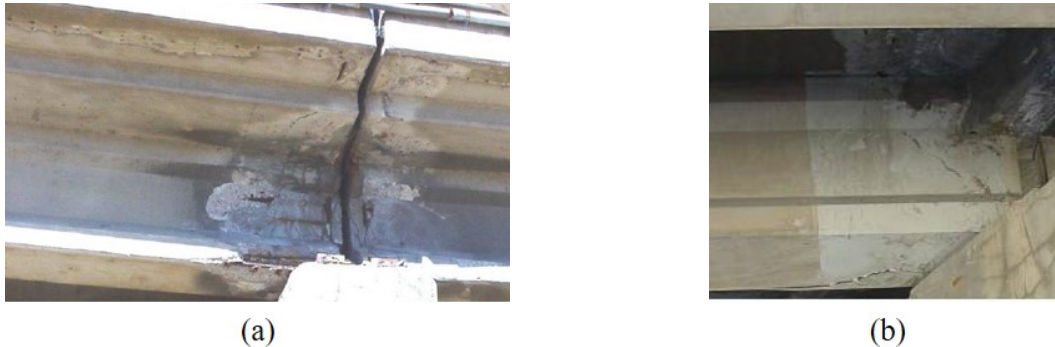
61 Fig. 1 End region of prestressed girder: (a) end damage of girder; (b) typical mortar repair of  
62 girder end  
63

56 primary concern is shear failure. Traditionally mortar is utilized to repair girder's end region  
57 as shown in Figure 1(b). However, no studies were ever conducted to quantify the shear  
58 capacity gained by using mortar alone.

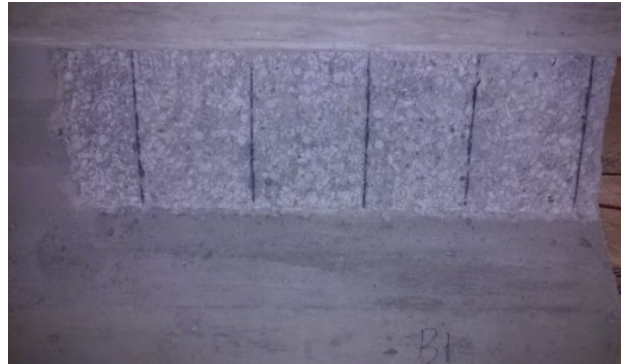
137  
 138 Fig. 4 Beam web after cover removal  
 139

133 To represent the damage to the end region of the girder in the field, removal of  
 134 concrete cover with a depth equal to 0.5 in. (12.7 mm) was applied to the web within shear  
 135 span on both sides. The beam web after removal of concrete cover is shown Figure 4.  
 136

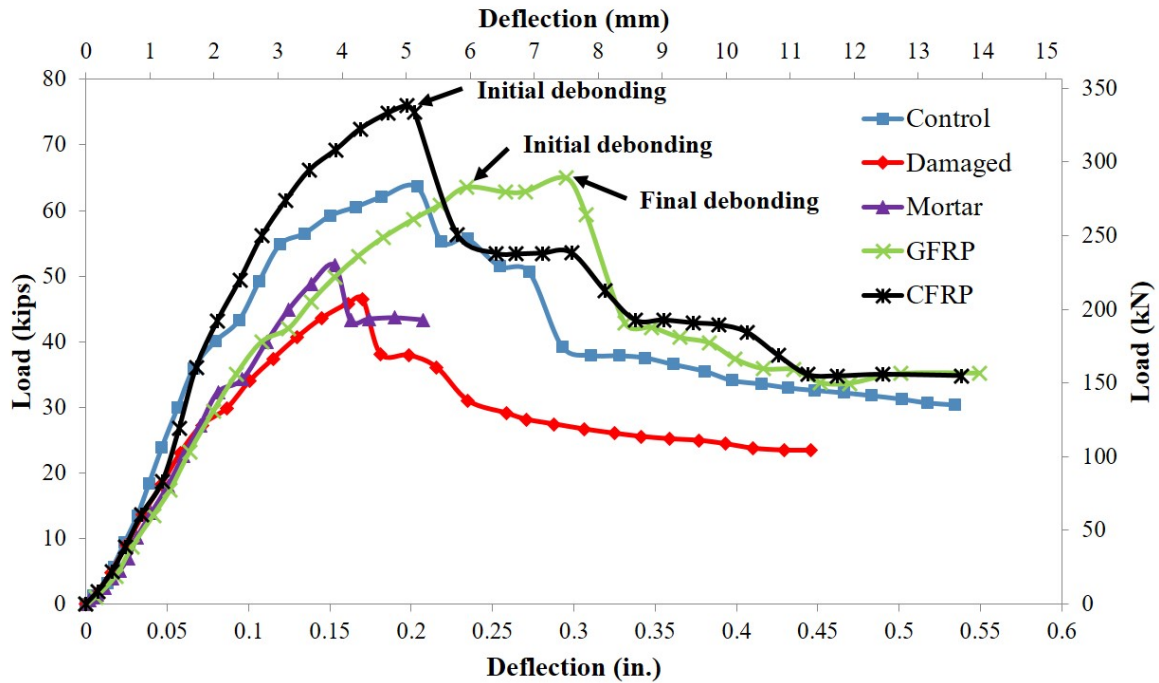
Fig. 6 Load-deflection curves

169  
 170 The test results including peak load, secant stiffness at deflection equal to 0.079 in. (2 mm),  
 171 slip of strand, max. principal strain and max. FRP strain are summarized in Table 3. The  
 172 failure modes of the beams were governed by either shear cracking along the diagonal  
 173 compression strut as in the cases of Control, Damaged, and Mortar specimens or debonding  
 174 of FRP reinforcement as in the cases of GFRP and CFRP specimens. The load-deflection  
 175 curves are depicted in Figure 6.  
 176

As shown in Figure 6, removal of concrete cover resulted in 27.0% and 24.1% reduction in peak load and stiffness respectively. Mortar repaired specimen reached 81.1% of the peak load and 78.9% of the stiffness of the Control specimen. The max. principal strain of Mortar specimen was lower than Control and Damaged specimen, which indicated that additional mortar didn't fully engage with the core concrete. Two reasons could contribute to this issue: 1) the compressive strength of mortar was lower than that of beam concrete; 2) the cold joint existed between the exposed core concrete and mortar repair. At this interface, reduced aggregate interlock diminishes the strength recovery effect of the mortar repair. Such phenomenon is also suggested by the cracking patterns shown in Figure 7. The shear cracks of Control case propagate directly from the support to the loading plate while the shear cracks of Mortar case travel along the junction between web and bottom flange before proceeding up through the web.

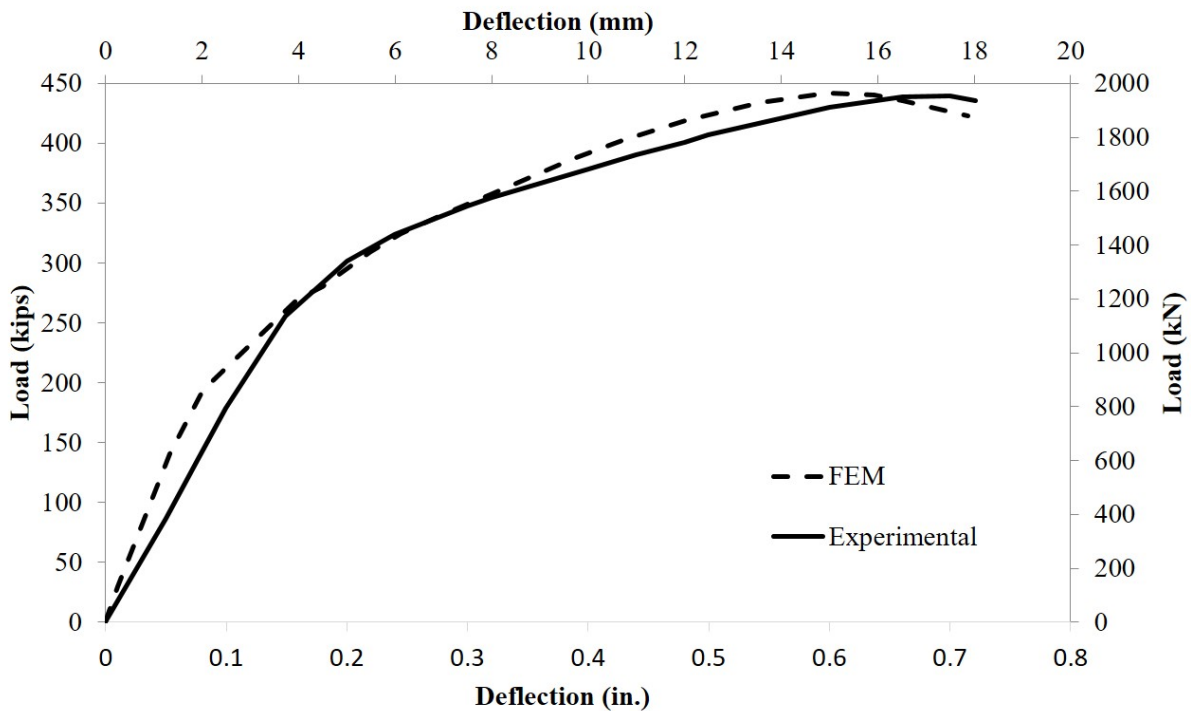
Fig. 11 Load-deflection curve

246  
 247 A three-point bending test was performed using the same test setup of Test 7 in  
 248 Andrawes and Pozolo's work<sup>8</sup>, which has a shear span of 57.9 in. (1.47 m) and a support-to-  
 249 support distance of 427 in. (10.84 m). The test setup and model assembly are illustrated in  
 250 Figure 10. The deflection was measured under the point of loading. The load-deflection  
 251 curve is shown in Figure 11. Although the FE model showed slightly higher initial stiffness  
 252 than test result, the load-deflection curve showed relatively good match.  
 253

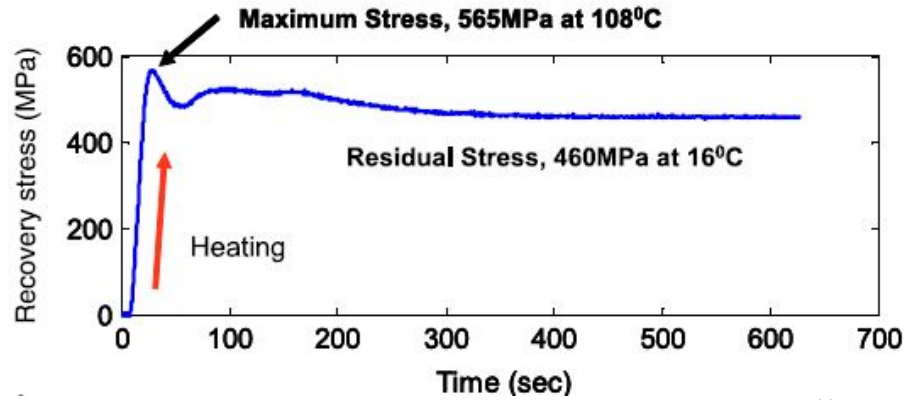
Fig. 14 Recovery stress developed in SMA during heating<sup>11</sup>

300 To address the concern which many bridge engineers express regarding recovery of  
 301 the already distressed regions of the beam with external FRP laminates, which makes future  
 302 inspection quite difficult, a new repair approach using embedded prestressed wires was  
 303 explored numerically. Due to the ease and low labor required for prestressing shape memory  
 304 alloy (SMA) wires<sup>11</sup>, they were considered in this exploratory study. As illustrated in Figure  
 305 14, previous studies showed that 0.079 in. (2 mm) -diameter SMA wire with 6.2% prestrain  
 306 could produce considerable recovery stress (prestress) simply through heating. This prestress  
 307 will be maintained at a wide range of ambient temperature.  
 308
